MERRIMACK RIVER BASIN  
TOWNSEND, MASSACHUSETTS

TOWNSEND HARBOR DAM  
MA 00138

PHASE I INSPECTION REPORT  
NATIONAL DAM INSPECTION PROGRAM

JUNE 1979

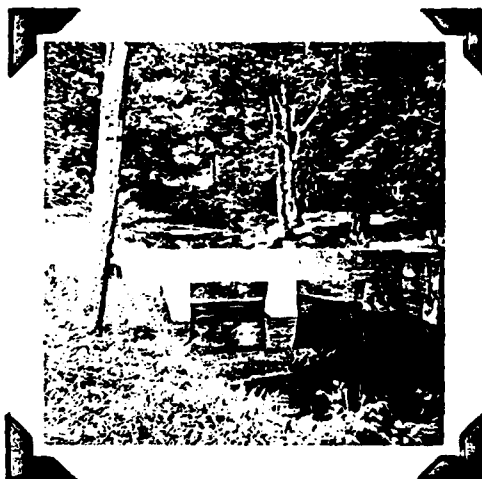
*STOPLOG GATES IN BY-PASS CHANNEL*

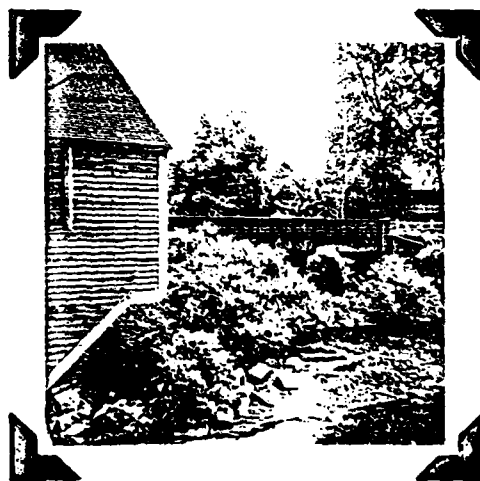
*HIGHWAY BRIDGE DOWNSTREAM*

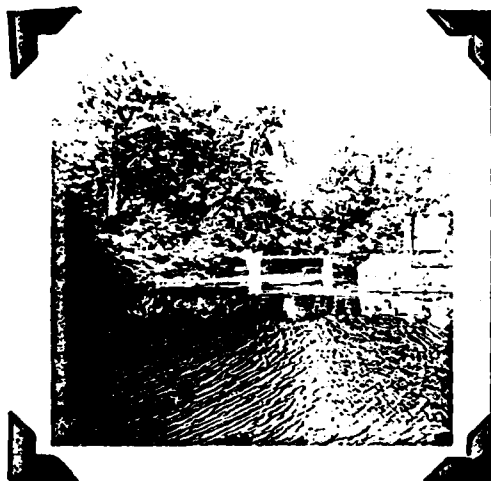
*RAILROAD BRIDGE AND NORTH UPSTREAM ABUTMENT*

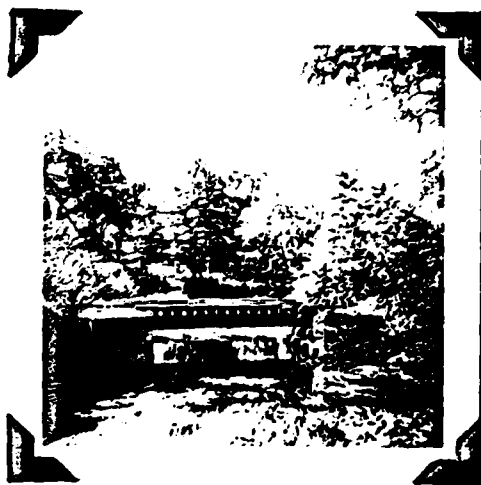
*RAILROAD BRIDGE AND POND BEYOND*

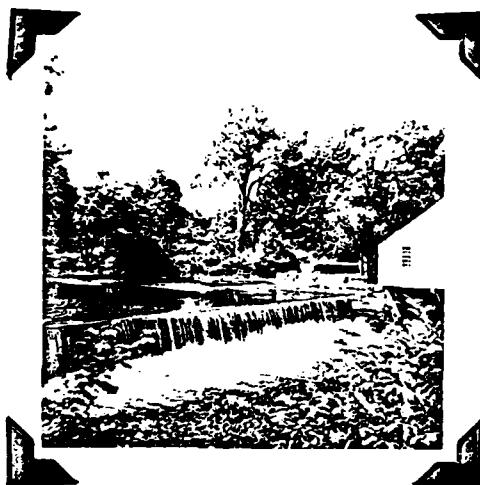
*SPILLWAY*

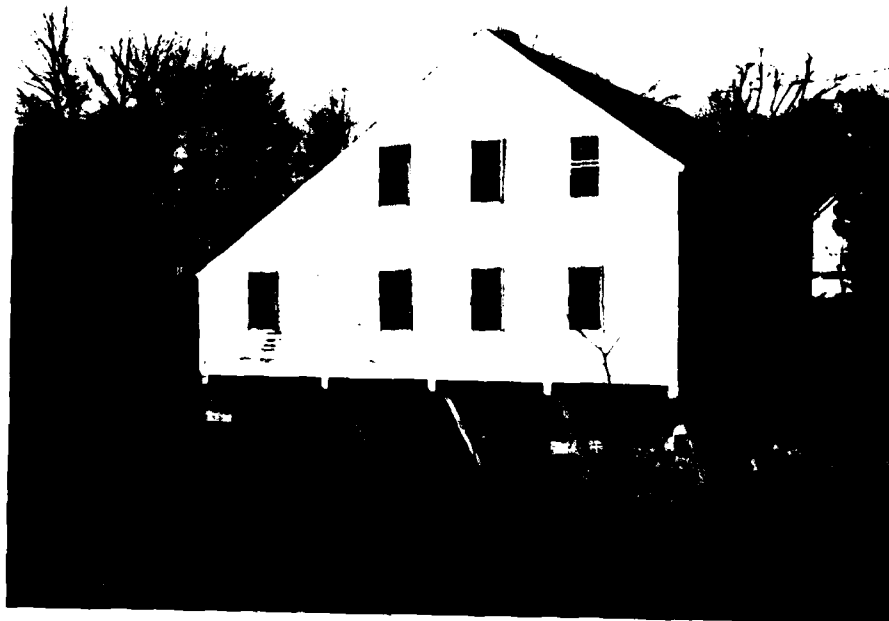
4. VIEW OF THE "COOPERAGE" FROM DOWNSTREAM RIGHT BANK OF SQUANNACOOK RIVER.

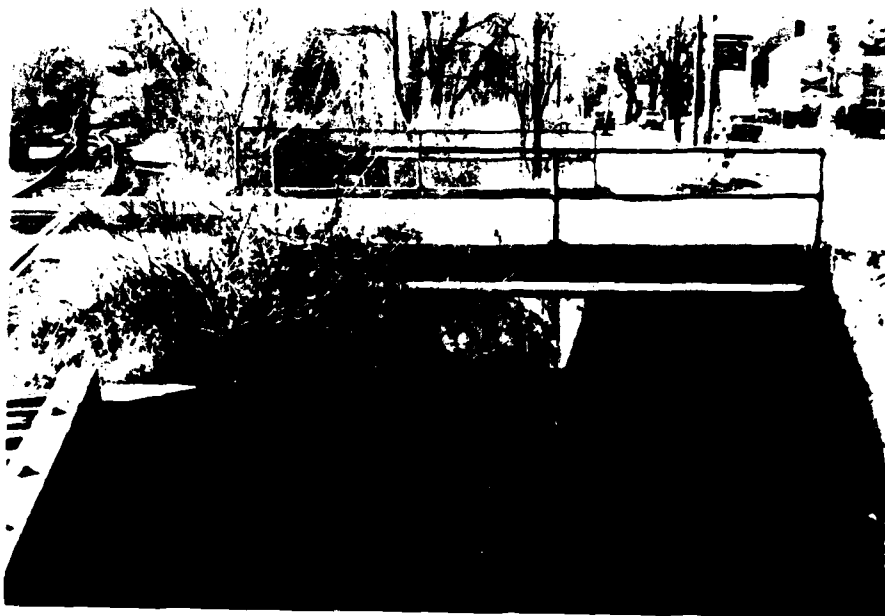
8. DOWNSTREAM FACE OF SOUTH HARBOR ROAD OVER MILLRACE.
