NATIONAL PROGRAM FOR INSPECTION OF NON-FEDERAL DAMS  
HASKELL POND DAM (MA..U) CORPS OF ENGINEERS WALTHAM MA  
NEW ENGLAND DIV SEP 79

HASKELL POND DAM  
MA 00155

PHASE I INSPECTION REPORT  
NATIONAL DAM INSPECTION PROGRAM

SEPTEMBER 1979

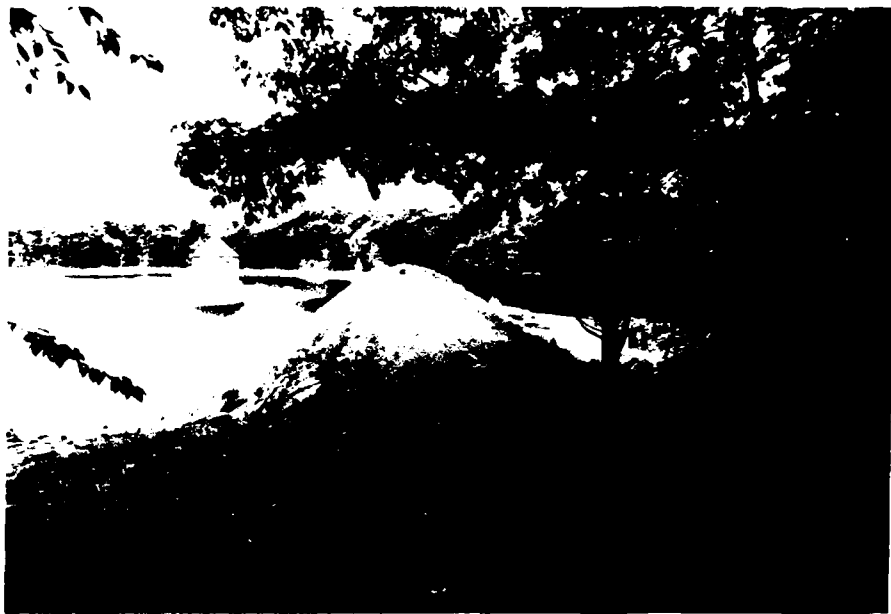
1. Overview of Haskell Pond Dam

On the top of the dam there is a one-lane gravel roadway with a thin layer of broken rock as a surface, Photo No. 1. The top of the dam measured about 17 ft. in width at the right end. The gravel roadway itself, which is about 3 to 6 in. higher than the shoulder areas, is about 10 ft. in width. The crest of the dam has been cleared of brush over about two-thirds of its length at the right end. At the left end, at the location of an abandoned cast iron emergency supply pipe which crosses the crest of the dam and the spillway, brush has not yet been cleared.

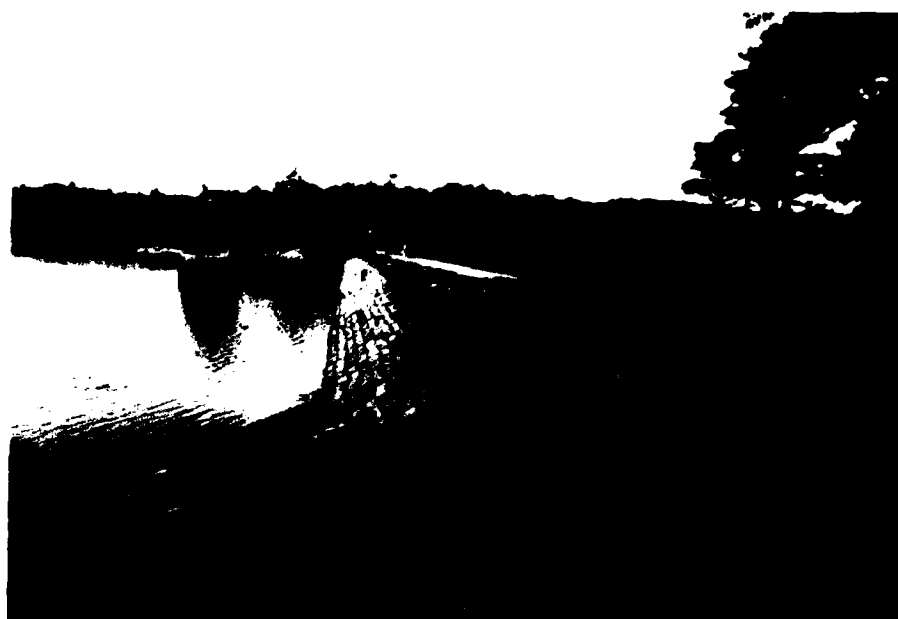
b. Dam. The upstream slope of the dam, Photos No. 2 and 3, is paved with rough cut granite stones, rectangular in shape and measuring approximately 12 to 15 in. by 15 to 24 in. There is no mortar in the joints between stones, but generally the stone paving appears to be in good condition. Joints between the stones are occasionally 4 to 5 in. in width and the depth is commonly 4 to 6 in. At some locations where the underlying material has washed out, the joints are 10 to 12 in. deep. Minor vegetation is growing in the joints near the top of the slope. In general, the stones appear to have slid downslope somewhat and in so doing have tilted slightly.

The concrete paving on the upstream slope at the top of the dam was reportedly placed in 1958 to correct an erosion situation which had apparently developed above the granite block riprap. The slabs measure 4.5 ft. up the slope and have construction joints spaced about 9.5 ft. The concrete paving is generally in good condition with water stains and only minor cracks, Photos No. 2 and 3.

The intake gatehouse is currently only accessible by boat, Photo No. 3. Consequently, the interior of the gatehouse was not observed. The gate valves controlling the four intake ports, 12-in. line and 20-in. line are all reported to be open. As viewed from the dam, Photo No. 4, the roof of the gatehouse appeared to have depressions indicating possible problems. The top of the concrete substructure has been covered with mortar. This mortar appears to be loose and spalling. The remaining exposed portion of this substructure is weathered, exposing aggregate in the concrete.

3. Upstream side of dam from right abutment

Remedial measures, including supplying access to the intake gatehouse, making sure gate valves for pipes through the embankment can be closed at the upstream end, removing flashboards and timber beams from across the spillway, completing brush removal, monitoring seepage near the toe on the right side, clearing vegetation along the spillway discharge channel and repairing the gatehouses and reservoir drain gate valves, as outlined in Section 7.3, should be implemented by the Owner within one year after receipt of this report. The Owner should also prepare a formal operations and maintenance manual for the dam and update the emergency preparedness plan.

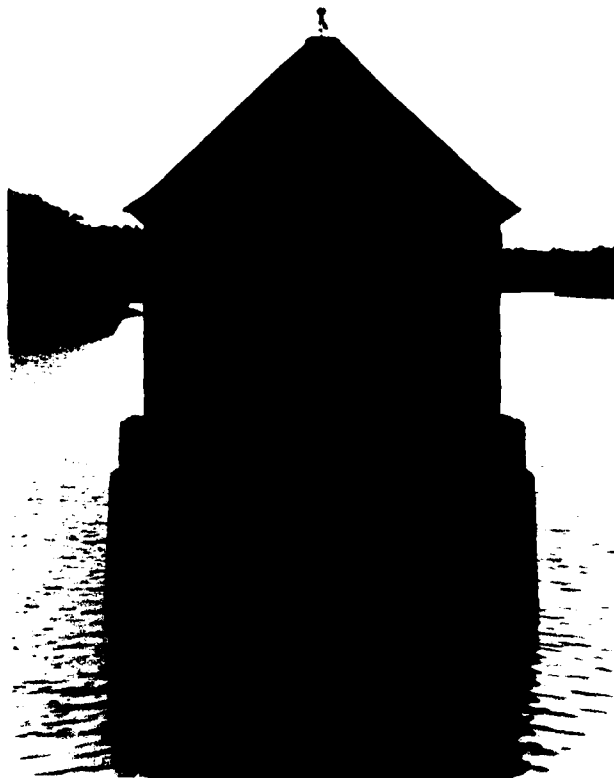
The roof of the outlet gatehouse has many bullet marks and a few missing slates. The portion of the roof facing the dam needs to have the major portion of the slates replaced. The brickwork is in good condition. There are some bullet marks and some minor loss of mortar in the joints. Traces of efflorescence were observed on the brickwork. The concrete base is sound, but there is some surface deterioration. The exterior of the outlet gatehouse is shown on Photos No. 4, 5, 6 and 11.

4. Circular intake  
structure with  
reservoir level  
guage

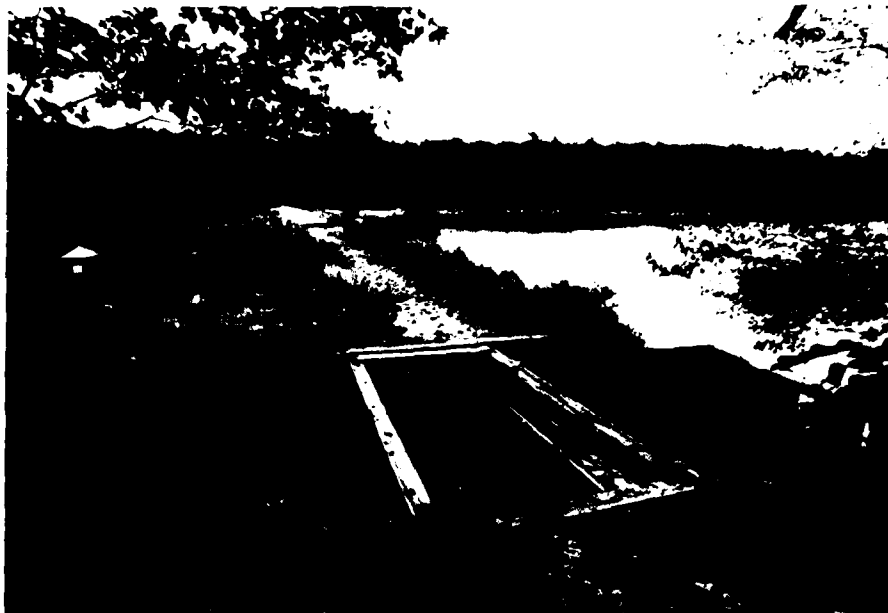
c. Appurtenant Structures. The spillway structure at the left abutment of the dam is in good condition. One tree is overhanging the spillway on the left side. The top of the walls at the entrance to the spillway have some deterioration present, probably due to the continued battering of the log boom against the concrete, Photo No. 8. The approach area appears to be free of vegetation. Semi-permanent flashboards are in place, forming the present weir of the spillway.

The chute discharge channel from the spillway appears to be in good condition. The invert of the chute is stone masonry, Photos No. 8, 9 and 10. Vegetation is very heavy on the left side and somewhat lighter on the right side of the chute, Photo No. 10. Many trees overhang the channel from the left side. It appears that there has been a buildup of earth at the transition between the spillway and the chute on the right side of the discharge channel, Photos No. 8 and 9. A small amount of loose overhanging rock is present at the upstream end of the chute on the left side.

8. Spillway weir and approach channel

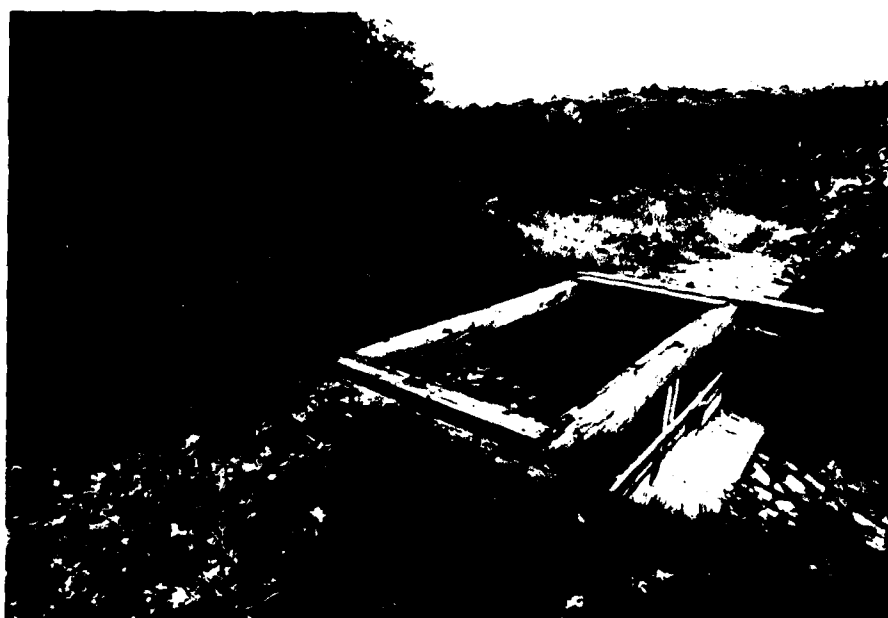
It appears that the remains of an old timber bridge across the spillway are present just downstream of the flashboards. The timbers are in poor condition. The upstream timber forms an additional support for the flashboards. Vegetation is present in the area just downstream of the flashboards at the invert of the spillway, Photo No. 9. Only slight efflorescence was observed on the concrete side walls.

9. Spillway weir and discharge channel
