WALLACE POND OUTLET DAM
MA 00162

PHASE I INSPECTION REPORT
NATIONAL DAM INSPECTION PROGRAM

DEPARTMENT OF THE ARMY
NEW ENGLAND DIVISION, CORPS OF ENGINEERS

APRIL 1980

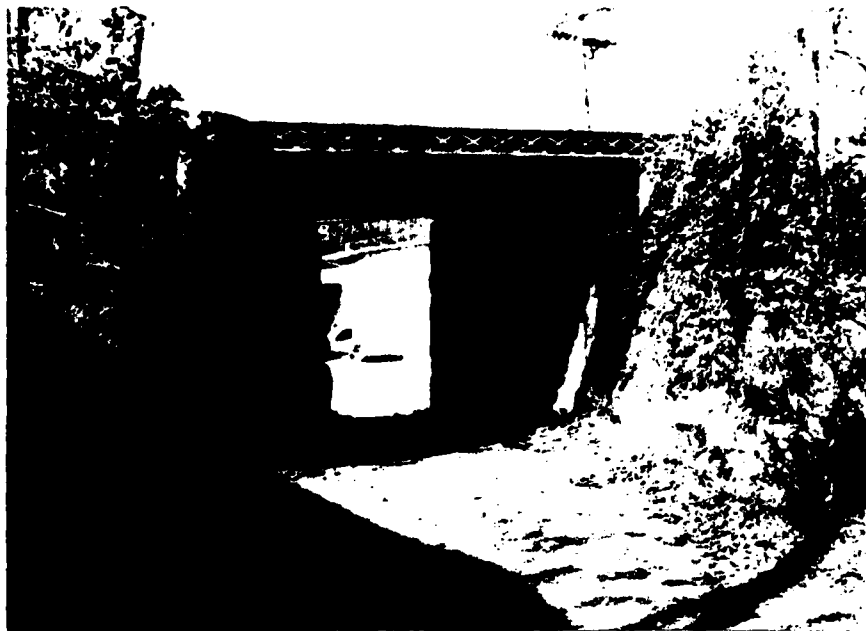
PHOTO NO. 13 - View of opening in railroad embankment for access road to Dam. The opening is 10.5 feet high by 15.5 feet wide. Most of the outflow from the test flood and at least 25% of that from a possible Dam failure could be discharged through this opening. The building showing in the opening is the water treatment plant, across Magnolia Street.

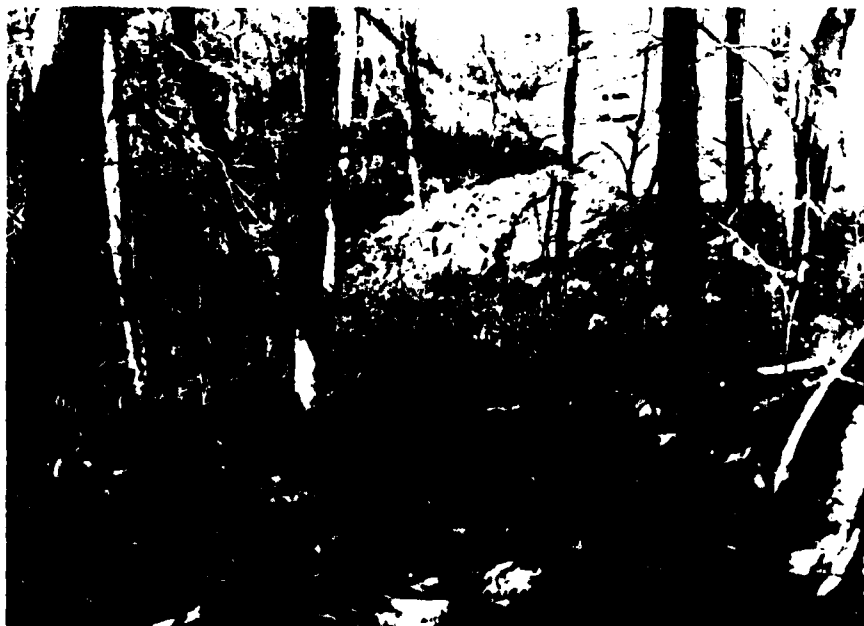
PHOTO NO. 14 - Looking at overflow area on downstream face of Dam from spillway. There is no defined downstream outlet channel from the spillway. Note logs, branches and other debris on downstream face. The riprap protecting the toe of the embankment for the Screen House is shown in the upper middle right portion of the Photo.

Furthermore, the Owner should institute remedial measures including clearing of brush and on the slopes, toe area and spillway channel; removal of debris at the spillway approach and at the stone culvert located downstream at the railroad embankment; repair of the collapsed portion of the right spillway training wall; reset and point the stone masonry spillway; repair of erosion on the slopes of the screen structure embankment;

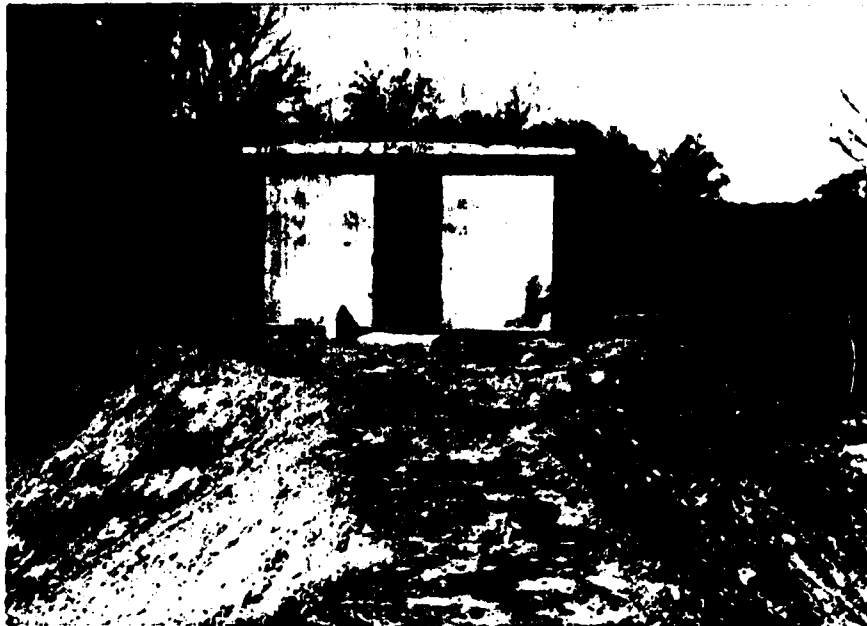
PHOTO NO. 15 - View of Screen House and embankment
taken from Dam embankment.

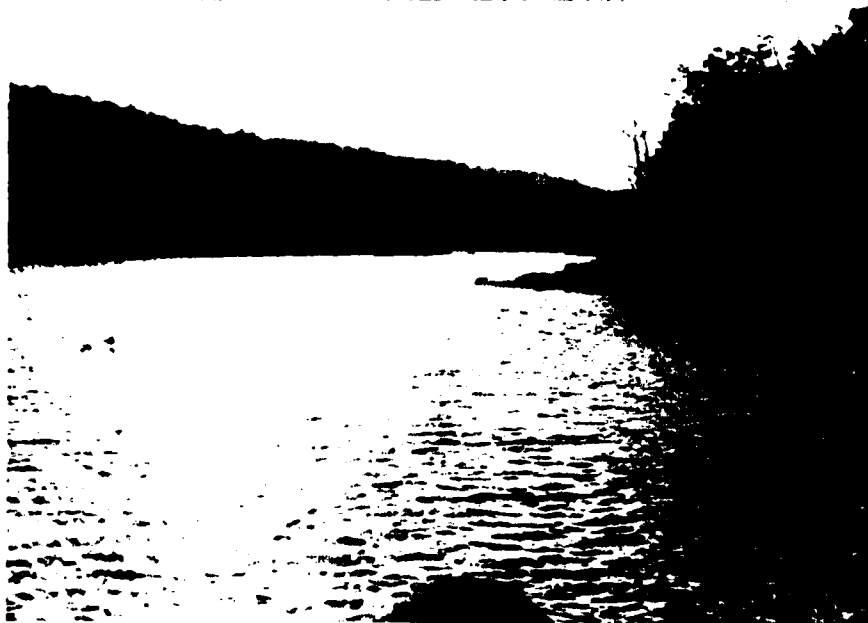
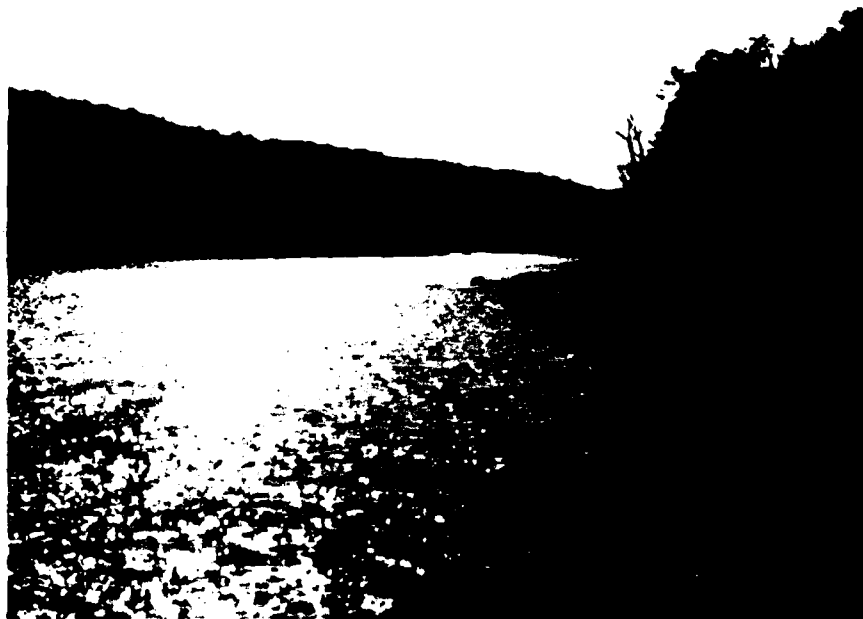
PHOTO NO. 16 - View of Wallace Pond looking eastward
from crest of Dam. On the day this photo was
taken, the Pond water level was about 11 feet
below the crest of the Dam.

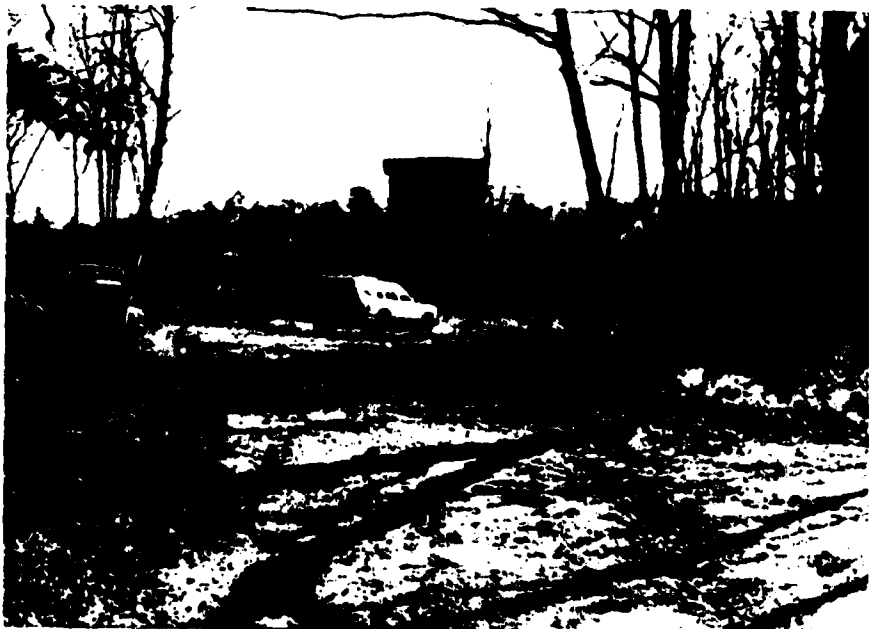
PHOTO NO. 18 - View of downstream side of Dam taken from access road. Note lack of grass for slope protection and erosion on Screen House embankment. The spillway for the Dam is located to the right of the Screen House in Photo. The Dam embankment is shown to the left of the Screen House.
