MILL POND DAM

MA. 00161

PHASE I INSPECTION REPORT
NATIONAL DAM INSPECTION PROGRAM

DECEMBER 1980

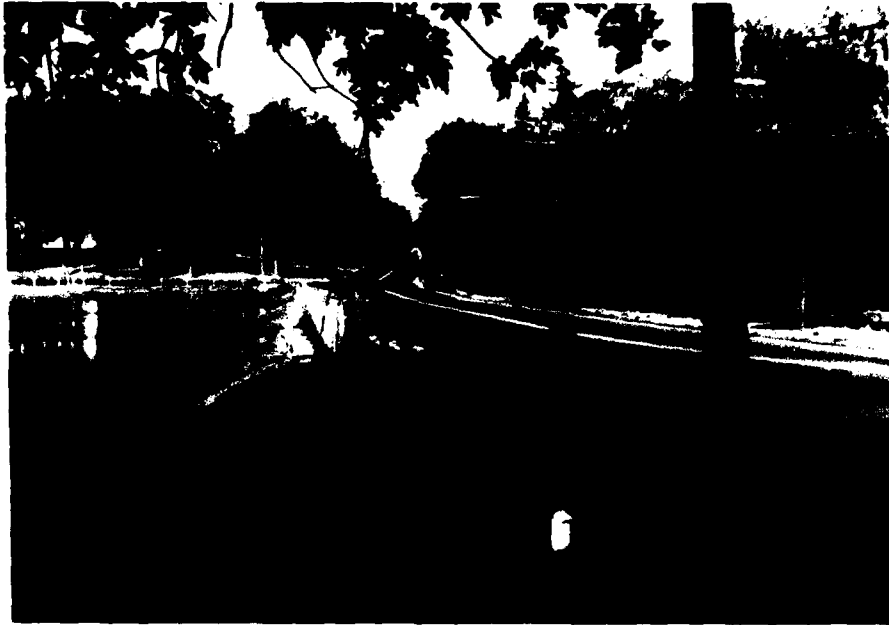
1. Upstream slope and crest of dam from right abutment.

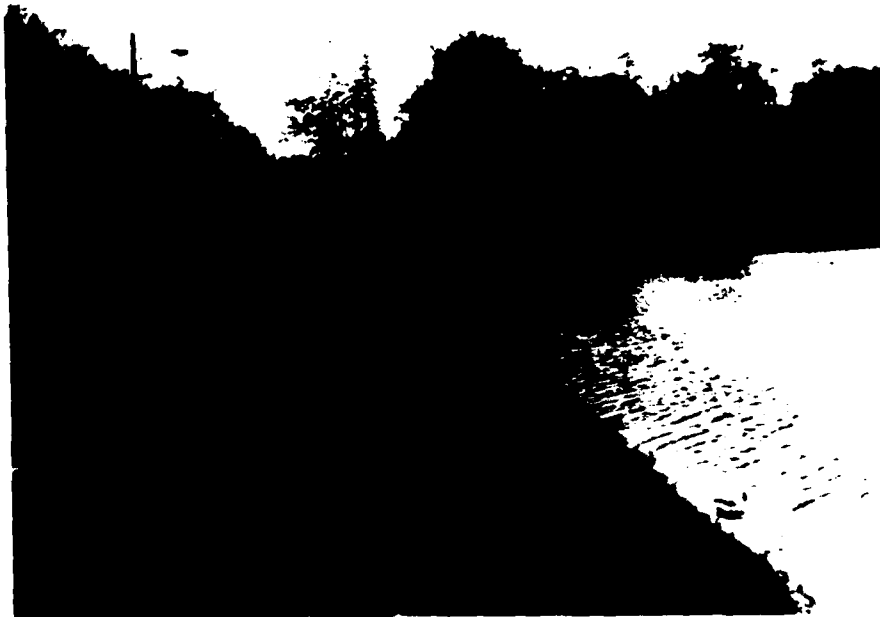
2. Upstream slope and crest of dam from left abutment.
