## PARKER MILLS POND DAM

MA 00150

### PHASE I INSPECTION REPORT NATIONAL DAM INSPECTION PROGRAM

JULY 1981

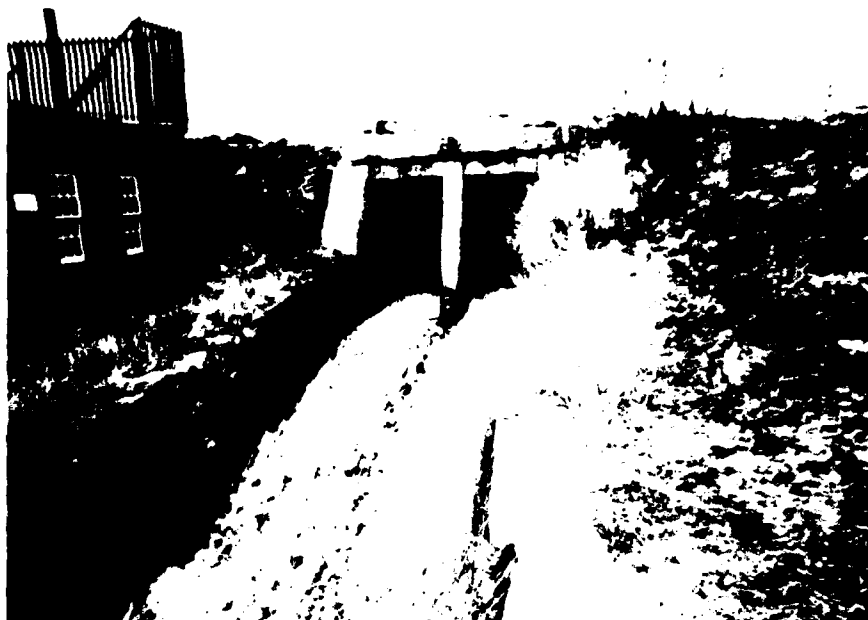
Photo # 5 Right spillway structure

The right spillway structure (referred to as the "Main Spillway" in inspection reports) is also a concrete structure with a stone and mortar upstream face wall and a weathered concrete roof. The culvert under the roadway could not be observed. The concrete at the structure's roof was in generally poor condition with much spalling and exposed reinforcing evident (Photo # 5 &

5. Design and implement repairs to the roof of the right spillway structure.

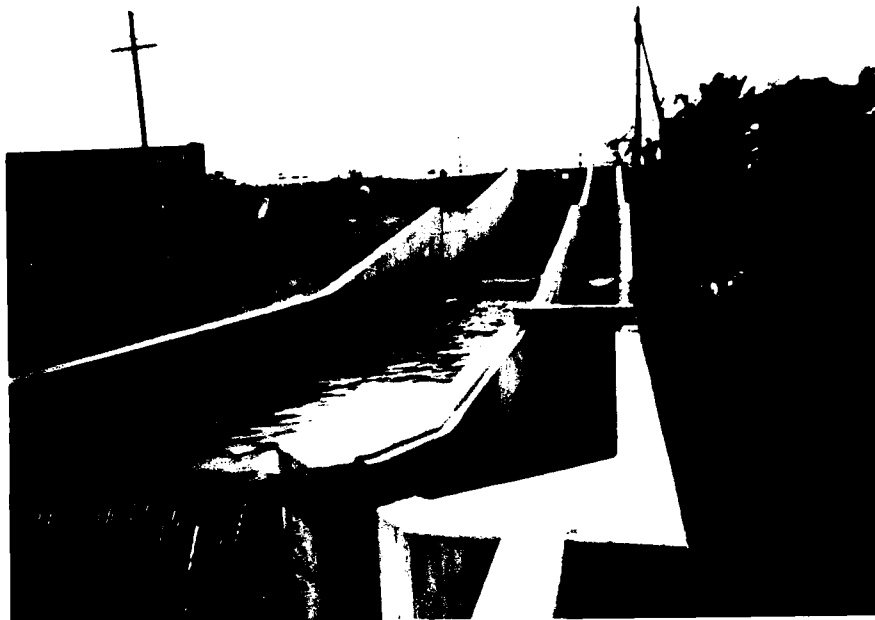
The left spillway discharge channel is generally clear of obstructions with some rocks, cans and litter scattered across the channel. The concrete channel floor and walls are intact, the concrete is in good condition (Photo # 7). The stone wall adjacent to the left side of the channel is also generally intact although several blocks have fallen out of one small section of the wall.

Photo # 7 Discharge channel, stilling basin, and fish ladder  
left spillway
