NATIONAL PROGRAM FOR INSPECTION OF NON-FEDERAL DAMS  
SHOE POND DAM (MA 001) (U) CORPS OF ENGINEERS WALTHAM  
MA NEW ENGLAND DIV SEP 79

DANVERS RIVER BASIN  
BEVERLY, MASSACHUSETTS

SHOE POND DAM  
MA 00183

**PHASE I INSPECTION REPORT  
NATIONAL DAM INSPECTION PROGRAM**

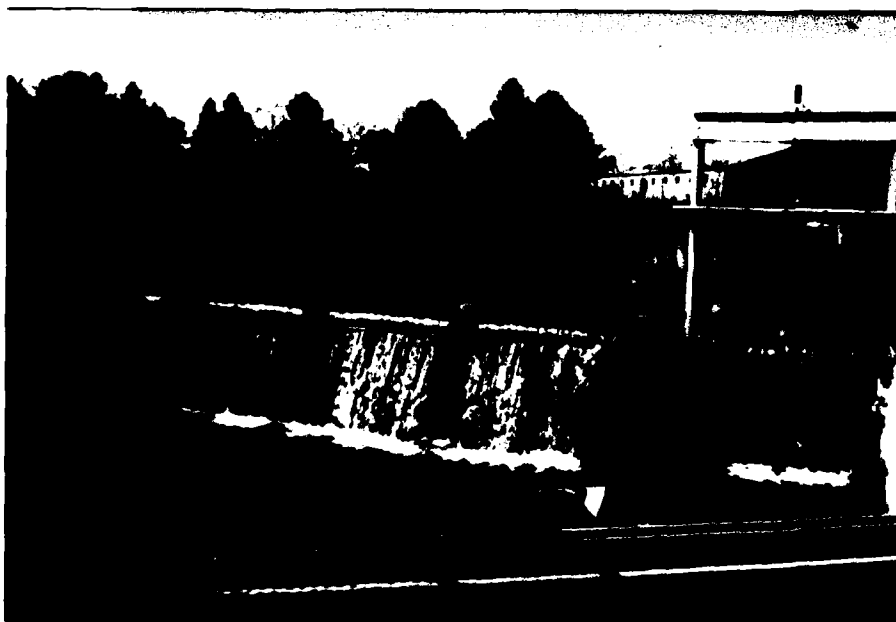
**NO. 2 SHARP CRESTED WEIR AND LOW LEVEL GATE**
