MASSACHUSETTS COASTAL BASIN  
GLOUCESTER, MASSACHUSETTS

FERNWOOD LAKE DAM  
MA 00184

PHASE I INSPECTION REPORT  
NATIONAL DAM INSPECTION PROGRAM

APRIL, 1979

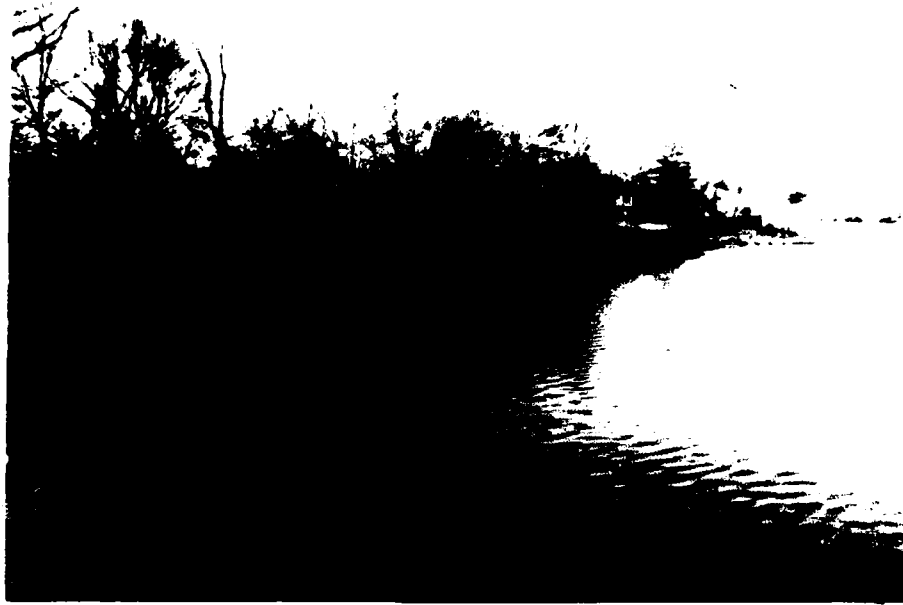
3. Upstream stone masonry wall near left abutment
