**BLACKSTONE RIVER BASIN
WORCESTER, MASSACHUSETTS**

**BELL POND DAM
MA 00148**

**PHASE I INSPECTION REPORT
NATIONAL DAM INSPECTION PROGRAM**

OCTOBER 1978

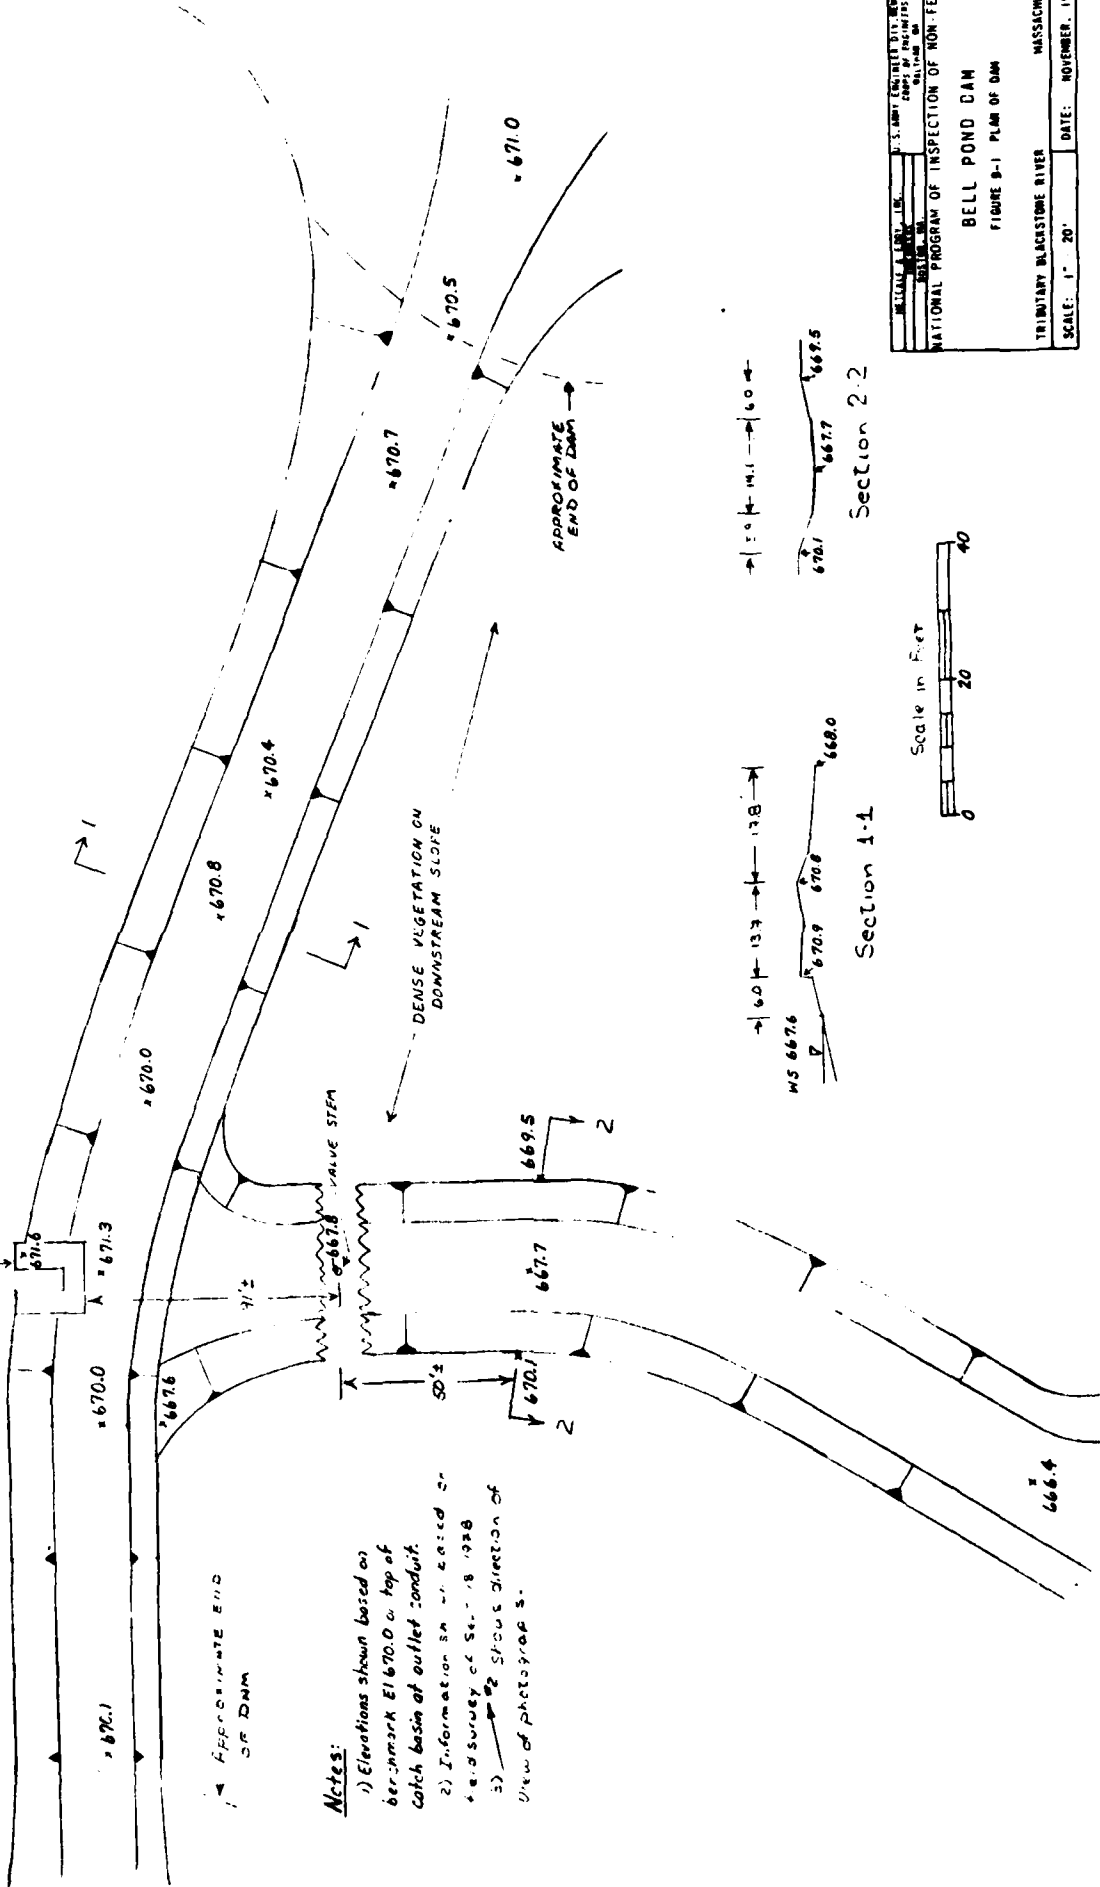
MILLER, L. L.	U.S. ARMY CORP. DISTRICT DIVISION
CONTRACT NO. 657.6	CONTRACT NO. 657.6
NATIONAL PROGRAM OF INSPECTION OF NON-FED DAMS	
BELL POND DAM	
FIGURE B-1 PLAN OF DAM	
TRIMBURY BLACKSTONE RIVER	MASSACHUSETTS
SCALE: 1" = 20'	DATE: NOVEMBER, 1978

- b. Description of Dam and Appurtenances. Bell Pond Dam is a 230-foot long, earthfill dam located on the southern slope of the pond (see Figure B-1). The dam has a maximum height of 3.7 feet, and the crest varies from El 670.0 to 671.3. The depth of the pond is about 10 to 13 feet. A foot path is located on the crest of the dam which is about 14 feet wide. The upstream slope, which is covered with grass and brush, slopes at 2:1. The downstream slope is covered with brush and small trees and slopes at 3:1. Outcrops of granite bedrock are located at both abutments of the dam.
