# NAVAL POSTGRADUATE SCHOOL

## THESIS

| REPORT DOCUMENTATION PAGE | | READ INSTRUCTIONS<br>BEFORE COMPLETING FORM |
|---|---|---|
| 4. TITLE (and Subtitle)<br>Development of a Field Repair Technique<br>for "Mini-Sandwich" Kevlar/Epoxy<br>Aircraft Skin | | 5. TYPE OF REPORT & PERIOD COVERED<br>Master's Thesis;<br>June 1984 |

Development of a Field Repair Technique  
for "Mini-Sandwich" Kevlar/Epoxy Aircraft Skin

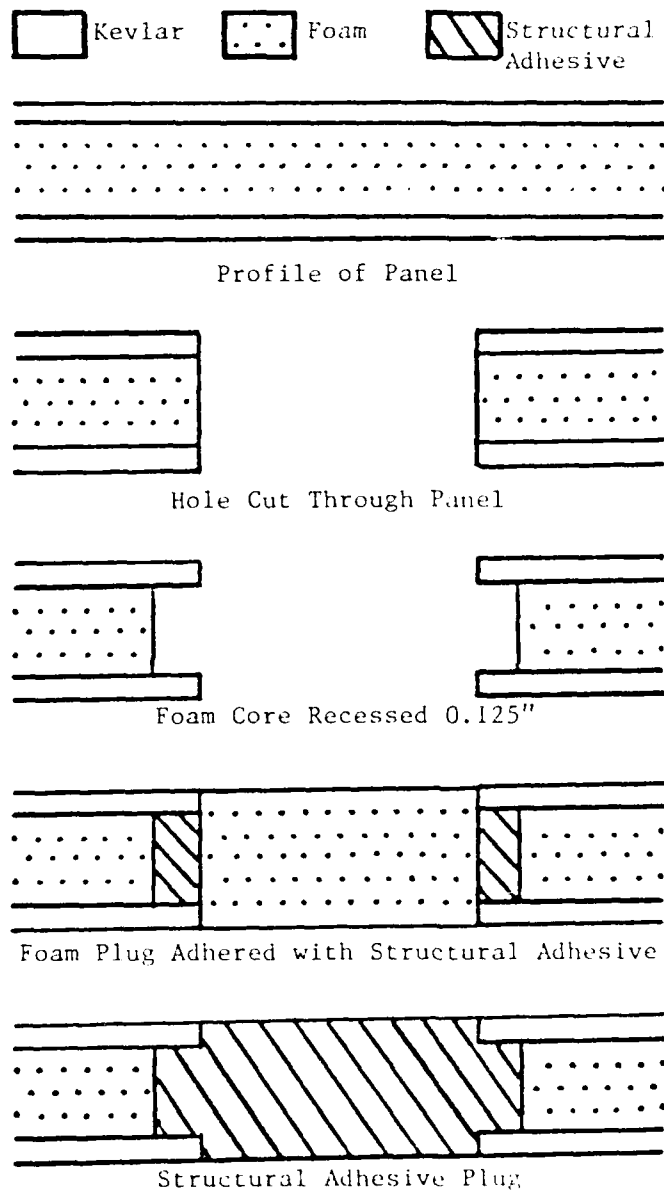
Fig. 2. Recessing of Foam Along Inner Edge of Holes

For each case in which there was to be a core filler to replace the cut out material, the foam core around the entire perimeter of the hole was removed to a depth of 0.125 inches from the edge of the hole. This allowed slightly more surface area for the adhesive holding the plug in place to attach itself. Figure 2 depicts how the core material was recessed for both foam plugs and structural adhesive plugs.

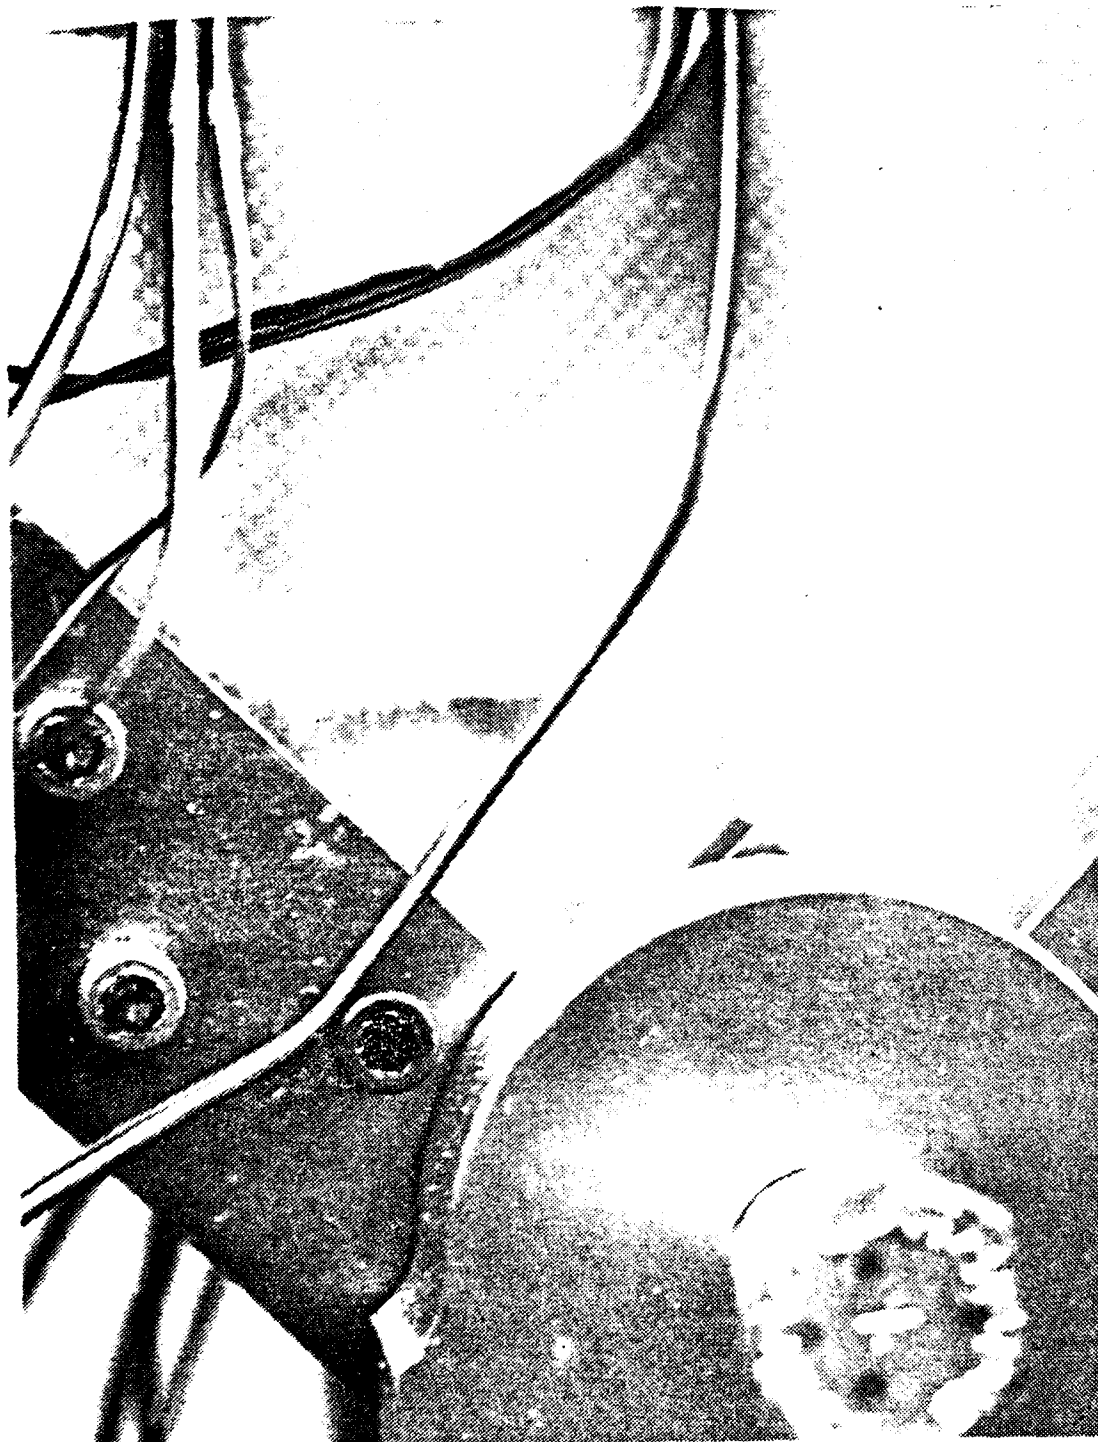
Fig. 15. Crack in Tension Corner of Panel 2

report accompanying large scale buckling at 5850 pounds. A vertical buckle was noted slightly off center to the left of the panel. The load fell off to 4125 pounds at failure. Continued loading was accompanied by constant moderate crackling sounds. During continued loading, a second loud report was heard at 7290 pounds of applied load. At this time the load dropped off to less than 1000 pounds, and a large crack was visible, extending horizontally across nearly half the panel about two inches above the lower tension corner. The panel was removed and inspected. The initial buckle was again characterized by delamination and pulverizing of the foam core. The horizontal crack was found to have penetrated the entire panel thickness. Figure 15 portrays this crack.

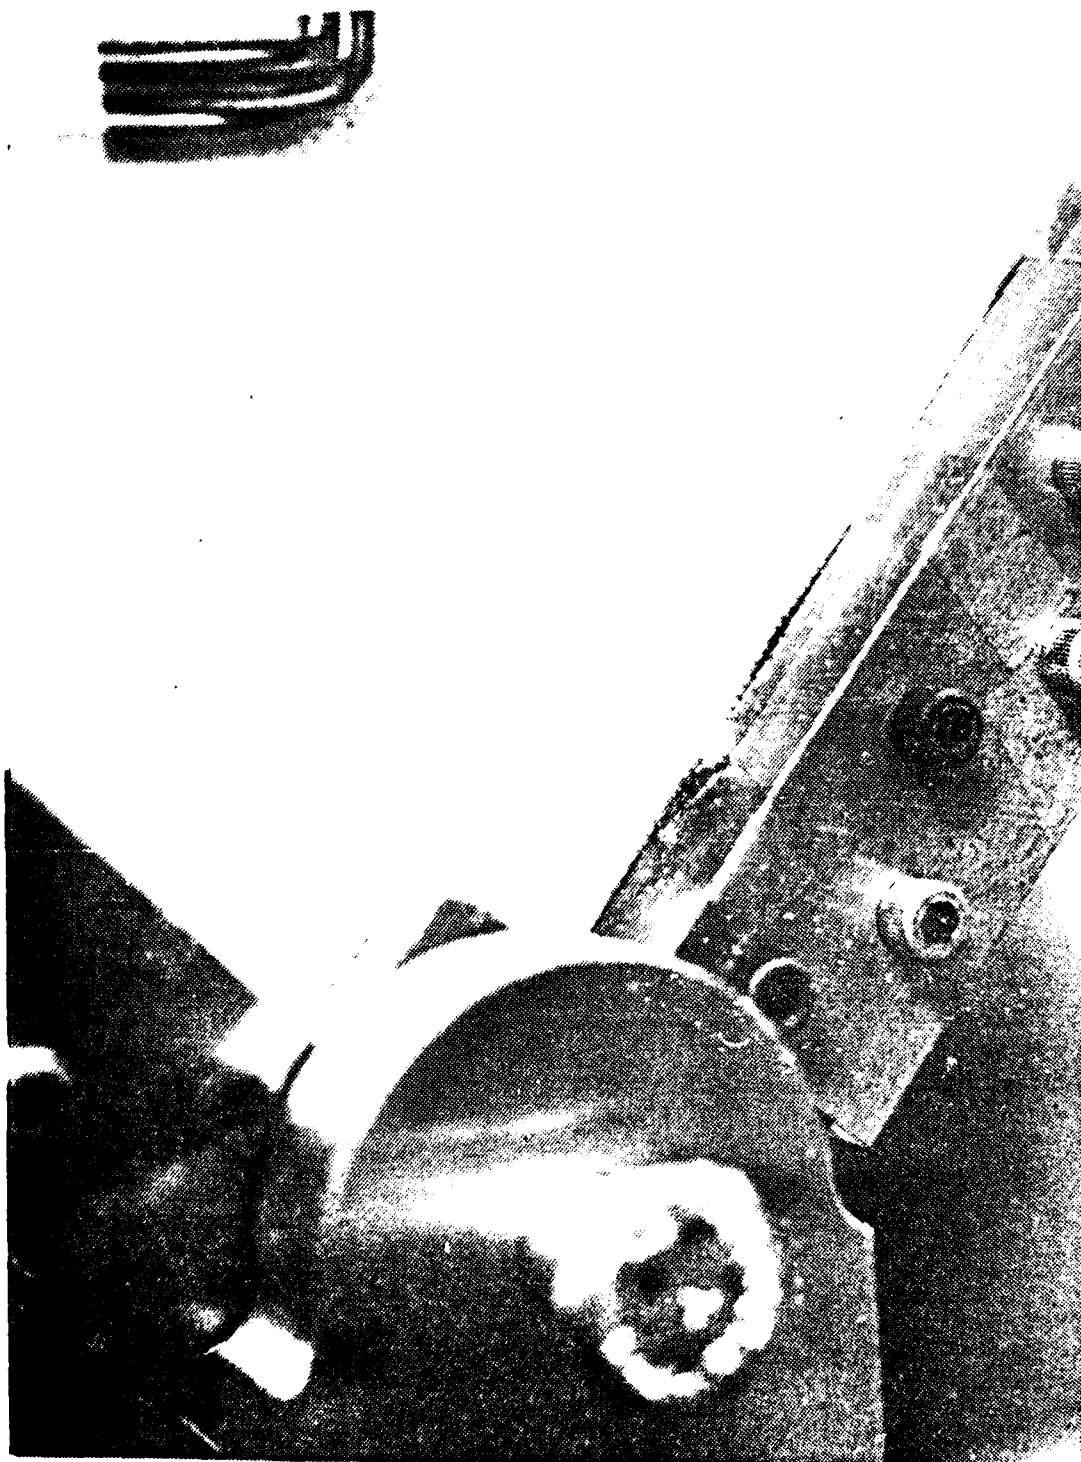
Fig. 14. Crack in Tension Corner of Panel Y

approximately 6990 pounds, at which time another loud report was heard, and the load dropped to below 1000 pounds. The panel was removed from the test fixture and inspected. The vertical buckle was of the same nature as that in Panel A. Cracks were found connecting the through bolt holes in the tension corners of the panel. These cracks penetrated entirely through the panel. A picture of these cracks appears as Figure 14.

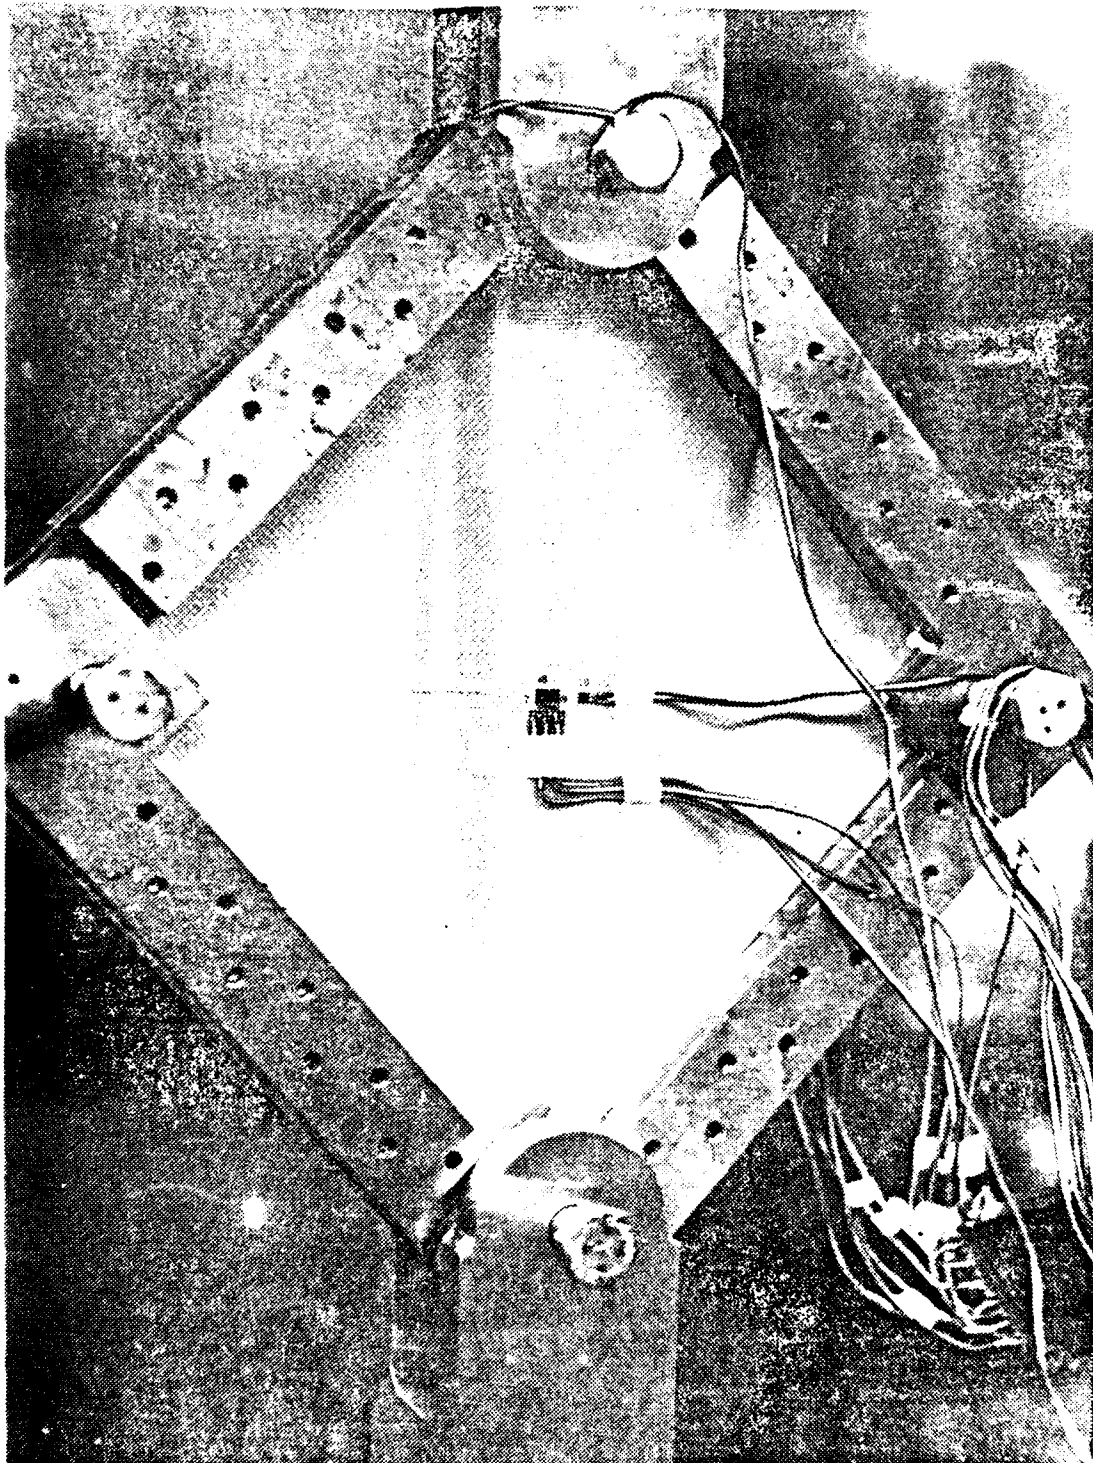
Fig. 13. Vertical Buckle of Panel A, Rear View

Beginning at about 5000 pounds applied load, occasional slight crackling sounds were heard. At about 5875 pounds of applied load, a slight bowing of the center of the panel was observed to be oriented vertically. Continued loading resulted in an accentuation of the vertical bowing. At 6300 pounds applied load, a loud report was heard, and the load carried by the panel dropped off sharply. A vertical buckle slightly off center to the right was observed, as shown in Figure 13. In the immediate vicinity of the buckle, the panel was found to have delaminated from the inner core material. The panel was removed from the frame and inspected. A profile view of the buckled region indicated failure of the foam core in shear normal to the plane of the panel. The foam was crushed and pulverized along the vertical lines of maximum bending of the Kevlar/epoxy layers.

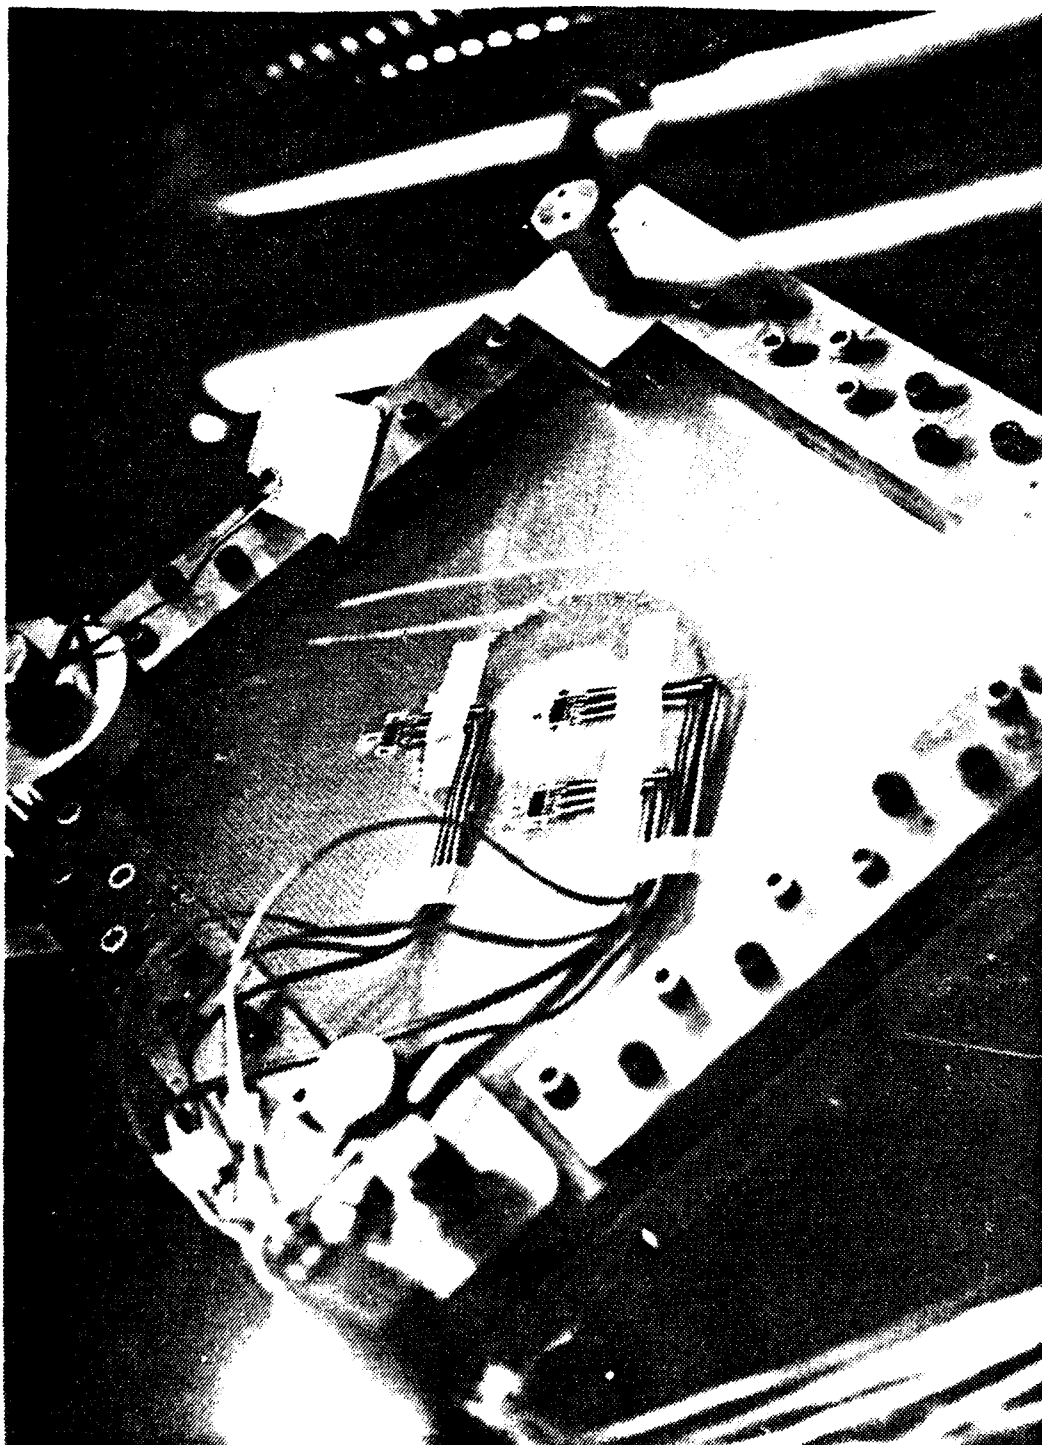
Fig. 12. Vertical Buckle of Repaired Panel

The loading and failure process for each of the twenty-six panels followed basically the same sequence. Within a band of a few hundred pounds of 4000 pounds applied load, crackling noises began. These noises continued occasionally until immediately prior to failure of the panel. In general, about two hundred pounds prior to failure, visible deformation of the panel could be seen, similar to that shown in Figure 11. Immediately before failure, a sudden increase of the crackling sound intensity occurred, followed by a loud sharp report at the time of failure. Failure in each case exhibited itself as a vertical buckle running either through or adjacent to the patched area between the opposite tension corners, as depicted in Figure 12.

After failure, panels were removed from the test fixture and inspected. In each case the buckled region exhibited shear failure of the foam core material and no other damage to the Kevlar/epoxy skins. Plots of maximum shear strain versus applied load were prepared (see Appendix B).

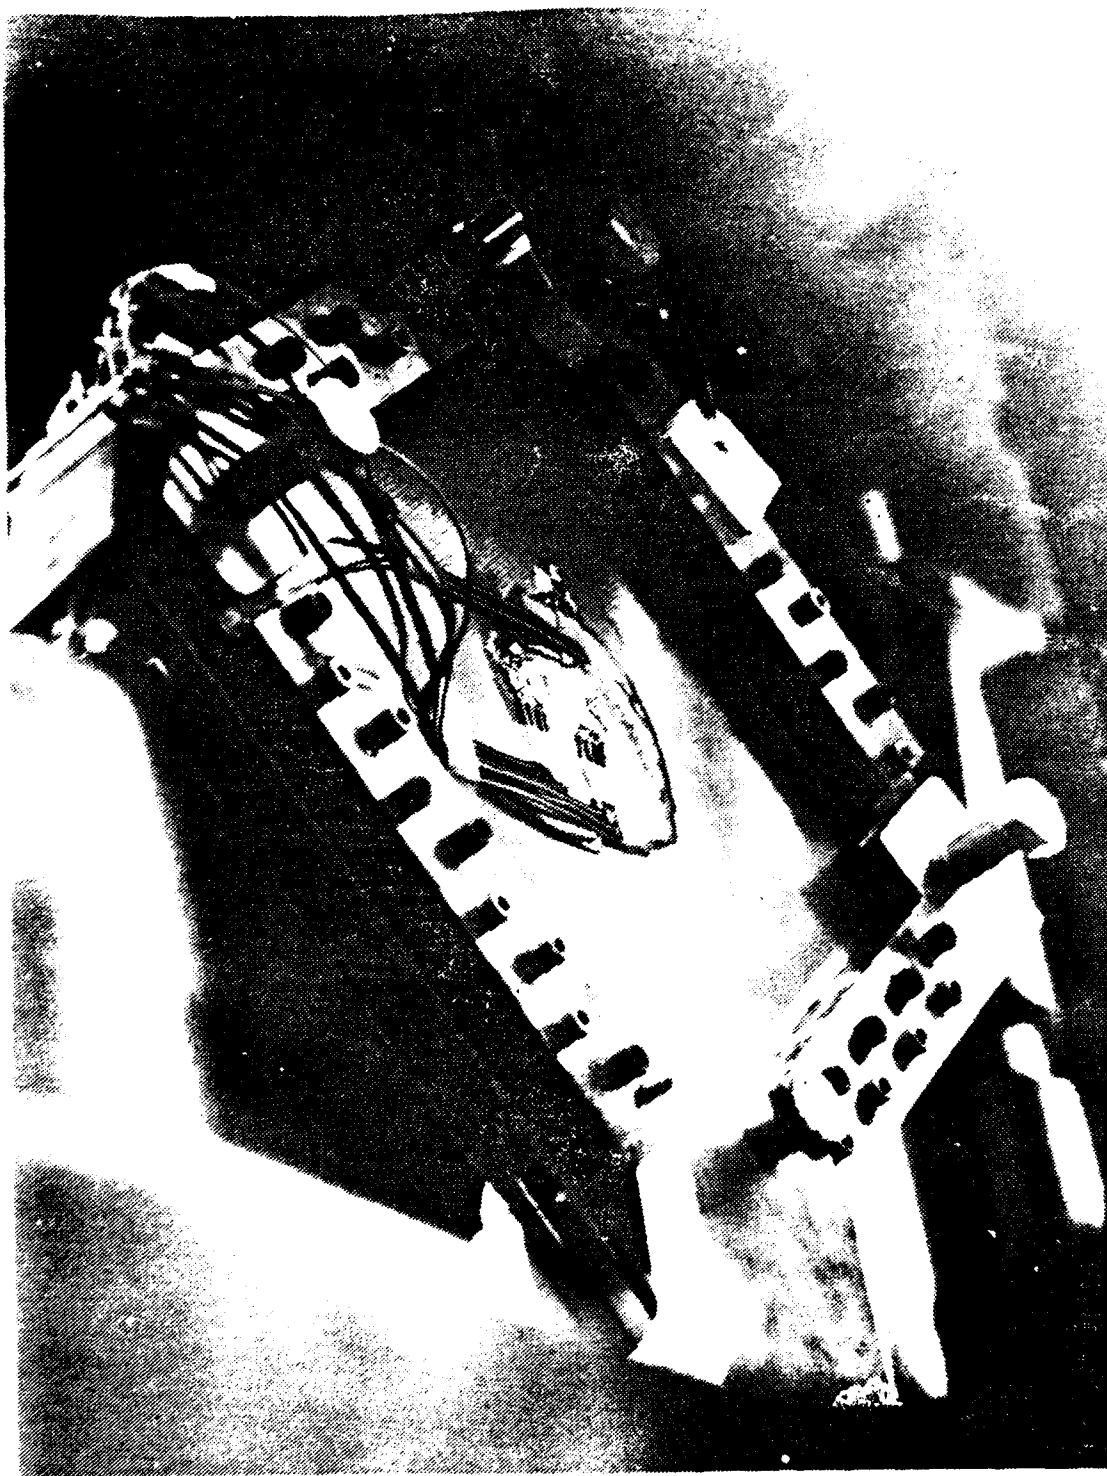
Slight crackling sounds were detected beginning at about 4000 pounds applied load. Visible deformation was noted at about 5125 pounds, similar to that shown in Figure 11. A loud report occurred at 5425 pounds, accompanying a vertical buckle that was offset to the right of center and just beyond the edge of the patch overlap area, in the same manner as depicted in Figure 12. There was no apparent damage to the patch area itself. After removal from the test fixture, inspection detected shear failure of the core material adjacent to the patch area. The shear strain versus applied load curve (see Appendix B) indicated buckling onset at approximately 5000 pounds, with an accompanying shear strain of 0.015600 in/in. The average shear flow was 393 lbs/in. Again, limit and ultimate shear flow requirements were met.

Fig. 11. Deformation of Repaired Panel

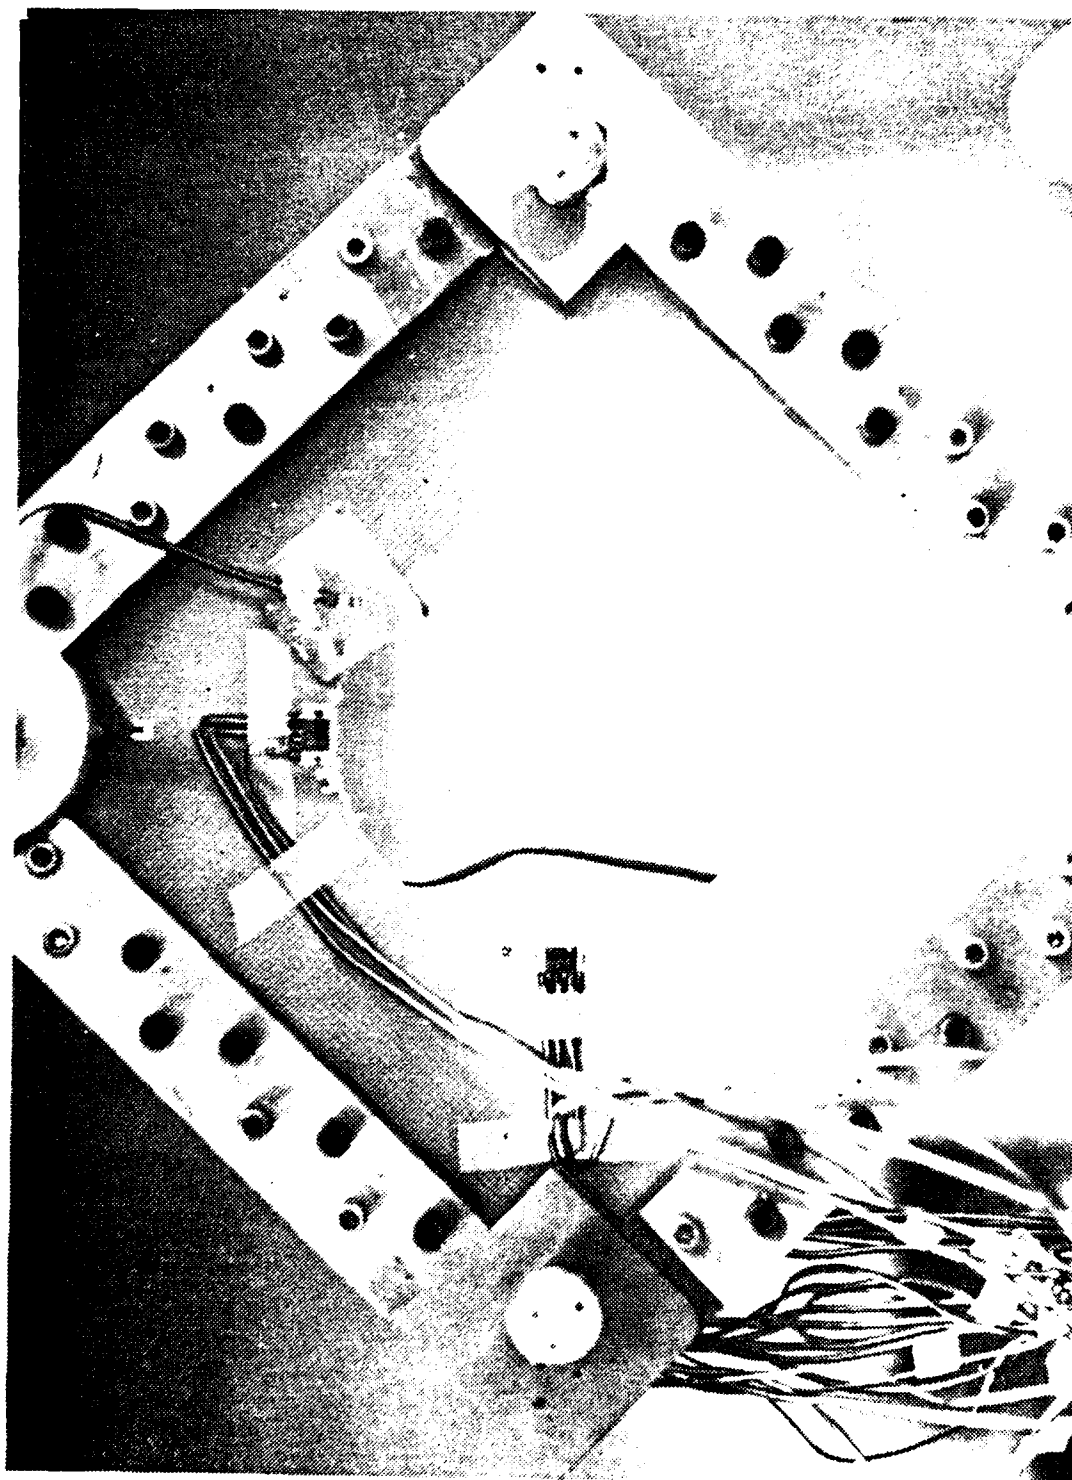
Fig. 16. Vertical Buckle and Horizontal Cracks on Panel X

of load carrying capacity, the average shear flow was 201 lbs/in, well short of the ultimate shear flow requirement.
