TECHNICAL MEMORANDUM 84/BB

CORROSION PROBLEMS  
IN THE CANADIAN MARITIME FORCES

R.S. Hollingshead - C.M. Hanham

Defence  
Research  
Establishment  
Atlantic

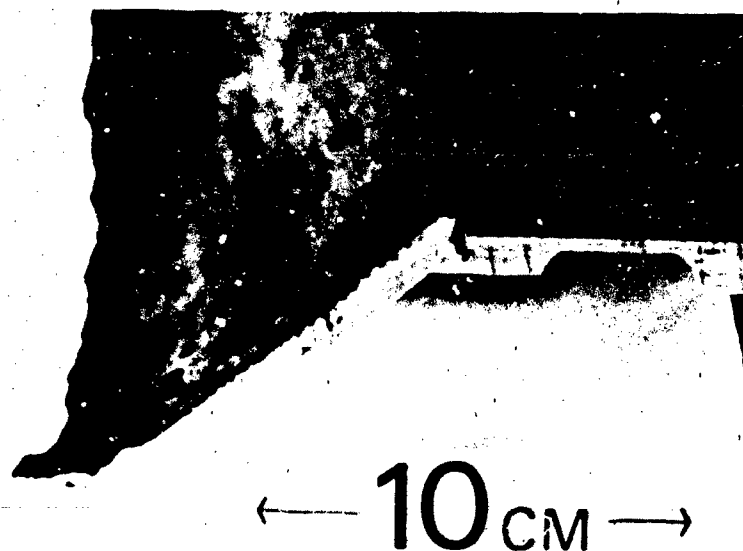
Another problem that has occurred in the past is the introduction of unsuitable and unspecified alloys into the firemain system. One example is a reducer which was required to connect a 5 inch pipe to a 2-1/2 inch pipe. Since a standard reducer could not be found in the stores system, one had to be fabricated in the shops. The material used was naval brass and the component lasted six months before dezincification penetrated the wall of the pipe (Figure 20).

**Figure 20**      Dezincification of naval brass reducer.

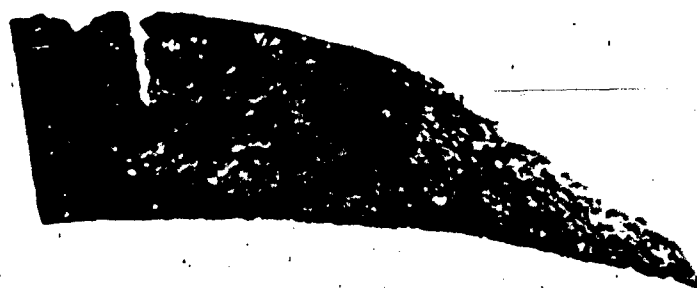
Pump impellers in hull and firemain pumps frequently suffer extensive erosion corrosion and cavitation damage in periods as short as three months (Figures 21 and 22).

**Figure 22**      Cavitation damage of bronze impeller vane.

The most common alloy used for impellers is G Bronze (UNS C90300). A program to find materials with greater erosion corrosion resistance has identified a cast chromium modified 70/30 copper nickel alloy similar to wrought UNS C71900<sup>14</sup>. Engineering trials have begun with an impeller made of this alloy, installed in a hull and firemain pump.

In addition, since the serviceable life of an impeller is not only related to the type of material used, but also to the operating conditions of the pump itself, ships' engineers are encouraged to operate their pumps more efficiently in order to reduce cavitation.
