MULTIPLE-PURPOSE PROJECT OSAGE RIVER BASIN OSAGE RIVER  
MISSOURI HARRY S T. (U) CORPS OF ENGINEERS KANSAS CITY  
MO KANSAS CITY DISTRICT R F GRIFFITH ET AL. 1984

| REPORT DOCUMENTATION PAGE | | READ INSTRUCTIONS<br>BEFORE COMPLETING FORM | |
|---|--|---|--|
| 4. TITLE (and Subtitle)<br>MULTIPLE-PURPOSE PROJECT<br>OSAGE RIVER BASIN<br>OSAGE RIVER, MISSOURI<br>HARRY S. TRUMAN DAM & RESERVOIR<br>OPERATION AND MAINTENANCE MANUAL<br>APPENDIX VIII, VOLUMES ONE AND TWO<br>CONSTRUCTION FOUNDATION REPORT | | 5. TYPE OF REPORT & PERIOD COVERED<br>Construction Foundation<br>Report from September 1966<br>November 1979 | |

APPENDIX VII  
CONSTRUCTION FOUNDATION REPORT

1-03. Purpose and Scope: The purpose of this report is to provide a record of foundation conditions encountered during construction and methods used to adapt to these conditions during construction. This information is a part of the permanent collection of project engineering data required by Appendix A to ER 1120-2-100 and ER 1110-1-1801, dated 15 Dec 81. This report deals with construction of the main embankment, the Sterett Creek Dike and the Spillway-Powerhouse.

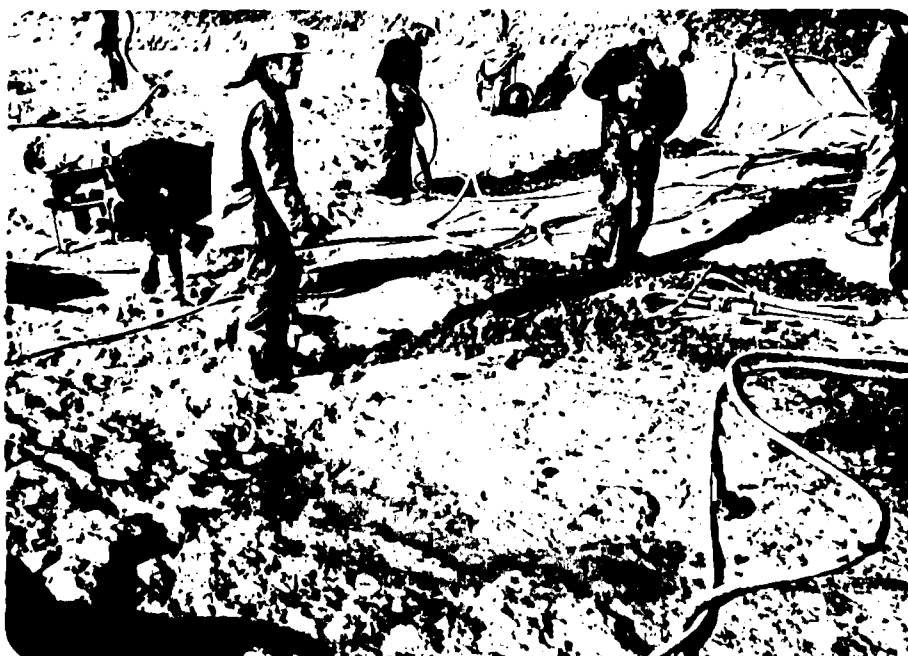
207. Harry S. Truman Dam, 25 November 1977, Neg. No. 77-718.  
Closure area cutoff trench, Sta. 63+50. Placing  
impervious clay in open joints.

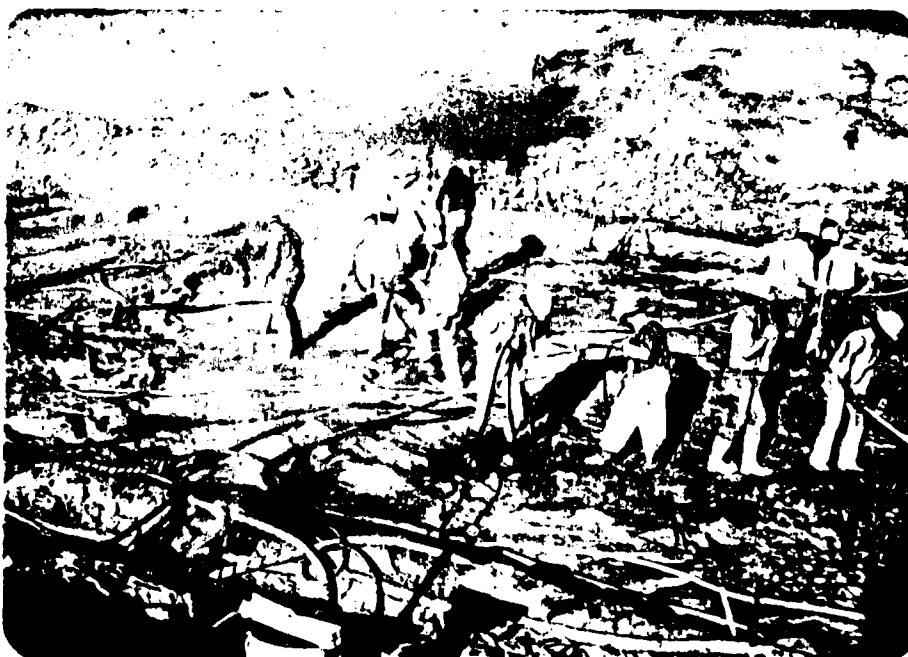
205. Harry S. Truman Dam, 11 November 1977, Neg. No. 77-701.  
Closure area cutoff trench, Sta. 63+40. Placing  
impervious clay in open joints.
