NATIONAL PROGRAM FOR INSPECTION OF NON-FEDERAL DAMS  
MERRIMACK RIVER BASIN.. (U) CORPS OF ENGINEERS WALTHAM  
MA NEW ENGLAND DIV SEP 79

LAWRENCE RESERVOIR

NATIONAL DAM INSPECTION  
PROGRAM

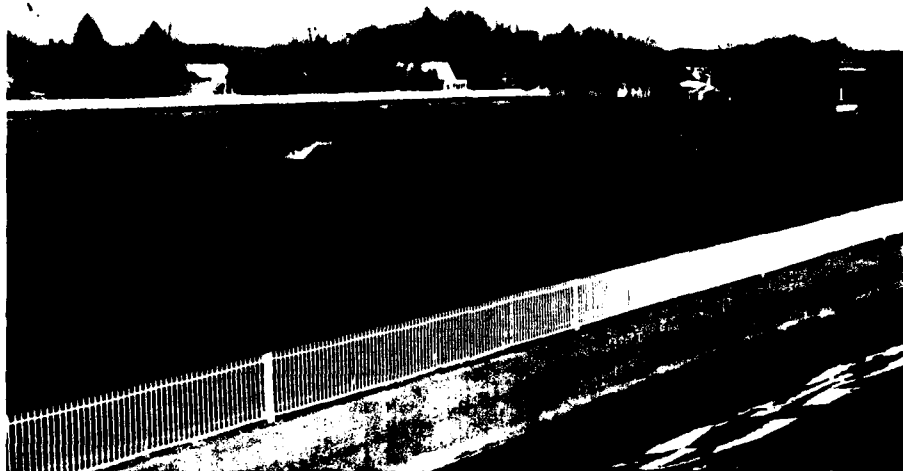
**NO. 1 VIEW OF INFLOW CONDUIT AND DIKE  
SEPARATING NORTH & SOUTH BASINS**

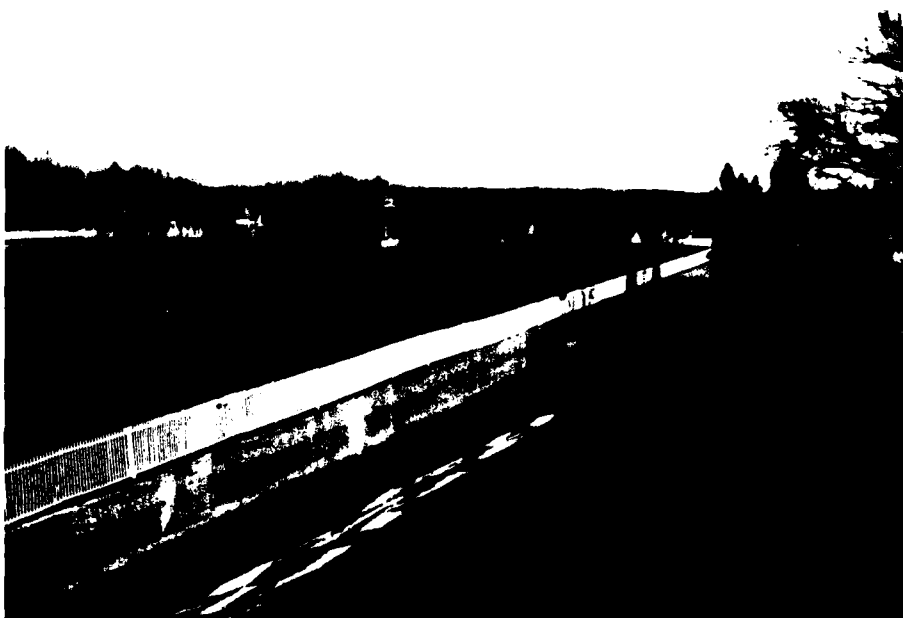
**NO. 2 VIEW OF WEST SIDE OF RESERVOIR AND GATE HOUSE**

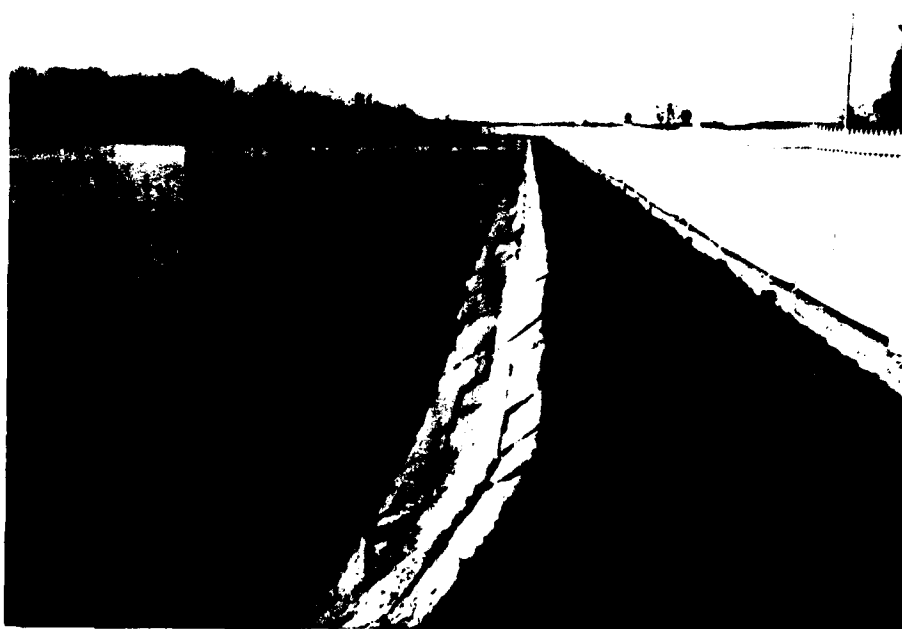
| AREA EVALUATED | CONDITIONS | |
|---|---|---|
| Rock Slope Protection - Riprap Failures | Stone lining in good condition | same as north side |

**NO. 4 LINER ON INSIDE SLOPE OF RESERVOIR**

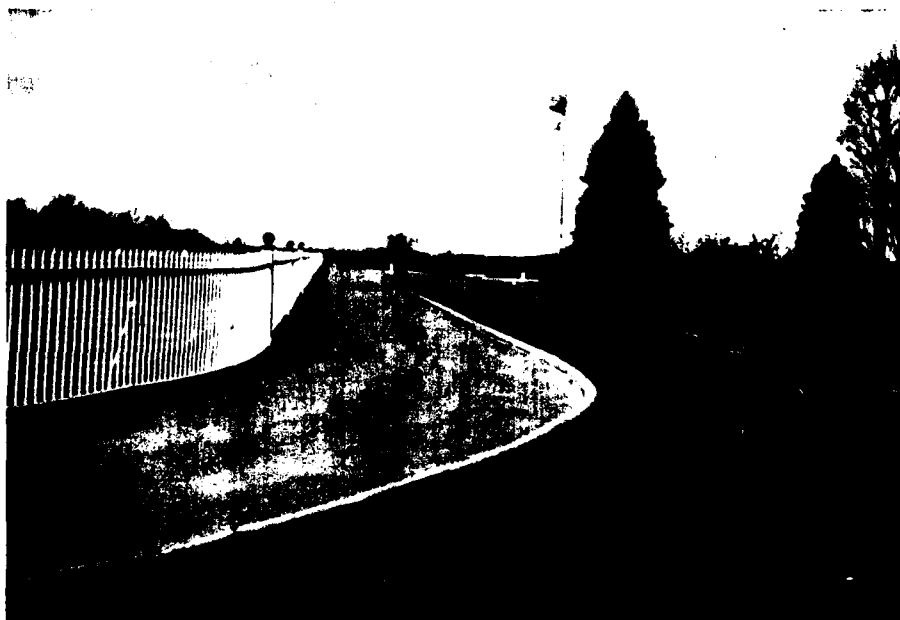
| AREA EVALUATED | CONDITIONS | |
|---|---|---|
| Pavement Condition | Longitudinal cracks in walkway | same as north side |

**NO. 7 CREST OF EMBANKMENT ON EAST SIDE OF RESERVOIR**

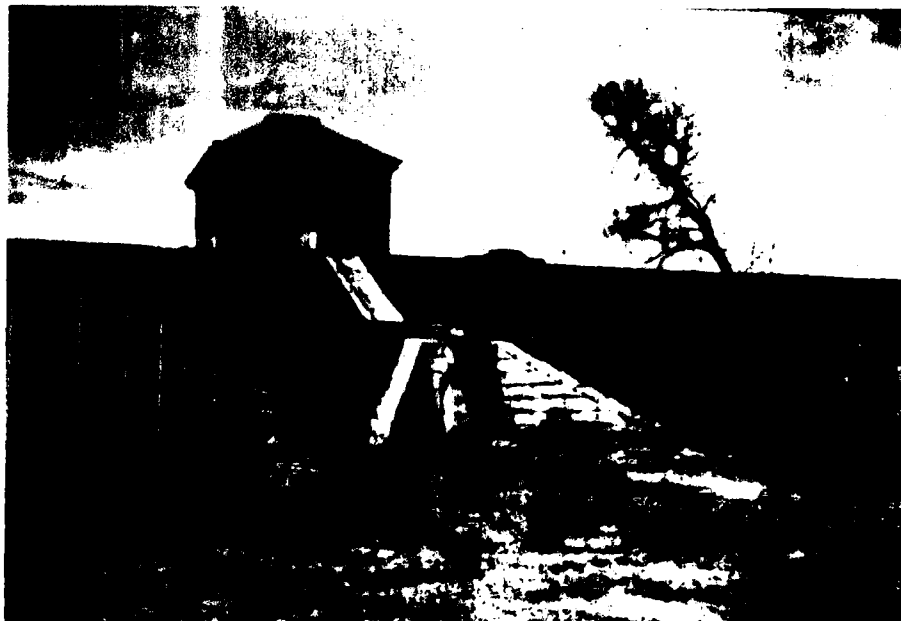
- c. Appurtenant Structures. The gate house for the reservoir is constructed of brick with a stone masonry foundation. The structure is in good condition. Inside the building, there are three threaded gate stems with hand wheels to operate sluice gates for the screen chamber. The stems are bent, making the gates difficult to operate.

Wing Walls (at entrance to access tunnel)- Mortared granite blocks, most of mortar is missing, capstones have shifted, weeds growing in unmortared joints.

**NO. 9 GATE HOUSE AND TUNNEL ENTRANCE  
ON SOUTH SIDE OF RESERVOIR**
