**TAUNTON RIVER BASIN  
TAUNTON, MASSACHUSETTS**

**MILL RIVER DAM  
MA 00813**

**PHASE I INSPECTION REPORT  
NATIONAL DAM INSPECTION PROGRAM**

**APRIL 1979**

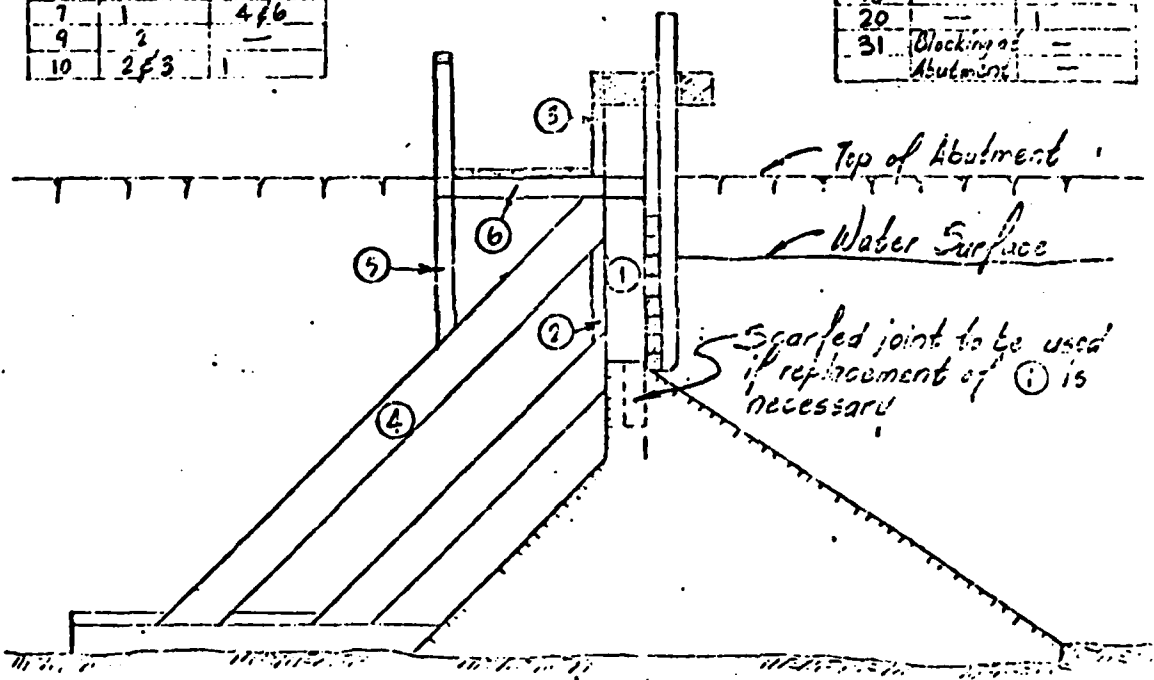
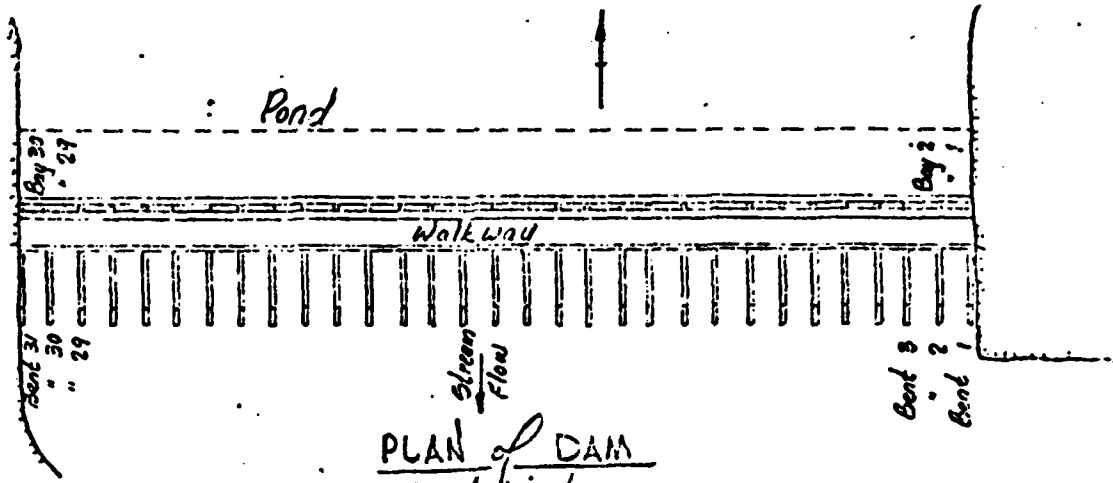
SECTION THRU DAM  
 with key numbers to members  
 1/2" = 1'-0"

Bent No	Replace Piece No	Examine Piece No
2	2	1
3	1 & 4	—
4	2	—
5	2	4
6	2	4
7	1	4 & 6
9	2	—
10	2 & 3	1

Bent No	Replace Piece No	Examine Piece No
11	2 & 5	—
12	2	1
16	1, 2 & 3	5
17	—	4
18	—	1
20	—	1
31	Blocking of Abutments	—

WHITTENTON MFG. CO. TAUNTON, MASS.  
 REPAIRS FOR DAM  
 traced from drawing by: H.F. KIMBALL, Engineer  
 BOSTON, MASS. 102-

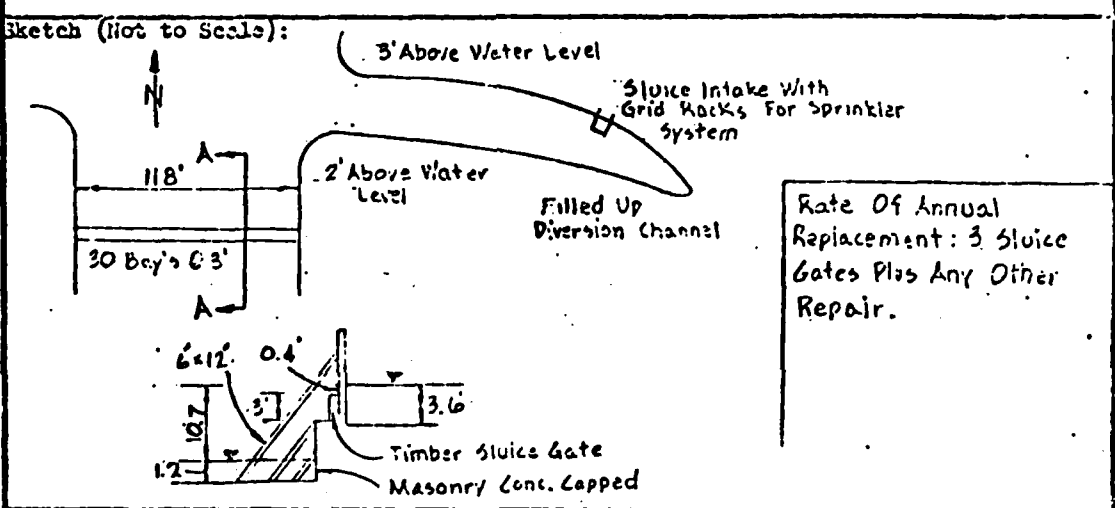
Remarks and Recommendations: Should be examined structurally and hydraulically. G.L.'s appear okay, but timber supporting lower portion of dam could not be appraised. It is reported to be in good condition. Overflow capacity may be adequate but should be checked since not more than 2 foot freeboard is available. Recommend opening sluice gates to lower pond level and reduce pressure on dam. Flooding of 1 foot in cellar during 1955 flood. The Whittenton Mfg. Co. owns all water rights above this dam.  
 \* Change Priority to 1 4-1-63
