**NASHUA RIVER BASIN
HOLDEN, MASSACHUSETTS**

**KENDALL RESERVOIR DAM
MA 00622**

**PHASE I INSPECTION REPORT
NATIONAL DAM INSPECTION PROGRAM**

OCTOBER 1978

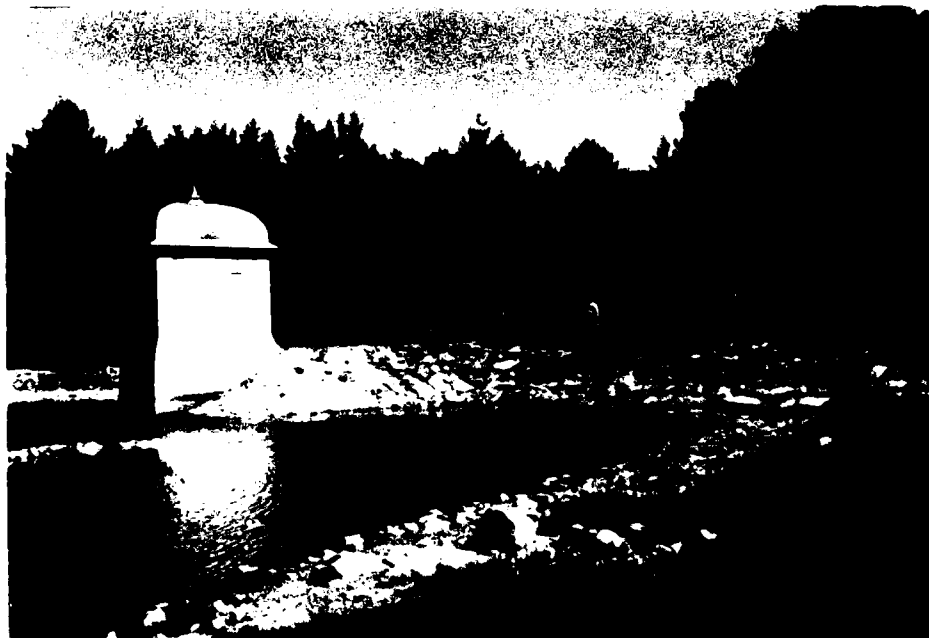
The dike and water supply outlet are located at the southern end of Kendall Reservoir. The earthfill dike ties into natural ground at both abutments. The crest is flat and clear of brush and trees. A concrete stairway is located on the downstream slope. The riprap on the upstream slope is in good condition, and supports only small amounts of vegetation.

NO. 7 DIKE AND GATE HOUSE AT SOUTH END OF RESERVOIR
