NATIONAL PROGRAM FOR INSPECTION OF NON-FEDERAL DAMS  
HAMILTON RESERVOIR DA. (U) CORPS OF ENGINEERS WALTHAM  
MA NEW ENGLAND DIV NOV 78

PHASE I INSPECTION REPORT  
NATIONAL DAM INSPECTION PROGRAM  
THAMES RIVER BASIN  
INVENTORY NO. MA 00536  
HAMILTON RESERVOIR DAM  
TOWN OF HOLLAND  
HAMPDEN COUNTY, COMMONWEALTH OF MASSACHUSETTS

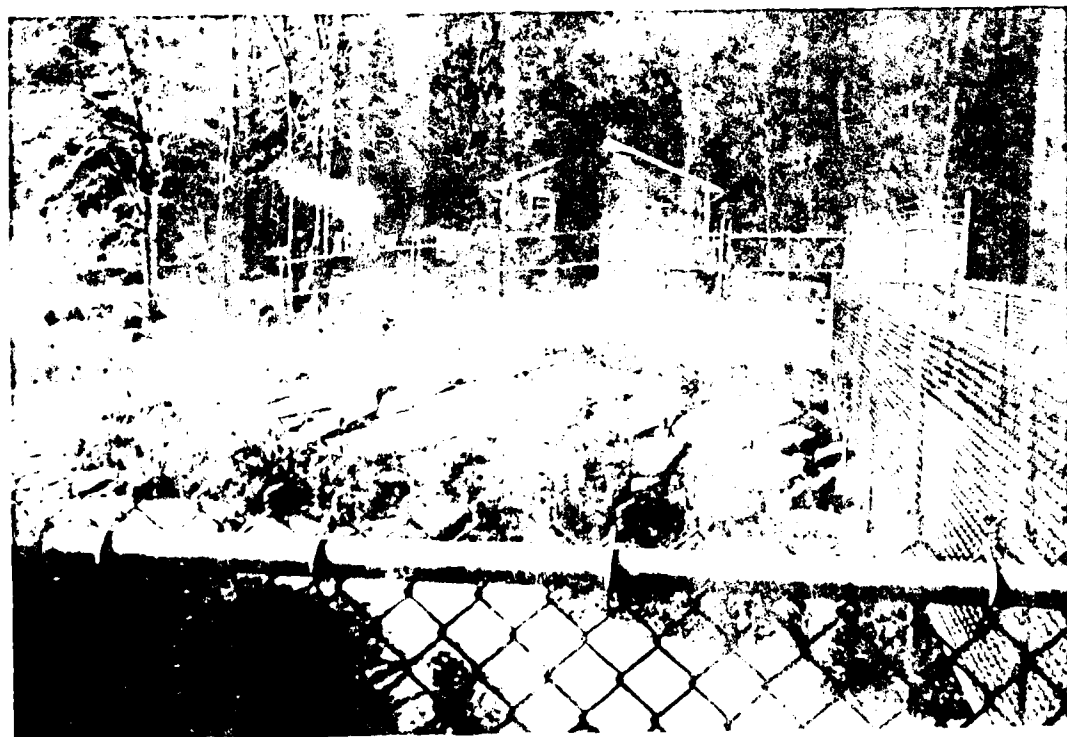
The upstream slope is in generally good condition. The stone rip-rap is sound with some tall grass growing through it. There are no signs of trespassing, sloughing or erosion, (See Photograph No. 5).

5. VIEW OF UPSTREAM DIVIDE OF EARTH  
FROM POINT 1.

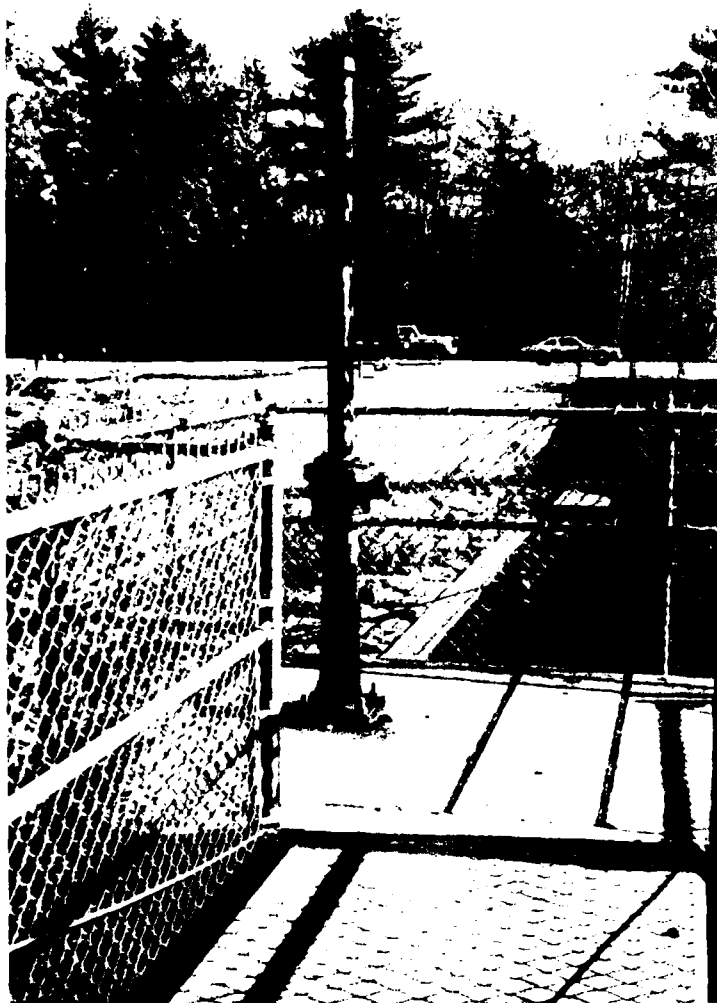
The intake structure is in good condition, the concrete is sound and free of spalled areas. There was no debris, other than some leaves observed at the trash rack. The operating stand is in good condition. (See Photograph No. 10). The operating handle was not in place, but reportedly is kept at the Public Works Dept. At the time of the inspection, the sluice gate was operable and open about two or three inches and the discharge did not appear to be impeded. (See Photograph No. 6).

10. VIEW OF LOW LEVEL GATE OPERATING STAND.
