20. ABSTRACT (Continue on reverse side if necessary and identify by block number)  The dam is a former mill pond dam about 330 ft. long. It has a maximum height of about 8 ft. Past inspection records and the lack of operating and maintenance procedures, there are several deficiencies which must be corrected to assure the continued performance of the dam. Generally, the dam is in poor condition. It is small in size with a hazard potential of high.

This Phase I Inspection Report on Forge Pond Dam has been reviewed by the undersigned Review Board members. In our opinion, the reported findings, conclusions, and recommendations are consistent with the Recommended Guidelines for Safety Inspection of Dams, and with good engineering judgment and practice, and is hereby submitted for approval.

FORGE POND DAM

**OVERVIEW  
FORGE POND DAM  
FREETOWN, MASSACHUSETTS**

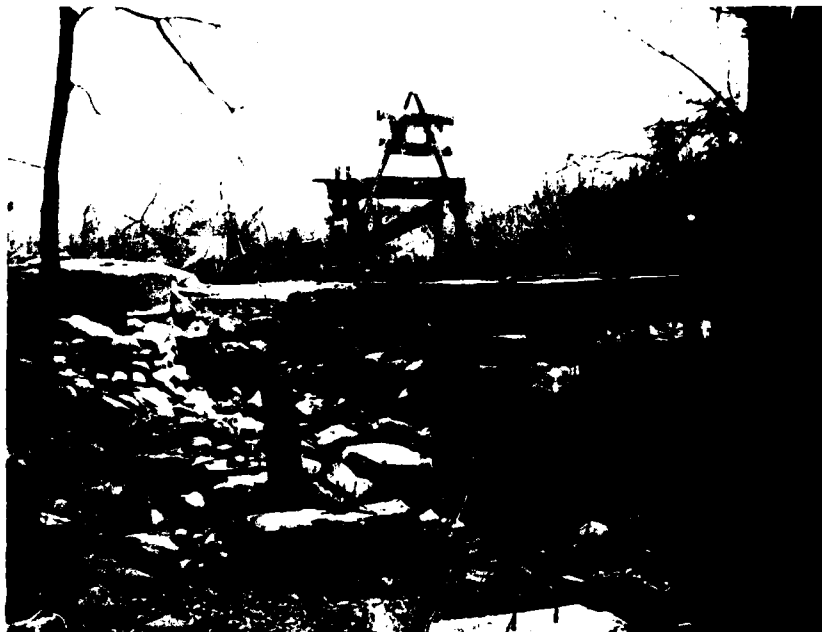
Several cavities were observed in the stone wall on both sides of the auxiliary outlet structure. The stone masonry is mostly dry joint with vines growing in it. The cavities were probably formed when the water flanked the structure and undermined loose stone. The largest cavity, 18 inches deep was observed on the right side of the auxiliary outlet structure. At this same location, it appears that precast concrete vehicular stop logs were recently placed to fill a gap in the wall.

**NO. 4 VIEW OF UNDERMINER TRAINING WALL AND CONCRETE APRON ON RIGHT SIDE OF AUXILIARY OUTLET STRUCTURE**

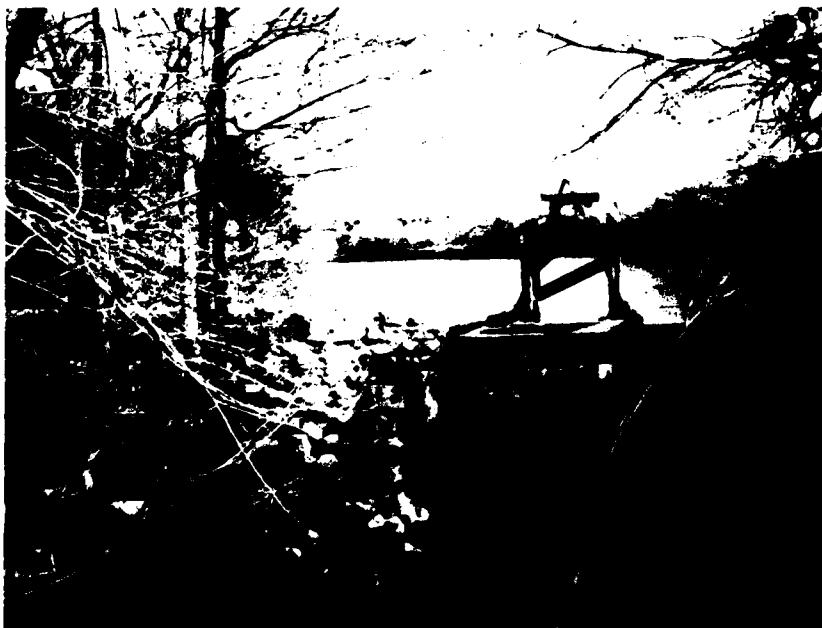
The auxiliary outlet structure is also in poor condition. It consists of a concrete intake structure leading to a 54-inch diameter outlet pipe. The remains of a wooden platform apparently constructed for a slide gate is located above the intake structure. The slide gate and mechanism are no longer present. The concrete sidewalls were cracked, spalled, stained and deteriorated. The stop log keyways on the inside of the concrete sidewalls are deteriorated. The concrete walls appear to have been placed directly on a dry joint stone wall, as cobble-size stones are embedded at the base of the sidewalls. Water was observed leaking between the right sidewall and the bottom of the dry-stone masonry section of the embankment. The downstream end of the intake structure is boarded up and covered with a sheet of rubber. However, there is a small amount of leakage into the

**NO. 6 VIEW OF AUXILIARY OUTLET STRUCTURE  
FROM FORGE ROAD BRIDGE**
