NATIONAL PROGRAM FOR INSPECTION OF NON-FEDERAL DAMS  
LUDLOW DAM (MA 00547) (U) CORPS OF ENGINEERS WALTHAM  
MA NEW ENGLAND) IV AUG 78

Ludlow and Cherry Valley Dams, which impound Springfield Reservoir, are in good condition. Based upon visual inspections, the reservoir dams are maintained in good operating condition with a continual maintenance program.

PHASE I INSPECTION REPORT  
LUDLOW & CHERRY VALLEY DAMS  
MA 000547 & MA 000548

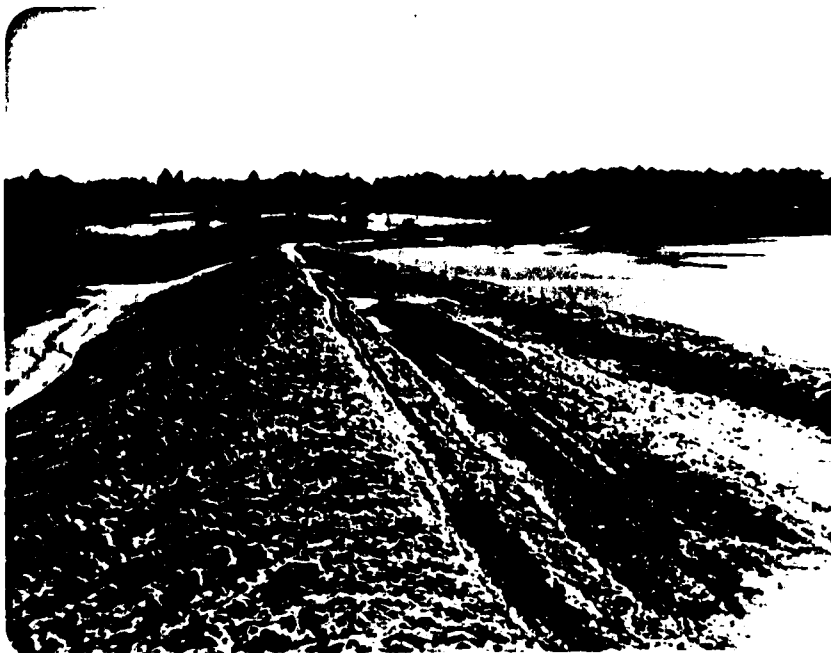
Photograph #14

Downstream View of Cherry  
Valley Dam - Left Abutment

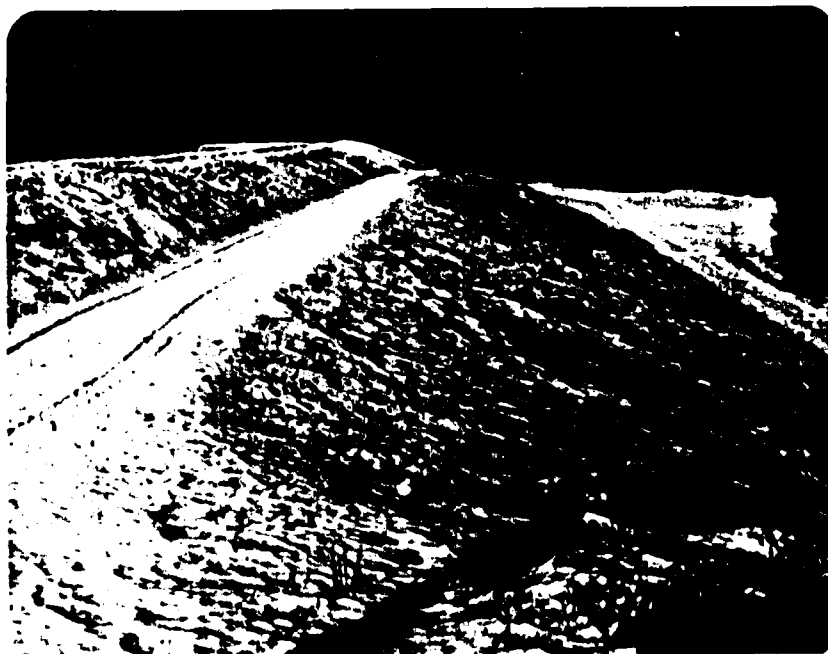
Photograph #15

Downstream View of Cherry  
Valley Dam - Right Abutment
