HOUSATONIC RIVER BASIN  
LEE, MASSACHUSETTS

LEAHEY (UPPER) RESERVOIR DAM  
MA 00265

PHASE I INSPECTION REPORT  
NATIONAL DAM INSPECTION PROGRAM

FEBRUARY 1979

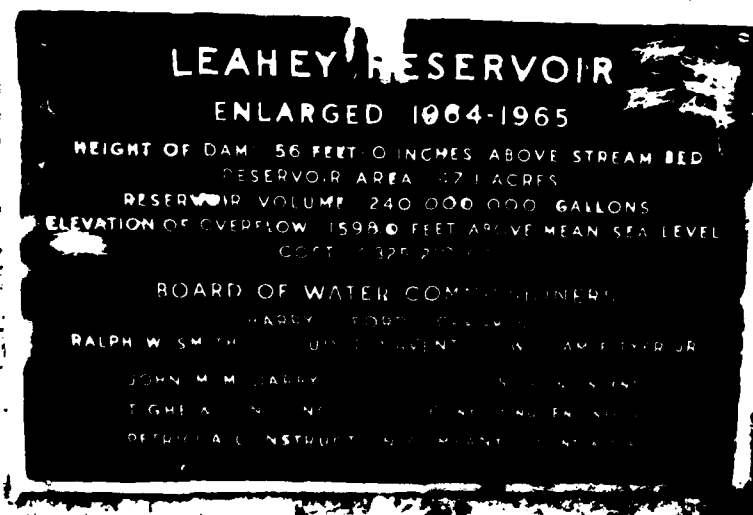
2. PLAQUE ON GATE HOUSE EXTERIOR.
