TAUNTON RIVER BASIN  
BROCKTON, MASSACHUSETTS

THIRTY ACRE POND DAM  
MA 00423

PHASE I INSPECTION REPORT  
NATIONAL DAM INSPECTION PROGRAM

MAY 1979

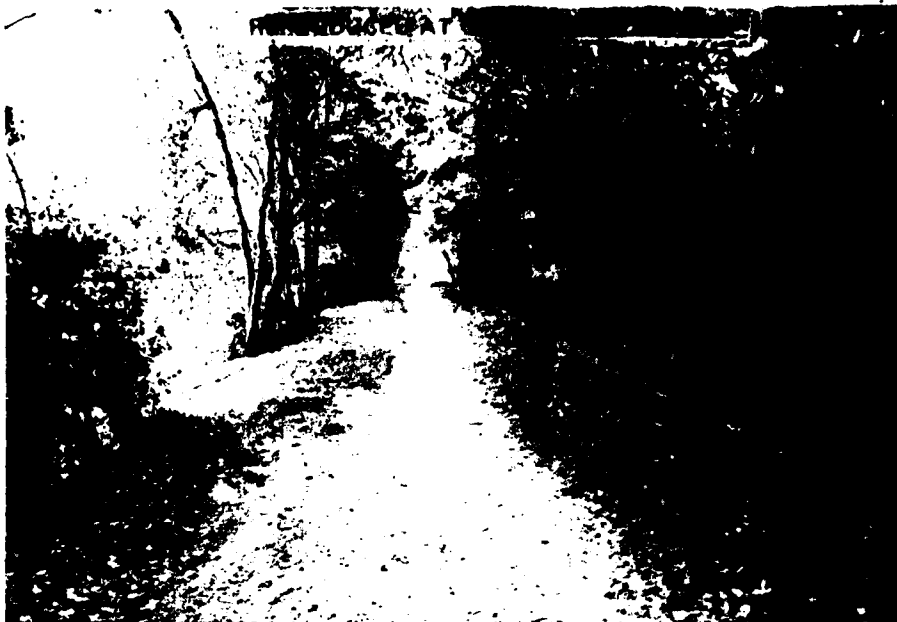
- (1) The top of the dam embankment at the right end is bare, and a bare path at least 4 ft wide has been worn along the axis for the entire length of the crest, as shown in Photos 1, 2 and 3. Grass on either side of the path was mowed. Both the upstream and downstream slopes of the embankment are covered by brush and trees, some of which are as large as 12 in. in diameter, as shown in the same photos. Sand and gravel fill with cobbles and boulders is exposed on the downstream slope around the trees. Localized erosion of the slope was observed where there is no vegetative cover. Part of the length of the upstream face is protected by cut stone masonry walls and part by broken rock and boulders, as shown in Photo 3.

3. Crest of dam looking east.

2. Reshape the downstream embankment slope and place topsoil as necessary to establish and maintain vegetative cover.
  3. Repair local eroded areas in the embankment and establish turf on the crest to resist erosion. If foot traffic does not permit such a growth, the trafficked areas should be protected by other means, such as pavement or crushed stone.

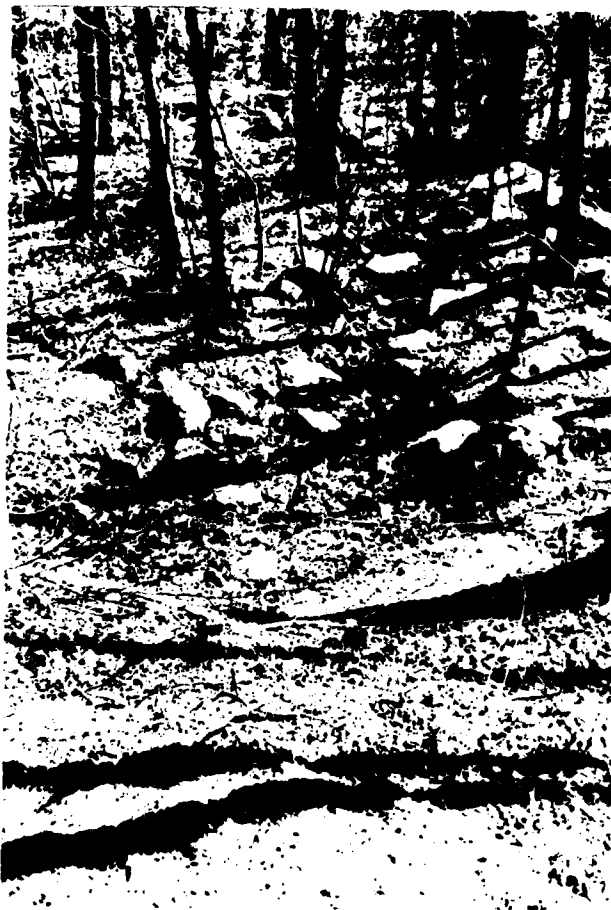
(c) At the downstream toe of the embankment within 200 ft to the right of the spillway outlet pipes, there are several wet areas at the location shown in Photo 4. The bed of these areas is again stained a reddish-brown color and the combined flow from the areas to a stagnant pool located about 40 ft downstream of the toe was estimated to be about one gallon per minute at the time of the visual inspection.

This condition was observed to be more active on 23 March 1979 during a supplemental visit to the site, when the level of the pond was 0.5 ft higher. Seepage flow was emerging approximately 100 ft right of the pipes near the downstream toe. At that time, the seepage rate at this specific location was estimated to be less than one gallon per minute. Soil particles were not observed in the seepage flow.

4. Downstream toe of dam in seepage area.

1. Assess the potential for a failure and/or excessive movement of the dam and dike embankments under earthquake loading conditions for Seismic Zone 3.
2. Investigate the seepage condition near the downstream toe of the embankment and assess the need for remedial measures. The investigation should include systematic monitoring of the seepage at the base and lowest berm of the ornamental embankment at the emergency spillway, at the service spillway discharge pipes, and near the downstream slope right of the pipes. Particular attention should be paid to the possible presence of soil

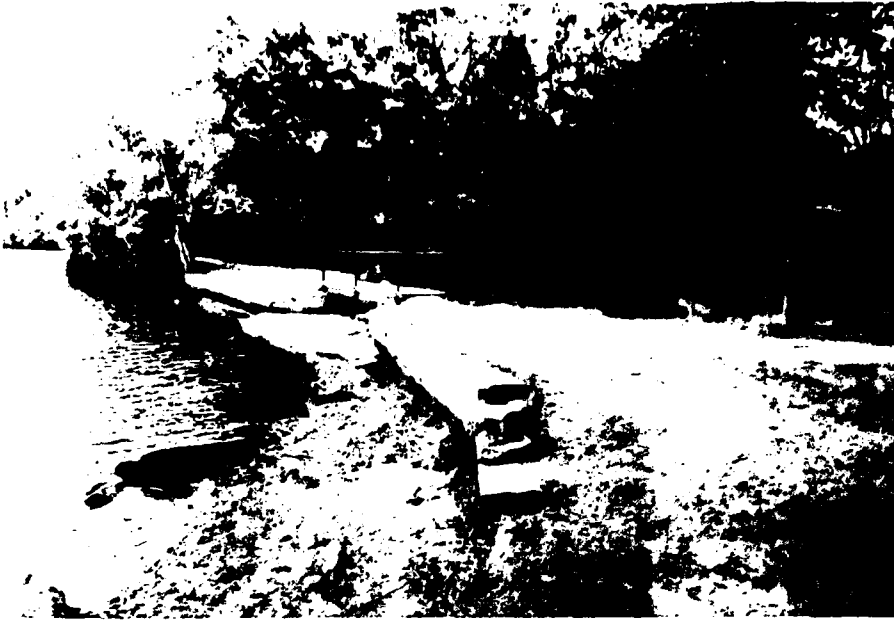
- b. Dam - The earth embankments of the dam and the dike are generally in fair condition. There is no visual evidence of settlement, lateral movement, piping or major erosion at this time. However, significant seepage, which varies with the level of the pond, has been observed at the dam. The spillways shown in Photos 5 and 7 are in good condition.

- c. Appurtenant Structures - The bridge over the emergency spillway, as shown in Photos 1 and 5, is in good condition.
- d. Reservoir Area - The reservoir is surrounded by moderately sloped, heavily wooded hills. No development exists along the banks of the reservoir, nor in the immediate upstream and downstream portions of the drainage area.
- e. Downstream Channel - Beaver Brook conveys the discharge from the outlet works of the dam to Salisbury Brook, a distance of about 0.5 miles. Along this course, two dams and hydraulic control structures, two ponds, and two culverts are located.

5. Upstream side of emergency spillway.

4. Repair the eroded concrete invert and patch the concrete spalls in the service spillway intake.
  5. Repoint the stonework at the front of the emergency spillway.

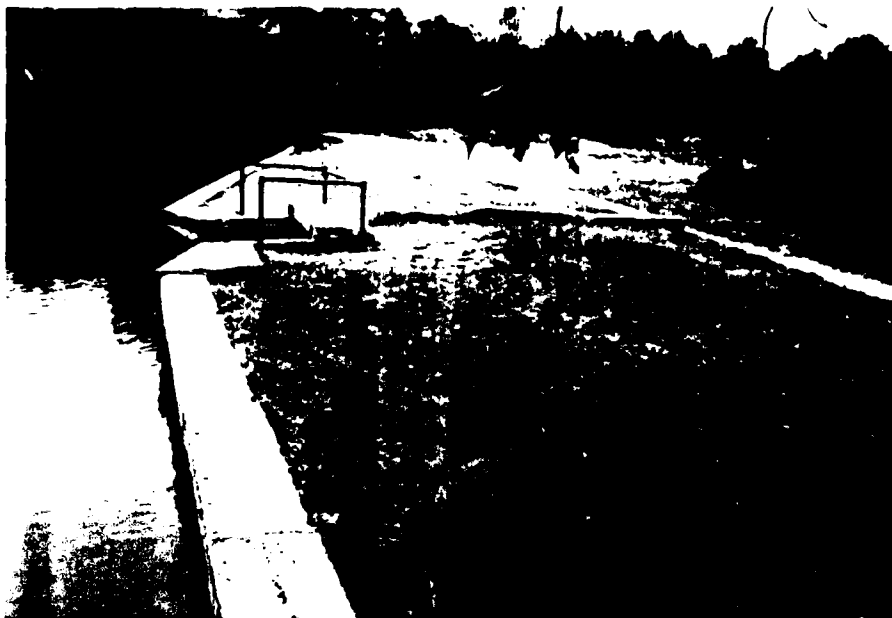
7. Entrance of service spillway.
