TAUNTON RIVER BASIN  
BROCKTON, MASSACHUSETTS

WALDO LAKE DAM  
MA 00426

PHASE I INSPECTION REPORT  
NATIONAL DAM INSPECTION PROGRAM

MAY 1979

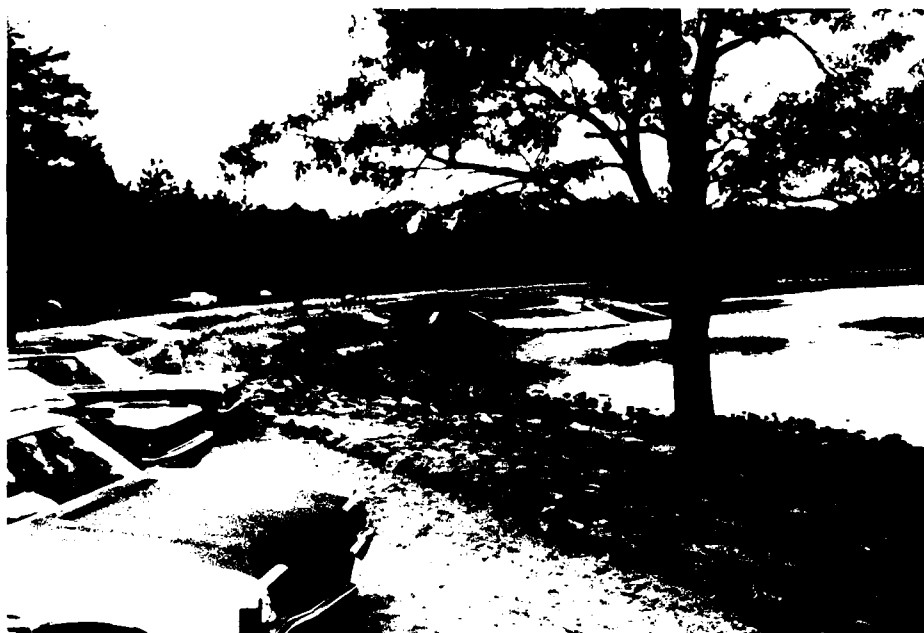
1. Overview of upstream face of dam and spillway from dike.

1. The upstream slope of the roadway embankment is relatively flat and generally protected by broken rock, cobbles and boulders to a level approximately 4 to 5 ft above the spillway crest. The slope protection has been locally displaced in some areas at and below the apparent high water line, as shown in Photos Nos. 1 and 2.

1. Repair stone riprap on the upstream slope at the locations where it has been displaced or damaged by erosion.
  2. Place earth fill adjacent to the spillway walls and outlet structures to restore the spillway embankment in areas where it is low and eroded. Turf should be established over areas presently bare to resist erosion. If pedestrian traffic prevents the growth of turf, the embankment crest should be paved or otherwise protected.

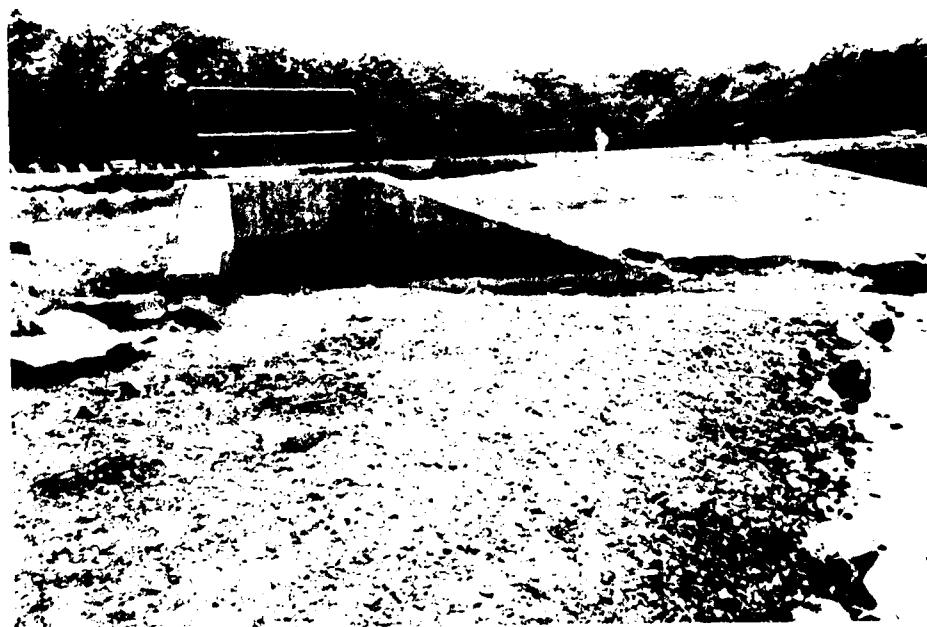
1. The upstream slope protection has been locally displaced in some areas at or below the apparent high water line as shown in Photos 4 through 8.
2. Foot traffic has caused many bare areas to develop as shown in Photos 4 through 8.

5. The headwalls of the principal spillway had some erosion of concrete present as shown in Photo 5.
6. The headwalls of the left reservoir drain and the right reservoir drain have significant deterioration especially at the elevation of normal water level as shown in Photos 6 and 8.

5. Upstream headwall of left spillway (principle spillway).

5. Remove silted materials, cobbles and debris from the principal spillway inlet.
  6. Patch eroded concrete areas at the principal spillway inlet and repair the upstream end of the overflow spillway sidewall.
