NATIONAL PROGRAM FOR INSPECTION OF NON-FEDERAL DAMS  
MILL POND DAM MA 0043. (U) CORPS OF ENGINEERS WALTHAM  
MA NEW ENGLAND DIV APR 79

MA 00436 April 1979

DAM: Mill Pond  
IDENTIFICATION NO. MA 00436

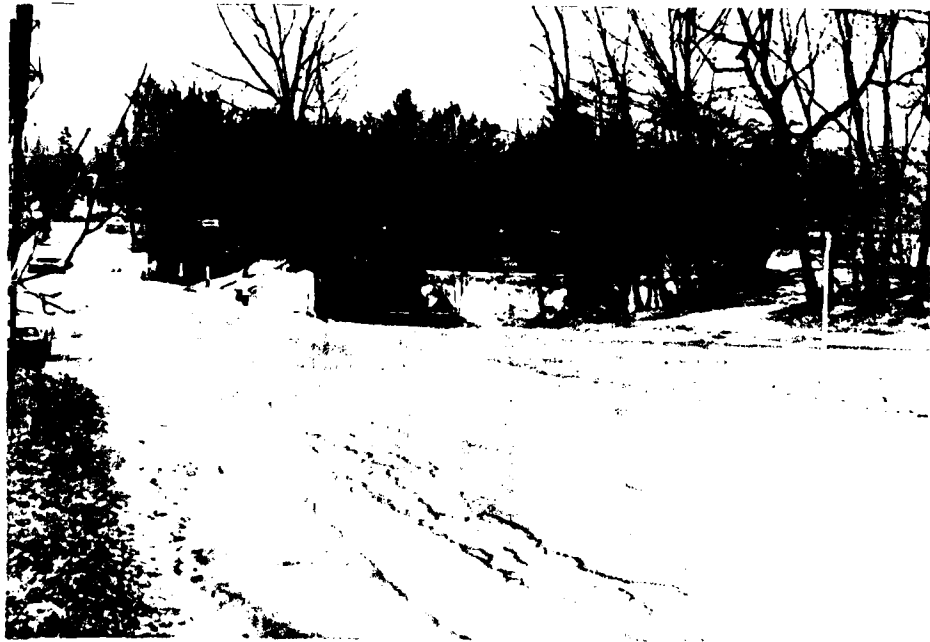
1. Overview of Mill Pond (Myrtle Street) Dam

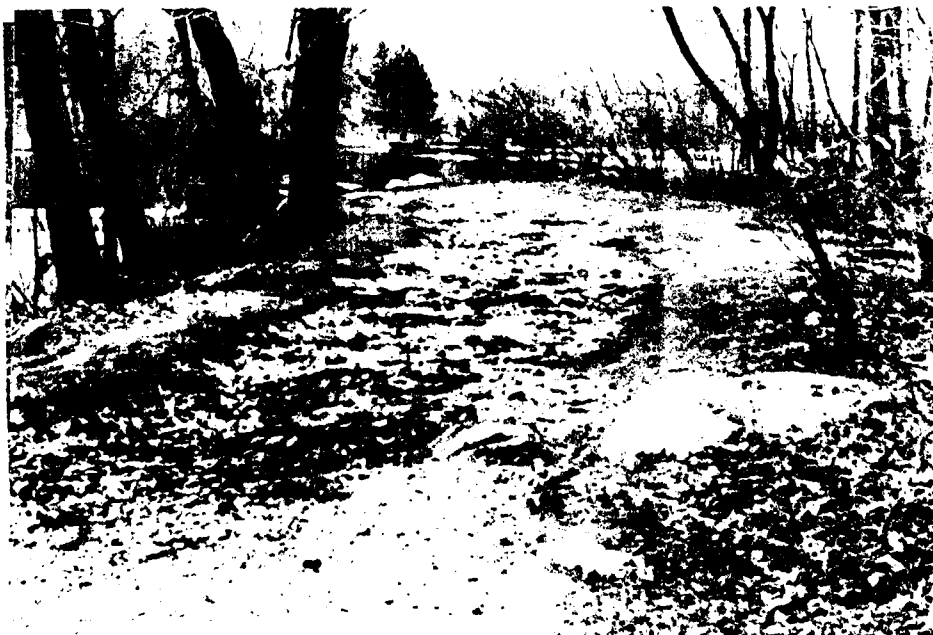
10. Badly eroded unpaved road at left abutment of dam

3. Repair upstream riprap protection and restore grade to top of dam at the left abutment.
4. Remove the flashboard supports on the spillway weirs, since they only serve to trap debris and further reduce the already grossly inadequate spillway capacity. This would also eliminate the possibility of anyone installing flashboards at the spillways.

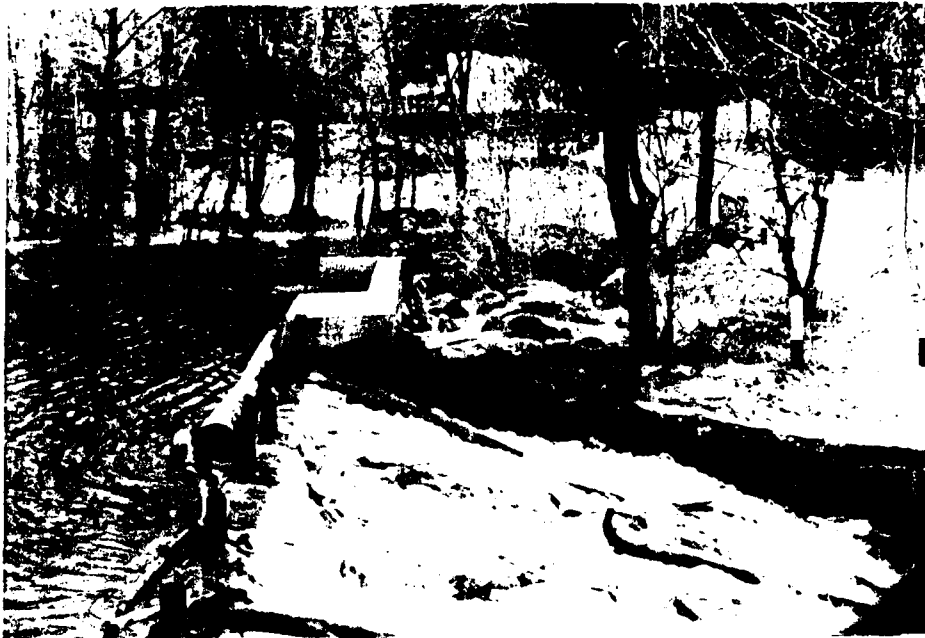
The general condition of the "L" shaped concrete wall, Photos No. 13 and 14, is good with some minor staining observed. The earth backfill on the downstream side has been washed out to about 3 ft. below the top of the wall, apparently most recently by overtopping of the wall in January 1979.

13. Concrete wall separating two spillways

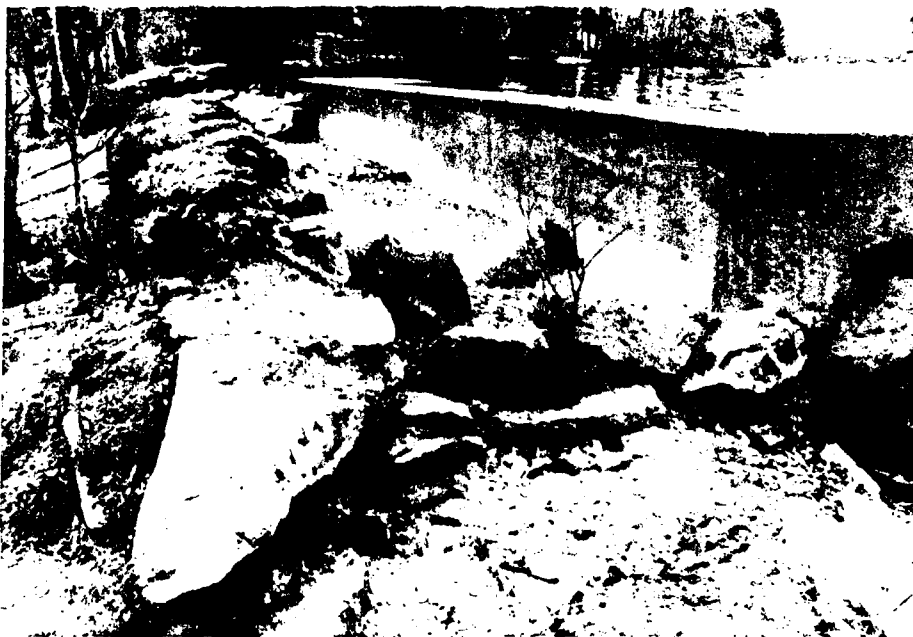
14. Eroded earth berm on downstream side of  
concrete wall

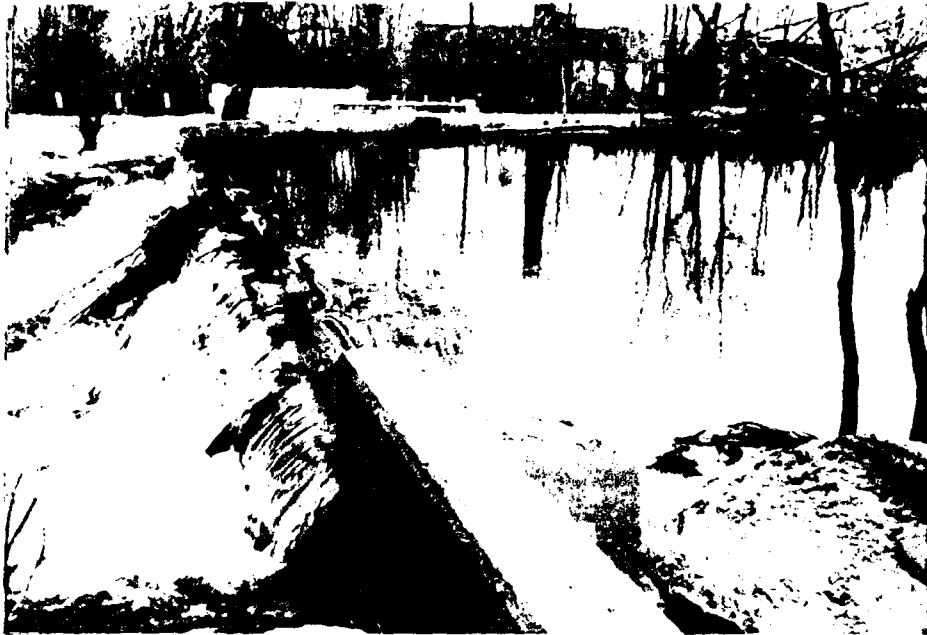
15. Weir and trapped debris at left (northerly)  
spillway

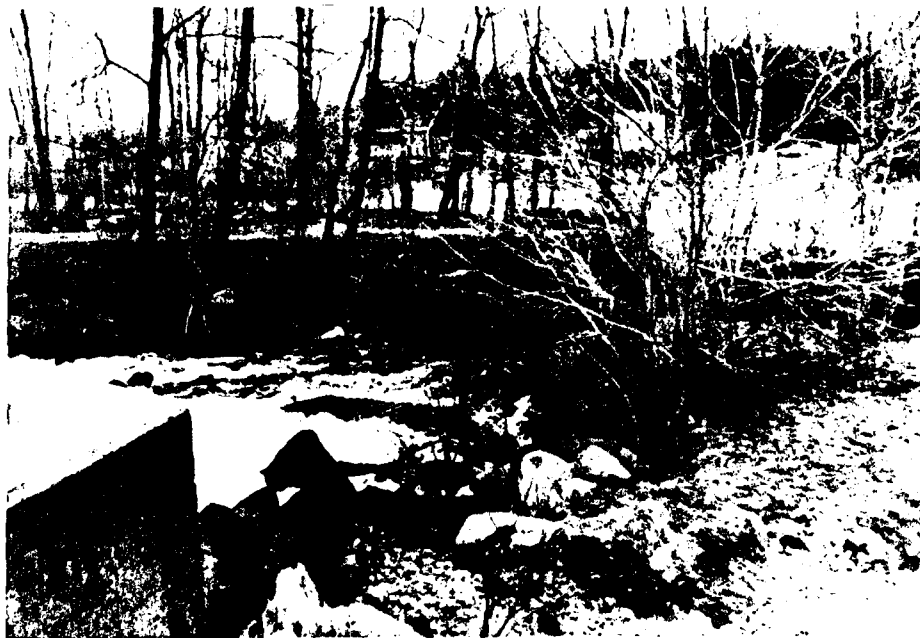
The remains of stone masonry walls can be seen on both sides of the cascades and discharge channels. Except for the left wall of the right spillway discharge channel, Photos No. 12 and 13, those portions of the stone walls which are still intact are in poor condition. Water could be seen flowing from the joints at the bottom of the remains of the right wall at the right spillway cascade, Photo No. 7. The left wall of the left spillway discharge channel is partially washed out, and part of the bank is undercut by about 4 ft., Photo No. 16.

16. Bank undercut along left spillway discharge  
channel

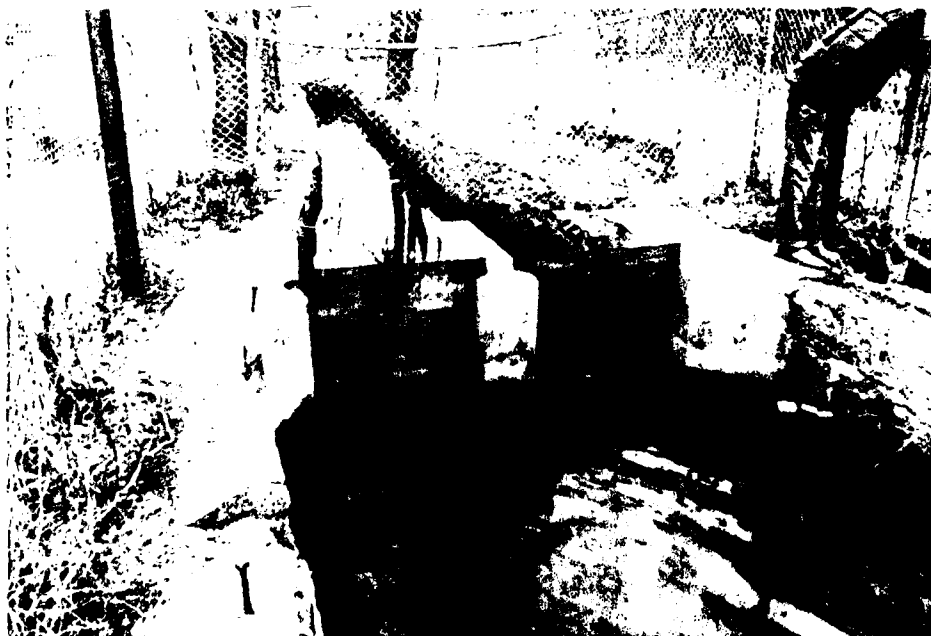
18. Steel gates at entrance of air conditioning  
water supply outlet channel

5. Replace trash rack at entrance to water supply outlet channel.
6. Provide a more positive seal than the existing gates at the entrance to the water supply outlet channel. Stoplogs could be used as a control weir for this outlet from which Gordon-Mindick Properties draws air conditioning water.

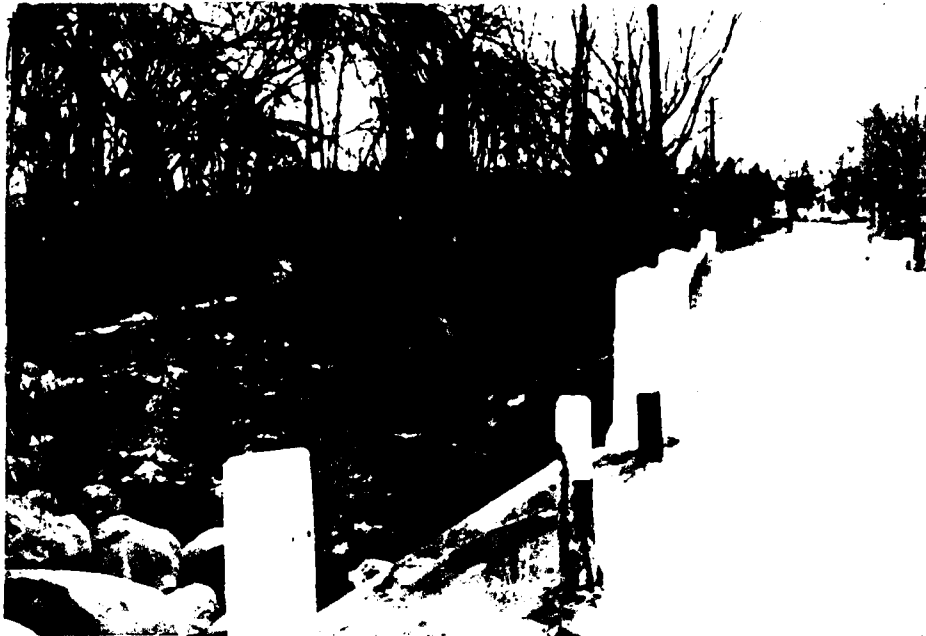
Myrtle Street bridges. The two channels join at a point about 80 ft. downstream of Myrtle Street. Various size trees and boulders were observed on both banks of the river downstream of Myrtle Street, Photo No. 23. The left bank rises at a very steep slope to a height of about 20 ft. The right bank borders the Gordon-Mindick Properties parking area.

23. Downstream channel from left spillway culvert under Myrtle Street

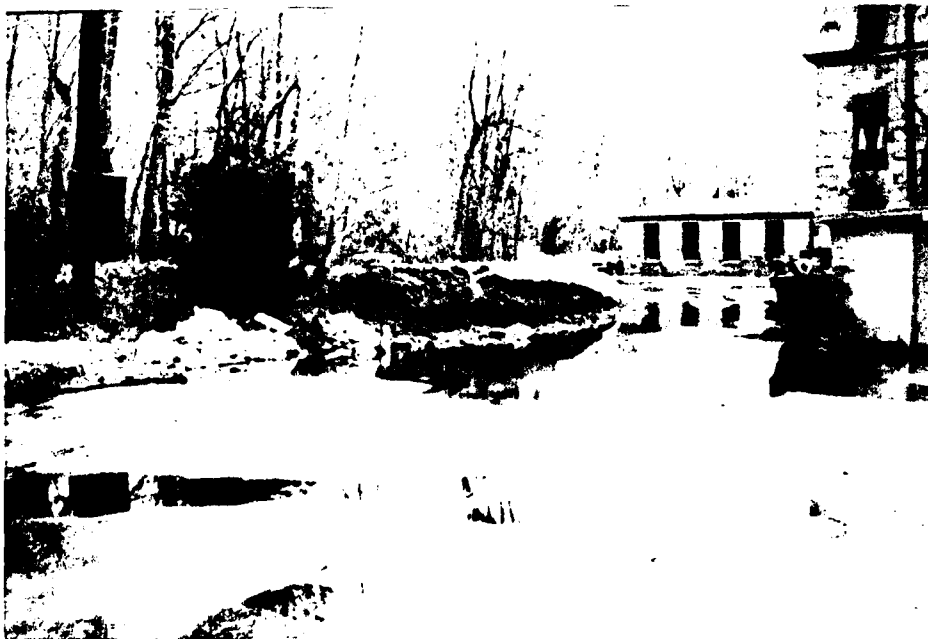
24. Earth flood-control dike along Gordon-Mindick Properties complex (January 1979)
