NATIONAL PROGRAM FOR INSPECTION OF NON-FEDERAL DAMS  
PALMER BROOK DAM MA 0 (U) CORPS OF ENGINEERS WALTHAM  
MA NEW ENGLAND DIV MAR 81

| REPORT DOCUMENTATION PAGE | | READ INSTRUCTIONS<br>BEFORE COMPLETING FORM |
|---|---|---|
| 4. TITLE (and Subtitle)<br><br>Palmer Brook Dam<br>NATIONAL PROGRAM FOR INSPECTION OF NON-FEDERAL DAMS | | 5. TYPE OF REPORT & PERIOD COVERED<br>INSPECTION REPORT |
| 20. ABSTRACT (Continue on reverse side if necessary and identify by block number)<br><br>- Palmer Brook Dam is an earthen embankment structure 33.5 feet high and 290 feet long. Based on visual inspection the dam is judged to be in good condition. It is classified as "intermediate" in size with a "high" hazard potential. | | |

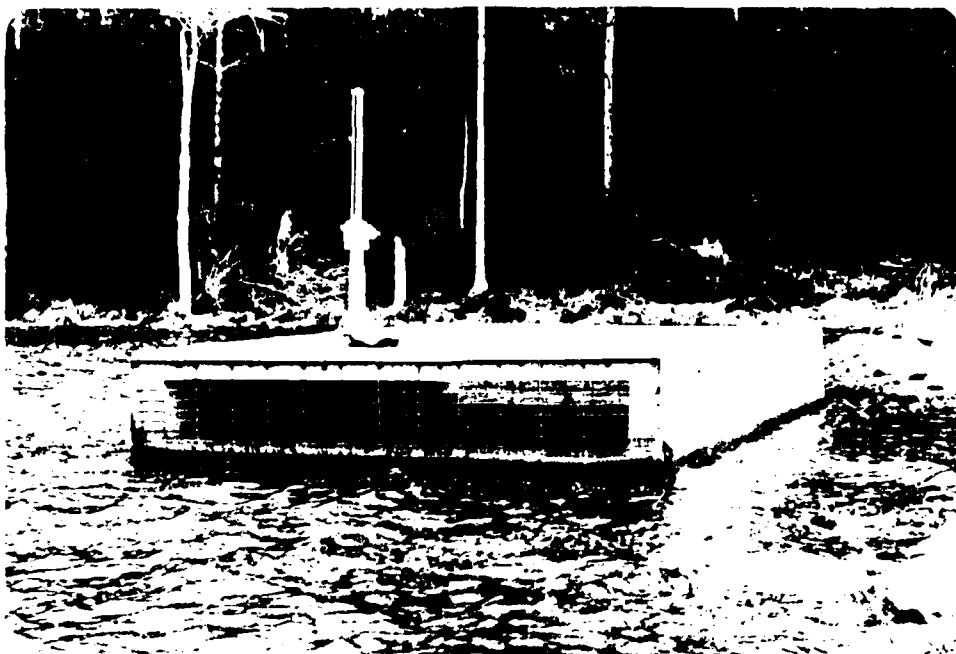
Photo No. 3

View of the service spillway intake. Note trash screens and slide gate operating mechanism.
