HOUSATONIC RIVER BASIN
HINSDALE, MASSACHUSETTS

BELMONT RESERVOIR DAM
MA 00224

PHASE I INSPECTION REPORT
NATIONAL DAM INSPECTION PROGRAM

MARCH 1980

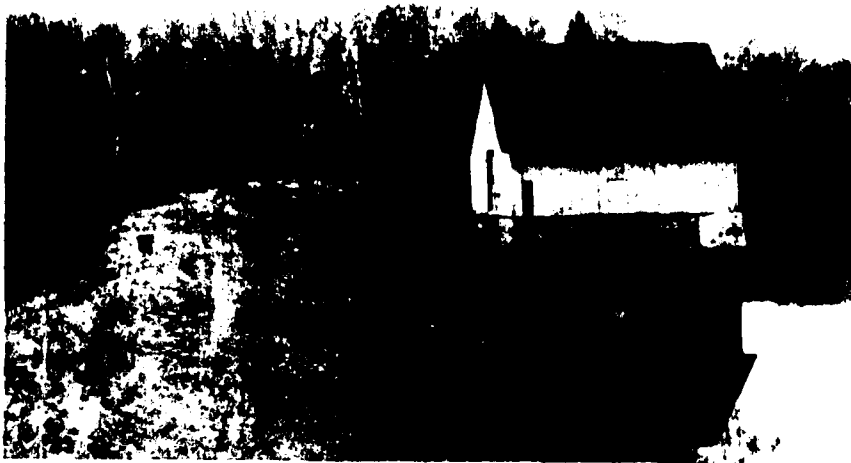
Photo 1

Dam overview looking southerly from left abutment

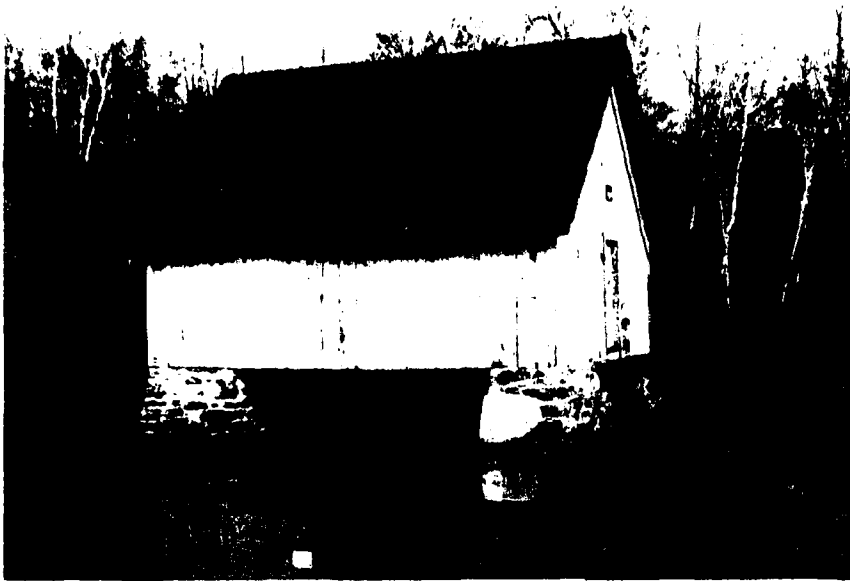
Photo 7

Gate house looking
northerly from crest
of dam

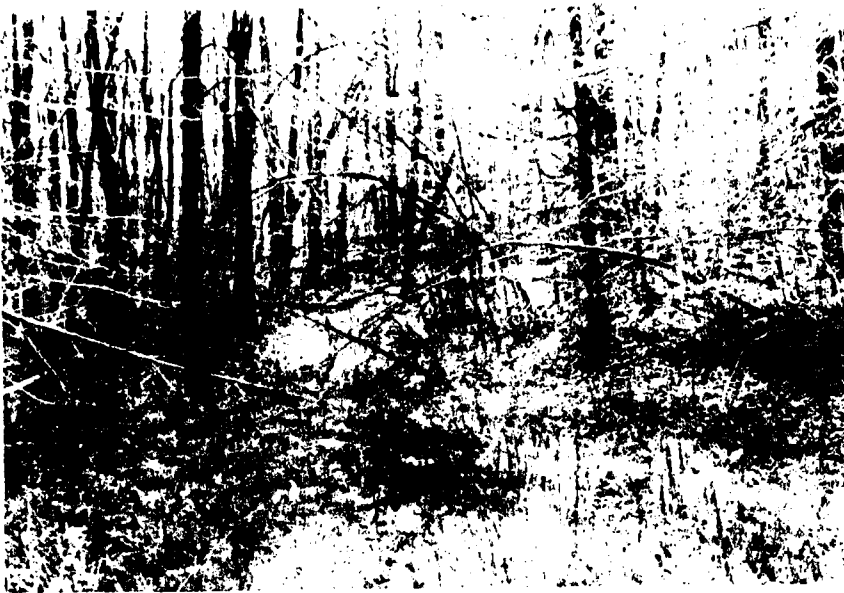
Photo 13

Downstream of emergency spillway
