WEIR RIVER BASIN
HINGHAM, MASSACHUSETTS

ACCORD POND DAM
MA 00430

PHASE I INSPECTION REPORT
NATIONAL DAM INSPECTION PROGRAM

APRIL 1979

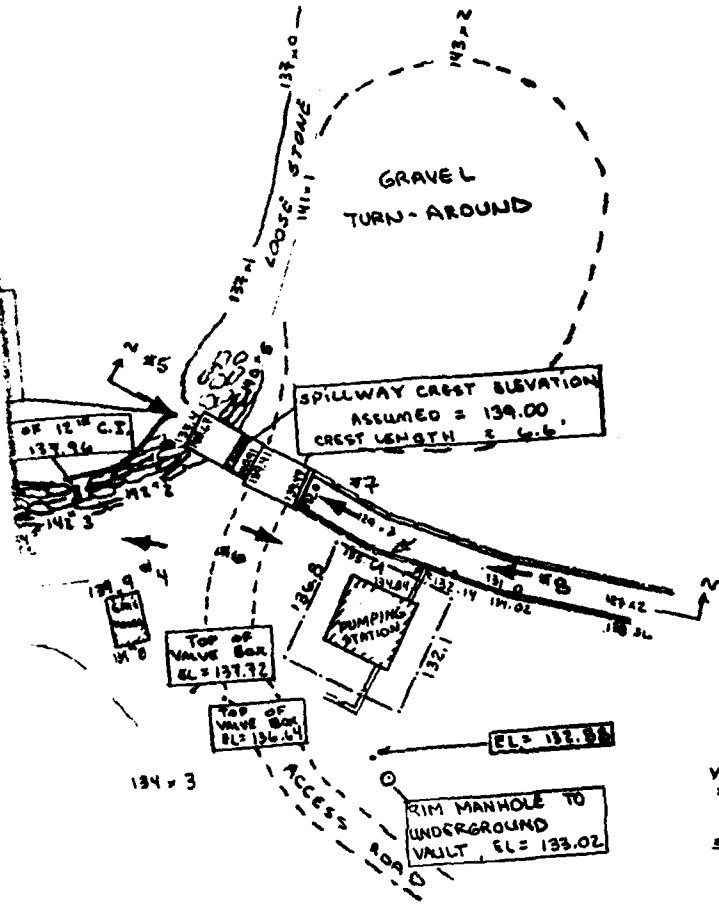
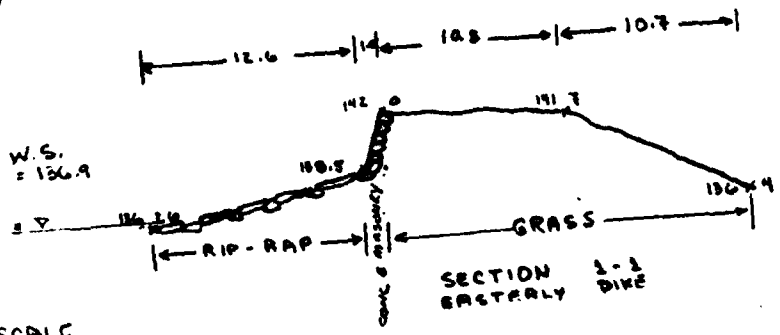
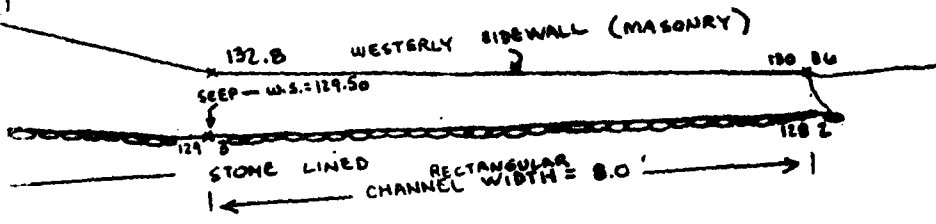
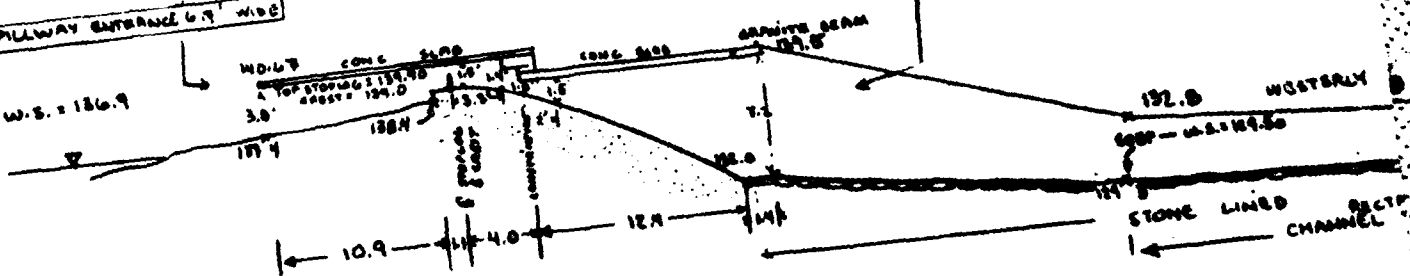
NETCALP & ASSOC., INC.
 NATIONAL PROGRAM OF INVESTIGATION
ACCURD
 FIGURE 8-1 PLAN & SECTION
 TRIBUTARY WIER RIVER
 SCALE: AS SHOWN

As shown in Figure B-1, the spillway is constricted by a covering concrete slab. The opening between the slab and the top of the stoplogs is 0.6 feet high, and will act as an orifice during periods of high water flow. The spillway apron contained considerable debris and the stone rubble dislodged from the bottom should be replaced.
