JONES RIVER BASIN  
KINGSTON, MASSACHUSETTS

FOUNDRY POND DAM  
MA 00394

PHASE I INSPECTION REPORT  
NATIONAL DAM INSPECTION PROGRAM

FEBRUARY 1980

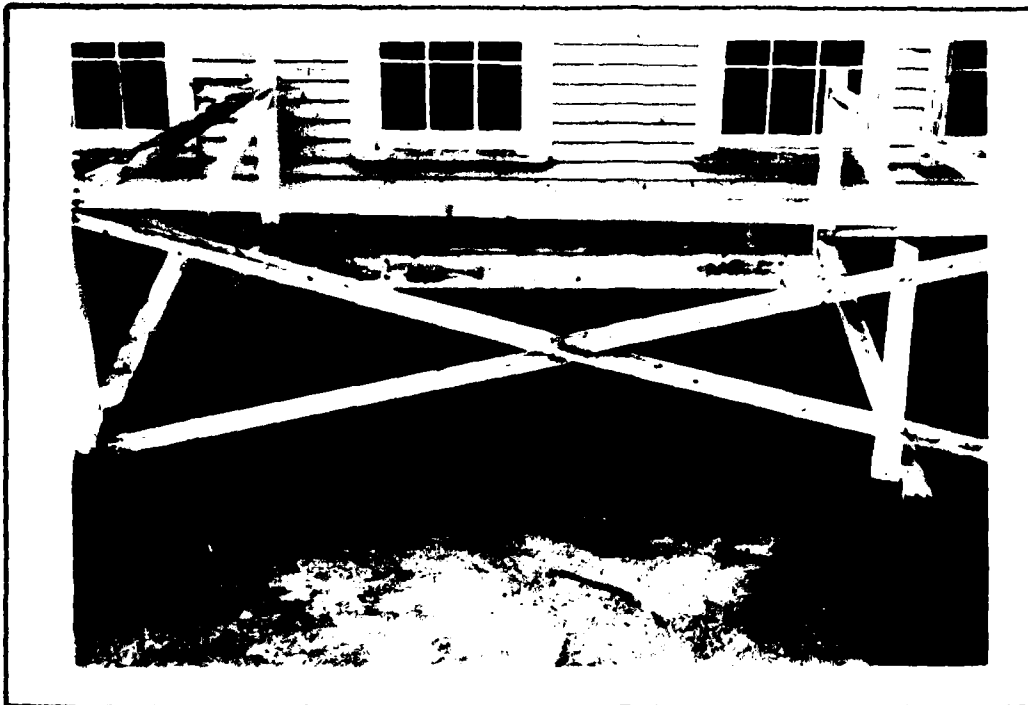
8. SPILLWAY DISCHARGE CHANNEL EMERGING FROM BENEATH INDUSTRIAL BUILDING  
ABOUT 170 FEET DOWNSTREAM FROM THE SPILLWAY. (10/24/79)

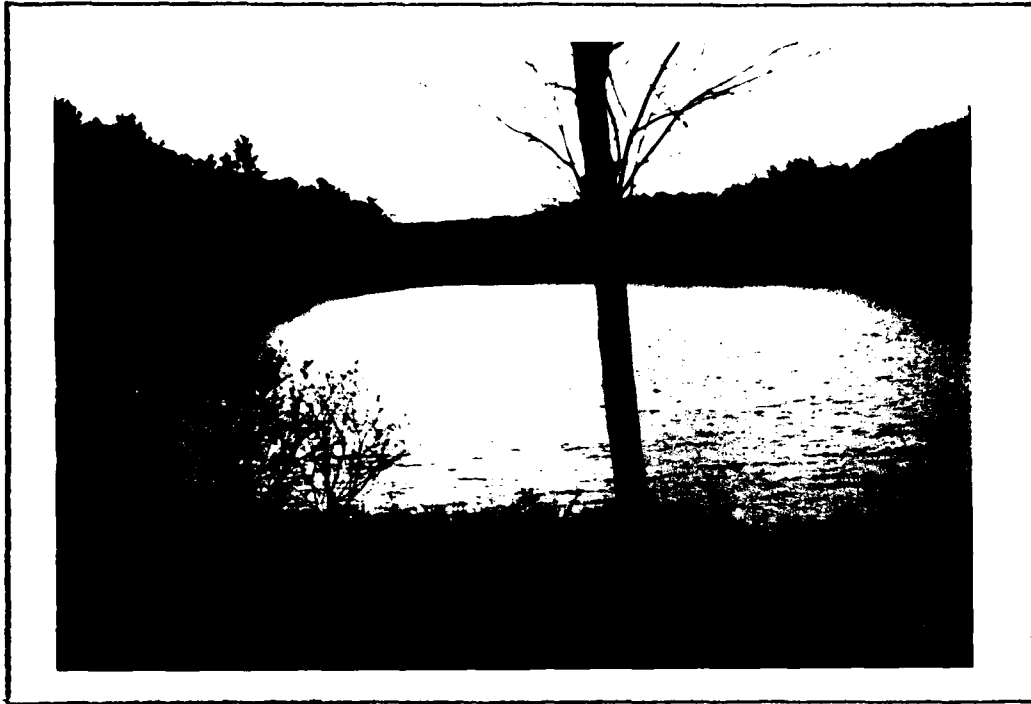
1. FOUNDRY POND AS VIEWED FROM THE RIGHT ABUTMENT OF THE DAM.  
(10/24/79)

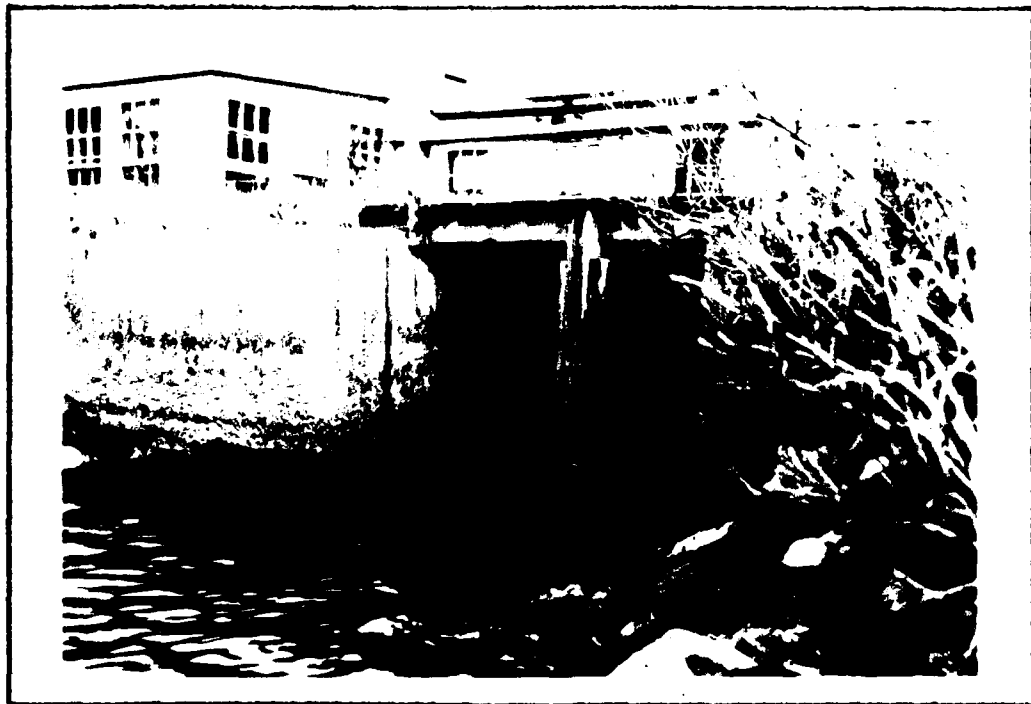
2. UPSTREAM END OF THE SPILLWAY SYSTEM WITH THE INDUSTRIAL FACILITIES IN THE BACKGROUND. (10/24/79)
