DARK BROOK RESERVOIR DAM

PHASE I INSPECTION REPORT  
NATIONAL DAM INSPECTION PROGRAM

JULY 1980

| REPORT DOCUMENTATION PAGE | | READ INSTRUCTIONS<br>BEFORE COMPLETING FORM |
|---|---|---|
| 4. TITLE (and Subtitle)<br>Dark Brook Reservoir Dam (and Dike A)<br>NATIONAL PROGRAM FOR INSPECTION OF NON-FEDERAL DAMS | | 5. TYPE OF REPORT & PERIOD COVERED<br>INSPECTION REPORT |

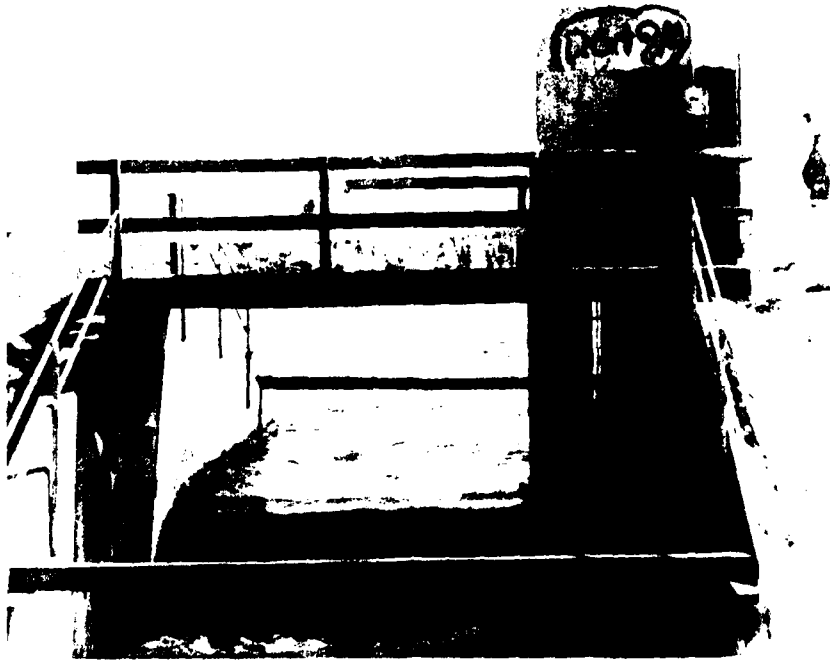
9. Spillway crest and sluice gate.

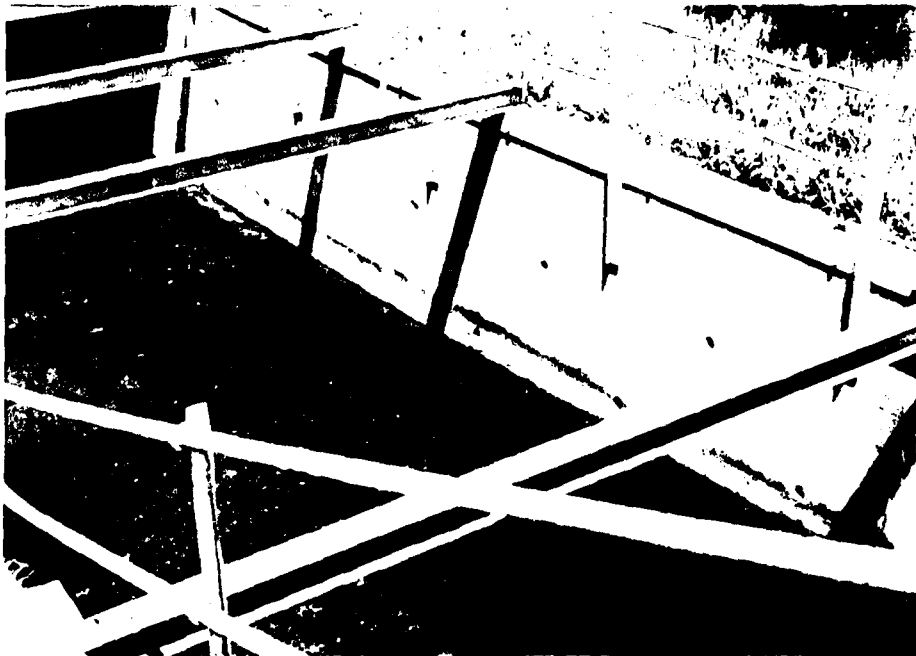
10. Right spillway training wall.

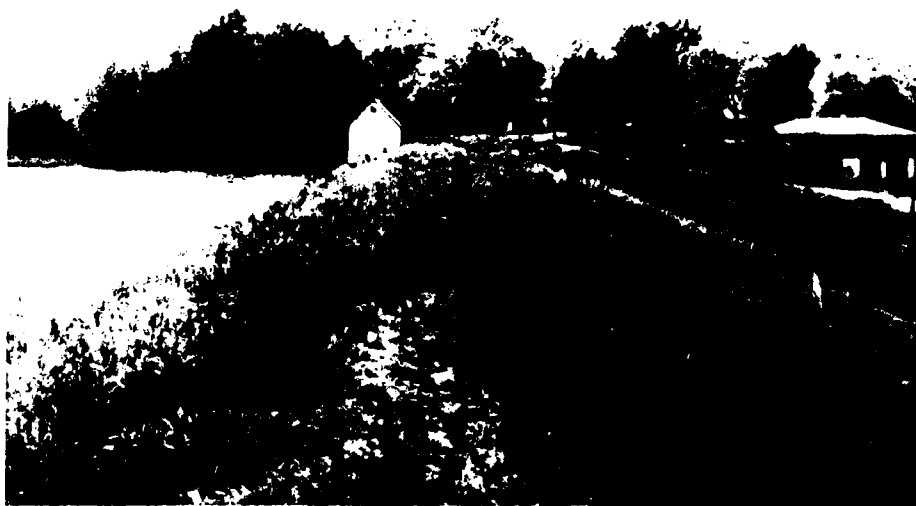
Photo No. 4 is a view of the upstream slope taken from the right abutment. The upstream slope has some minor growth generally not over 3 ft. high intermingled with the riprap on the slope. The upper 3 ft. of the slope is not riprapped but is grass covered. The riprap appears to be in good condition. It varies in size from 1 in. stones up to 4 ft. slabs. It appears that the brush on the upstream

4. Upstream slope of main dam from right abutment.

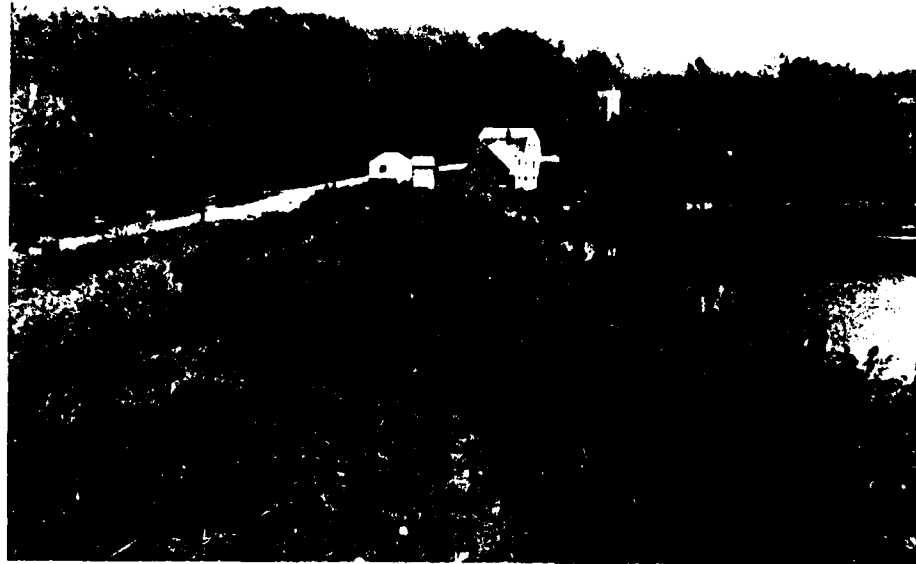
1. Crest of main dam from left abutment.
