THOUSAND ACRES SITE NO. 1 DAM  
MA 02154

# PHASE I INSPECTION REPORT NATIONAL DAM INSPECTION PROGRAM

OCTOBER 1979

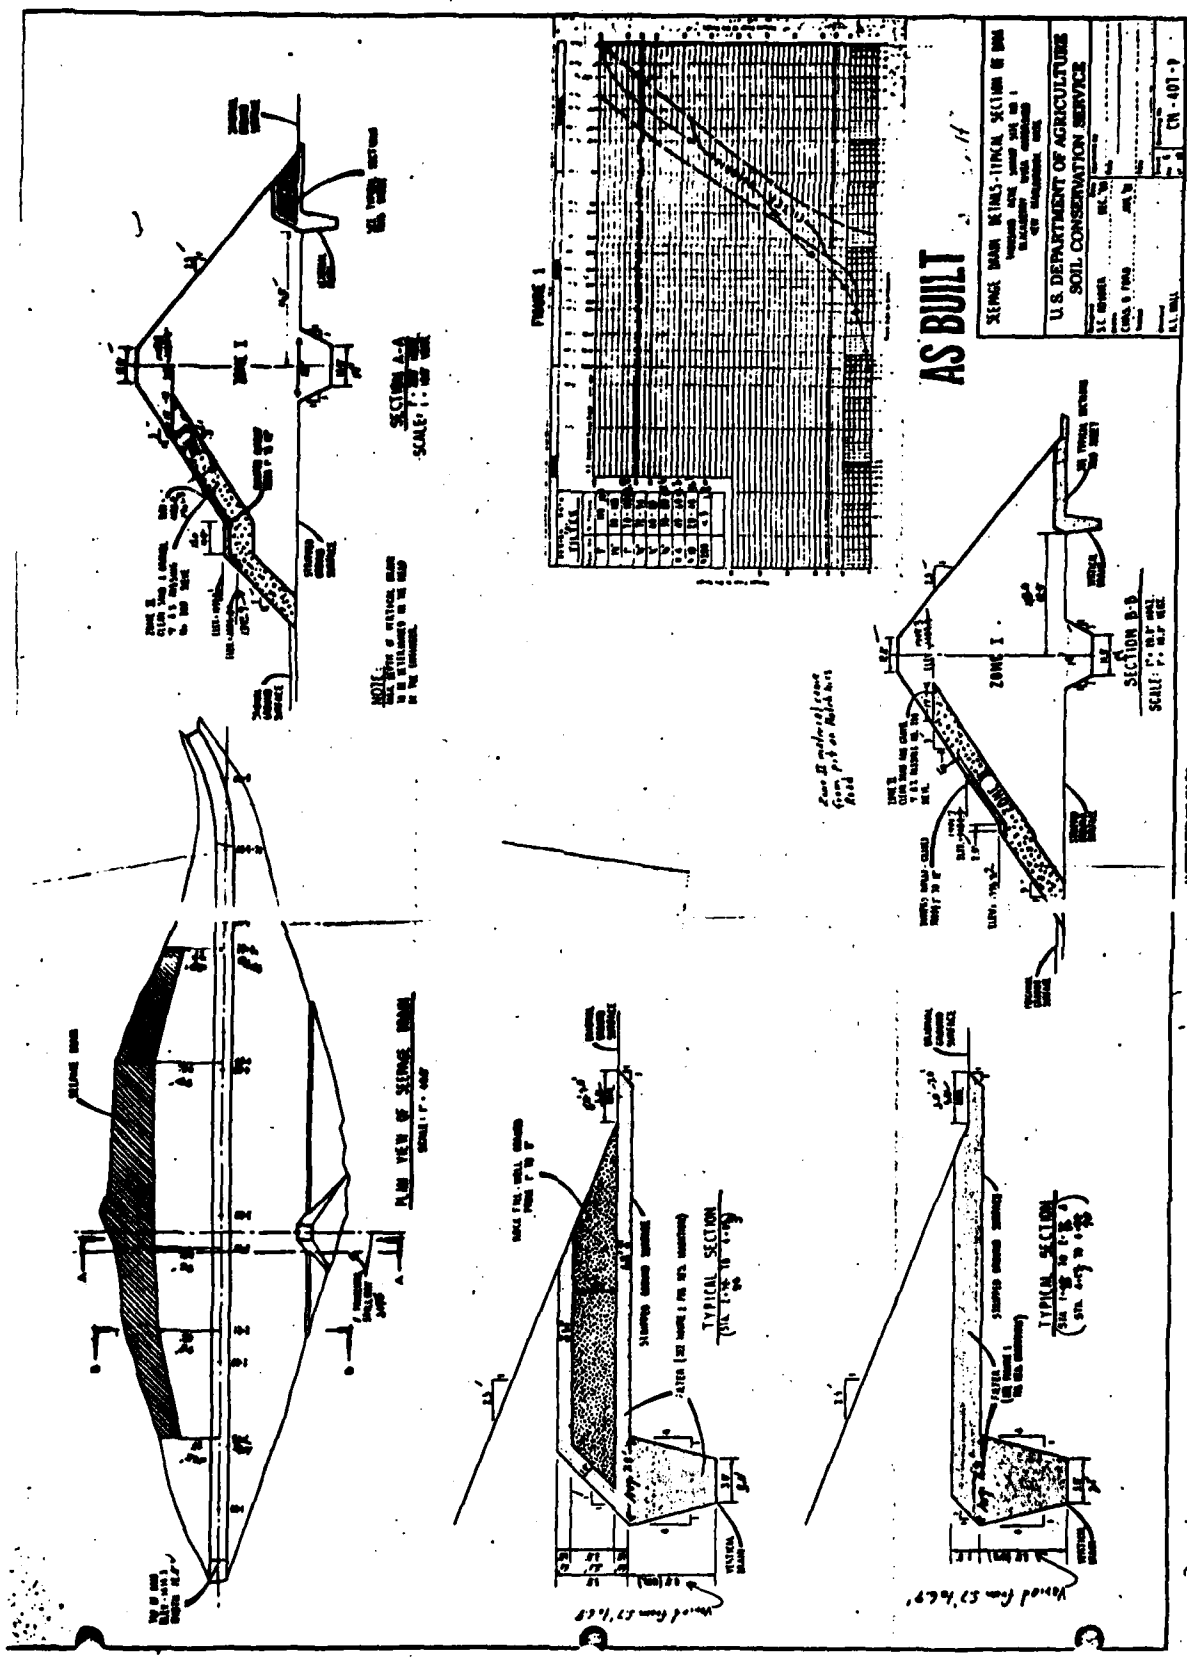
FIGURE B-5

The upstream face is a 3:1 (horizontal to vertical) grassed slope. The downstream face is a 2.5:1 grassed slope. Available drawings indicate that the dam is a zoned embankment founded on silty sand with a cutoff trench varying from 2 to 6 feet deep. The zoned embankment consists of earthfill with an upstream zone of sand and gravel below El 1408.3, and a seepage drain at the downstream toe (see typical sections on Figure B-5).

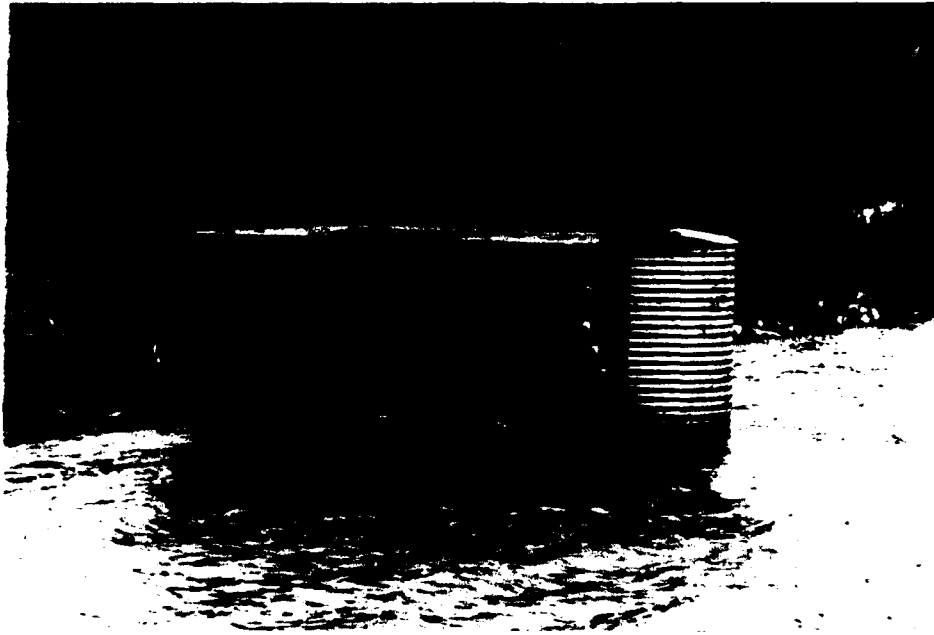
The concrete on the intake structure is in good condition. Minor spalling and erosion has occurred along the normal pool level. There is minor efflorescence of the concrete in this area.

The low level outlet was submerged and not visible. The sluice gate stem is enclosed in a gate well. The hand wheel to operate the sluice gate was not in place, therefore its operability could not be determined. Minor rusting was noted on the sluice gate shaft. No seepage through the sluice gate was observed.

**NO. 5 CONCRETE INTAKE STRUCTURE AND GATE STEM  
ON LOW LEVEL OUTLET**

- a. Operating and Maintenance Procedures. It is recommended that the Owner accomplish the following:
  - (1) Determine the operability of the sluice gate and, if necessary, restore the low-level outlet to good operating condition. This should include clearing of any silt or debris from the outlet pipe. The operability of the low-level outlet and sluice gate should be checked as part of the annual technical inspections.
  - (2) Clear trees and brush from the area at the downstream end of the emergency spillway channel.

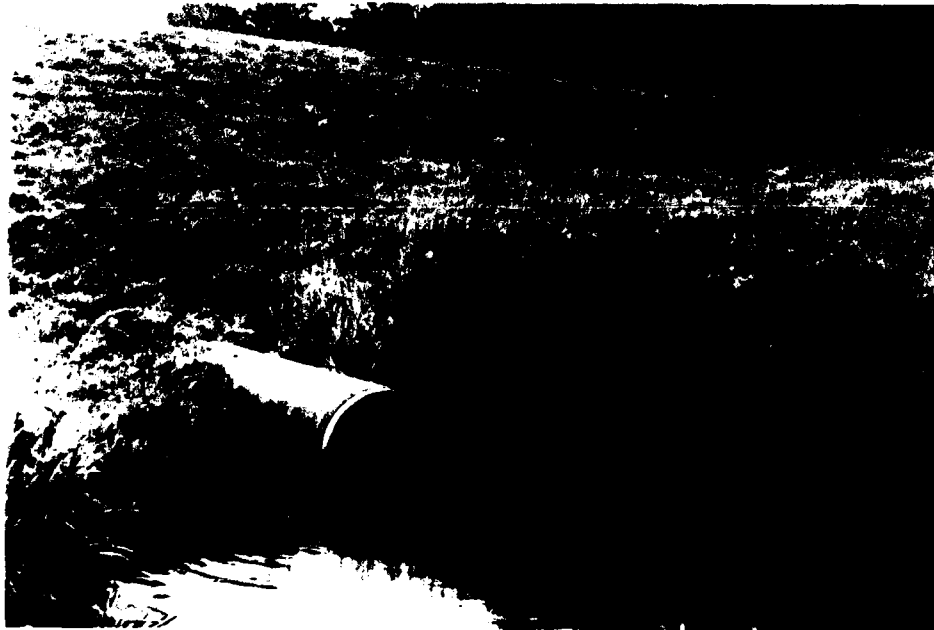
The discharge pipe is only visible at the intake and outlet ends. Some debris was noted near the intake and minor siltation was visible near the outlet. Moderate flow was noted at the time of the inspection (see Photo No. 6).

**NO. 6 DISCHARGE PIPE AT DOWNSTREAM TOE OF DAM**
