MASSACHUSETTS—RHODE ISLAND COASTAL BASIN
BROCKTON, MASSACHUSETTS

BIGNEY POND DAM
MA 00422

PHASE I INSPECTION REPORT
NATIONAL DAM INSPECTION PROGRAM

DECEMBER 1978

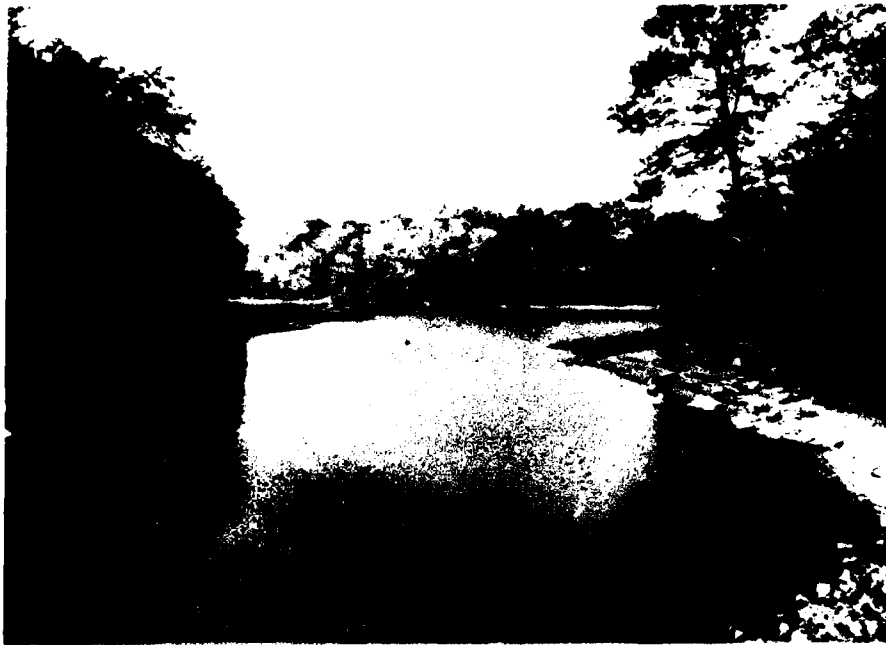
10. Bigney Pond upstream of dam

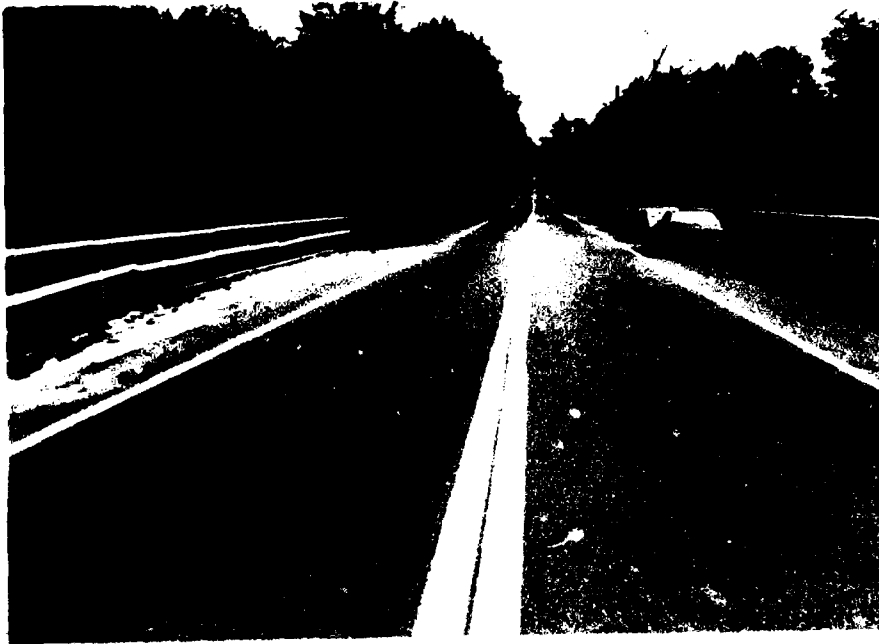
The crest of the dam is the paved Torrey Street roadway, shown in Photo No. 7. The road slopes downward to the east, at approximately a 3 percent grade from Bigney Pond to the overflow culvert. The pavement is in excellent condition, showing no signs of settlement, cracking, or lateral movement of the embankment.

7. View down axis of dam
