NATIONAL PROGRAM FOR INSPECTION OF NON-FEDERAL DAMS  
FARNHAM RESERVOIR DAM. (U) CORPS OF ENGINEERS WALTHAM  
MA NEW ENGLAND DIV FEB 70

FARNHAM RESERVOIR DAM  
MA 00314

PHASE I INSPECTION REPORT  
NATIONAL DAM INSPECTION PROGRAM

FEBRUARY 1980

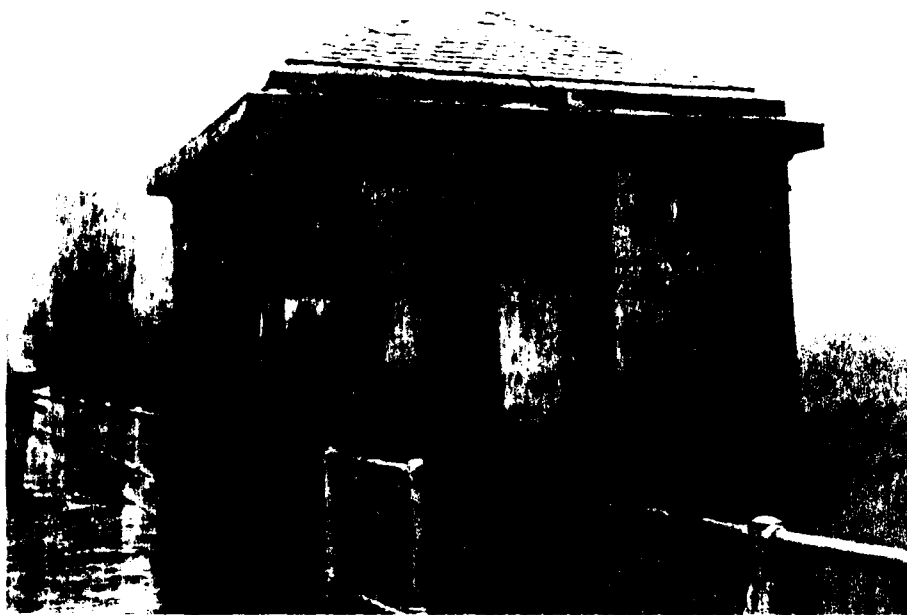
Photo 7

The gate house was found in poor condition. The walls above window sill height have tipped out about 1/4 inch on all sides and cracked above the window lintels. The gate house floor appeared to be in good condition as were the gate operating hand wheels which were secured from unauthorized operation by a steel cable and lock.

General view of gate house  
exterior condition.

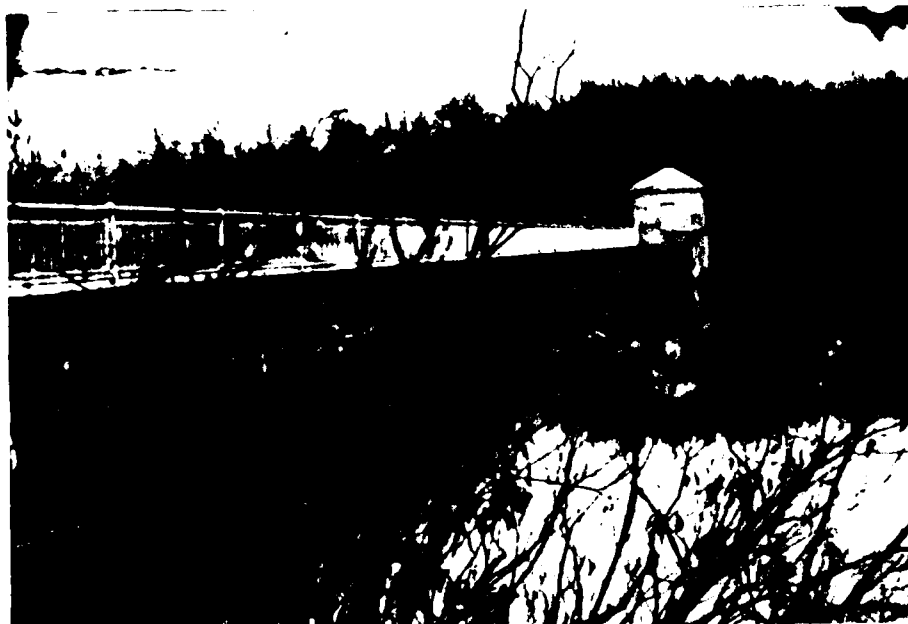
101  
 downstream face of dam  
 at left end.

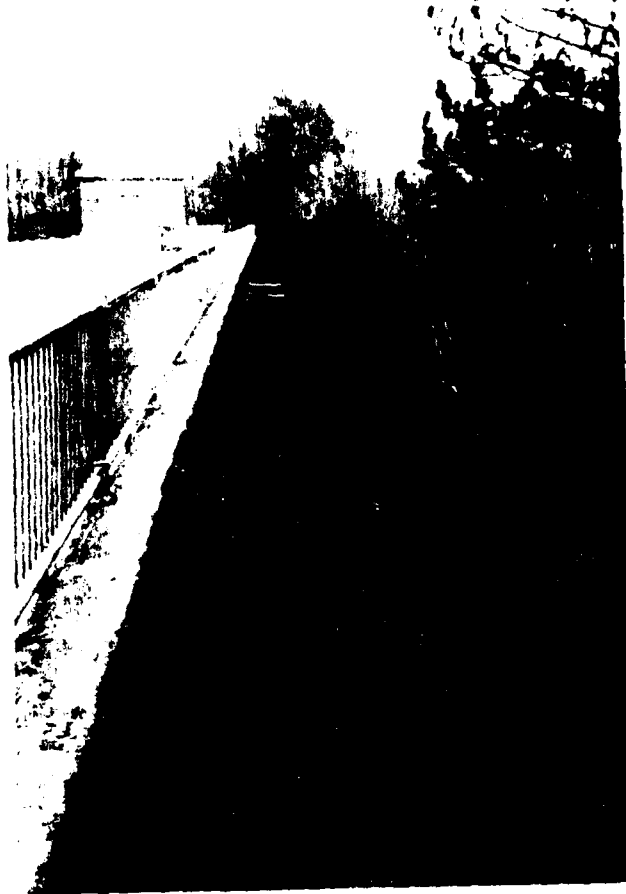
Photo 1

Downstream face of dam  
from right end.

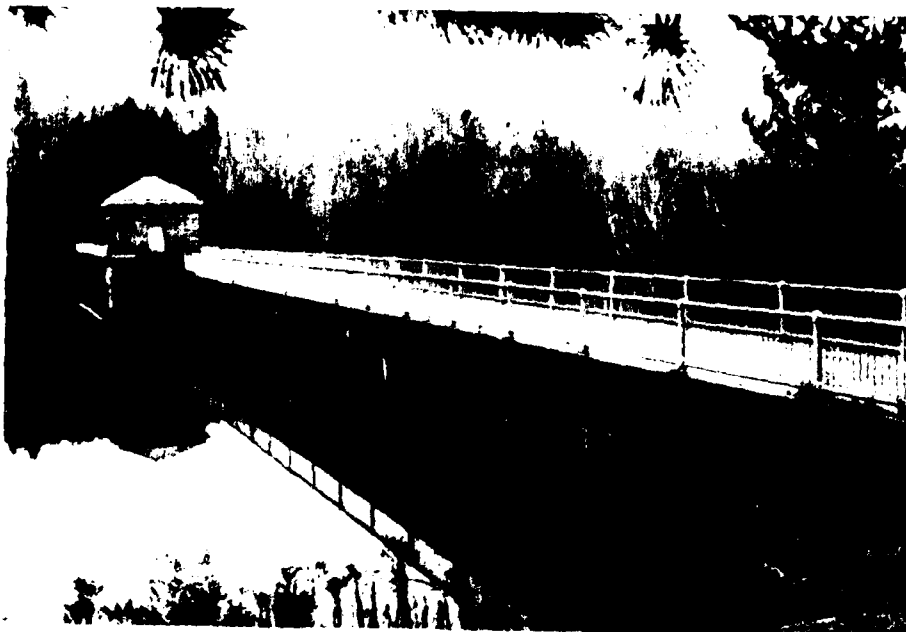
Photo 2

Upstream face of dam  
from right end.

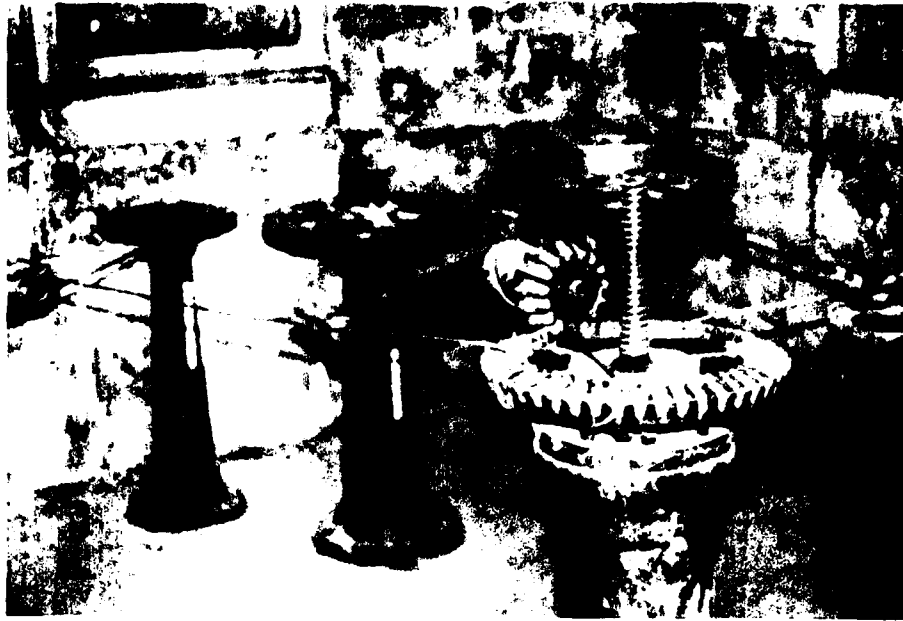
Photo 18

Operating handwheels for  
outlet gates.
