TAUNTON RIVER BASIN  
BROCKTON, MASSACHUSETTS

LOWER PORTER POND DAM  
MA 00424

PHASE I INSPECTION REPORT  
NATIONAL DAM INSPECTION PROGRAM

JANUARY 1980

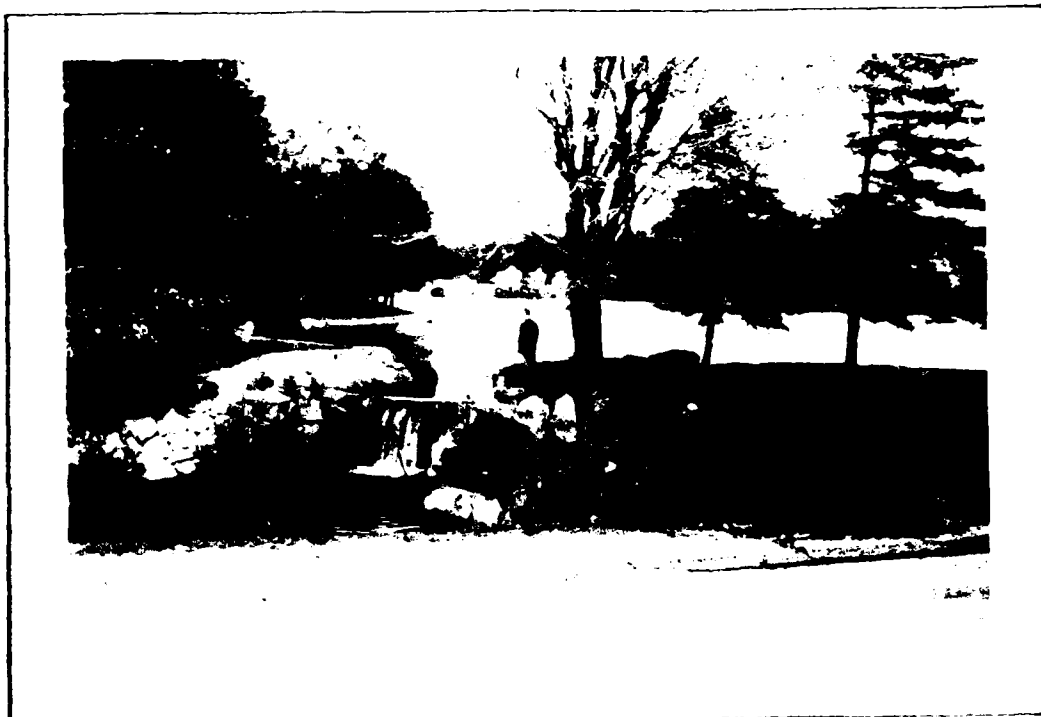
AN OVERVIEW OF THE LOWER PORTER POND DAM. (10/17/79)

The dam is considered to be in fair condition. Bare spots on the crest of the dam and lack of erosion protection on the upstream slope could lead to surface erosion of the embankment. The roots of the trees growing from the crest create potential seepage paths through the dam. In the event of severe winds uprooting the trees, portions of the embankment could be dislodged. Both spillways appear to be in satisfactory condition.

3) The trees and their root systems should be removed from the embankment to the extent possible and the voids in the embankment replaced with appropriate compacted embankment materials.

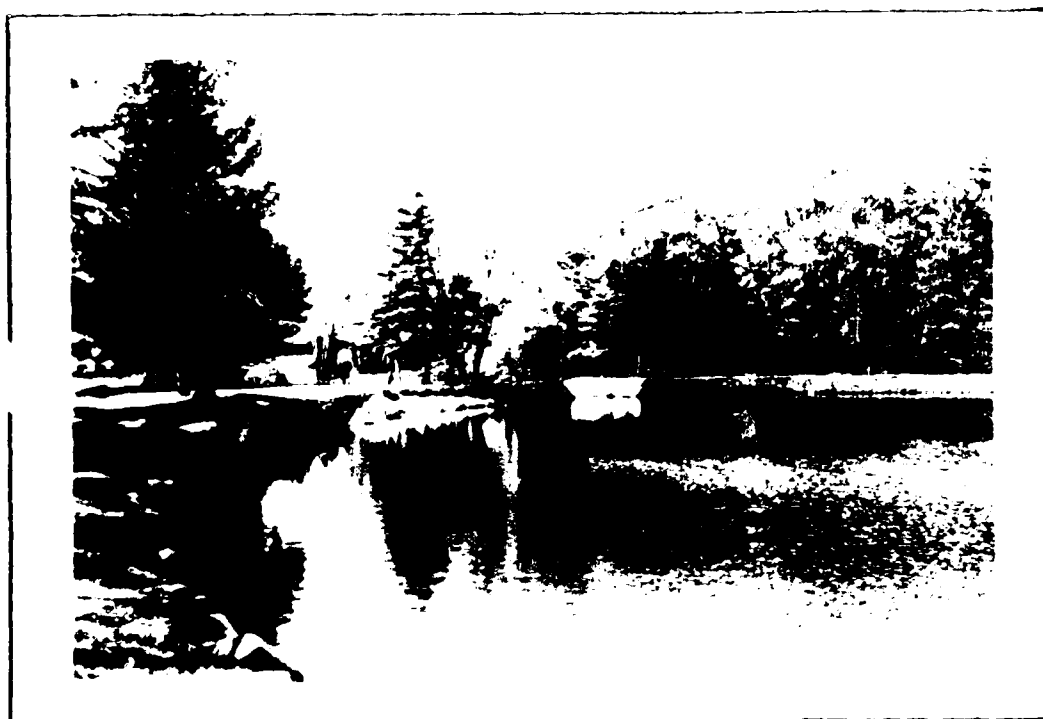
AN OVERVIEW OF THE LOWER PORTER POND DAM. (10/17/79)

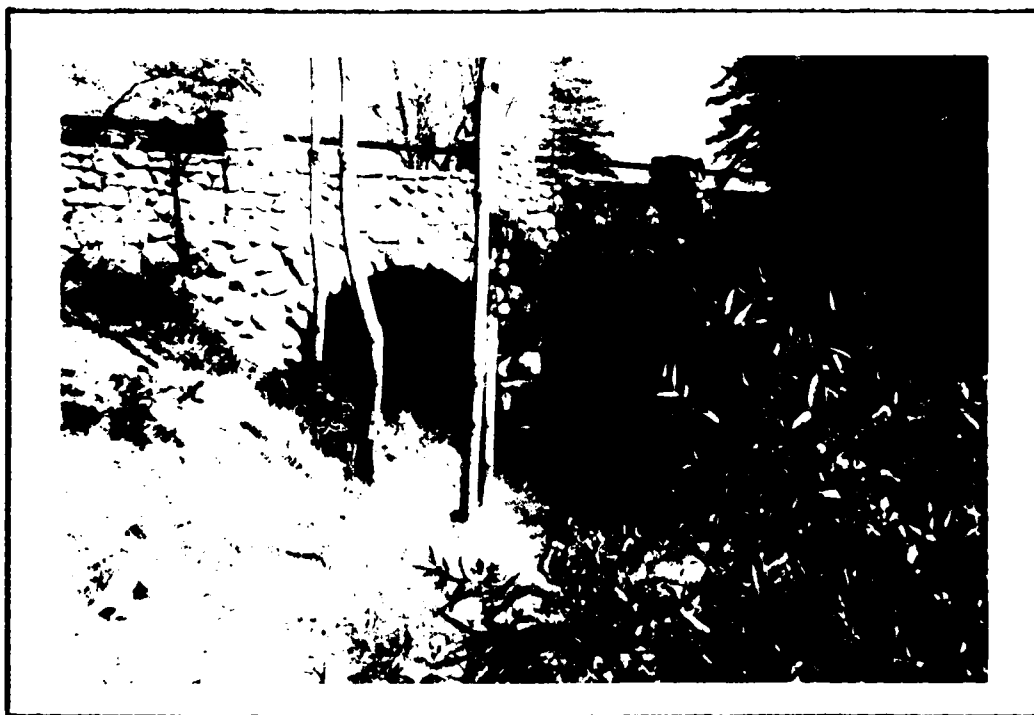
4. CHANNEL DOWNSTREAM OF THE BRIDGE WHICH IS DOWNSTREAM OF THE  
IMPOUNDMENT. (10/17/79)

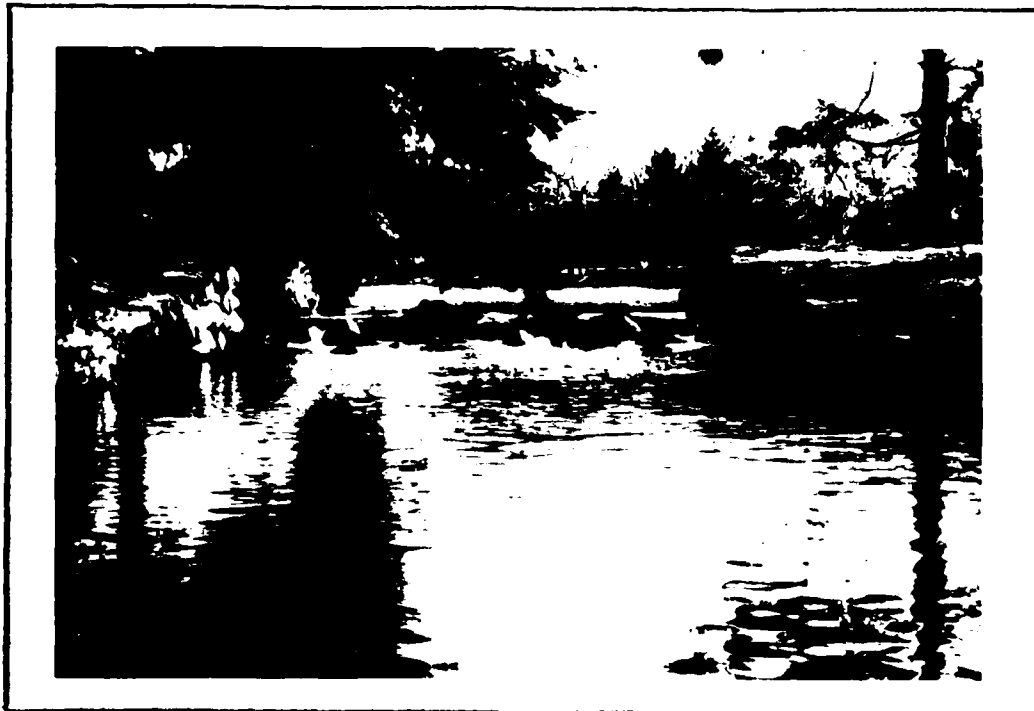
c. Appurtenant Structures. The broad-crested masonry service spillway located at the right abutment appears to be in fair condition. The masonry walls of the approach channel have a slope of 1H:1V and show little evidence of deterioration. The center five feet of the masonry weir crest is depressed about 3 inches below the remaining length of weir. It could not be determined if this section was constructed in this manner or if there is settlement of the spillway headwall.

1. SERVICE SPILLWAY LOOKING UPSTREAM TOWARD THE IMPOUNDMENT.  
(10/17/79)
