HOUSATONIC RIVER BASIN  
HINSDALE, MASSACHUSETTS

ASHMERE LAKE DAM  
MA 00223

PHASE 1 INSPECTION REPORT  
NATIONAL DAM INSPECTION PROGRAM

AUGUST 1978

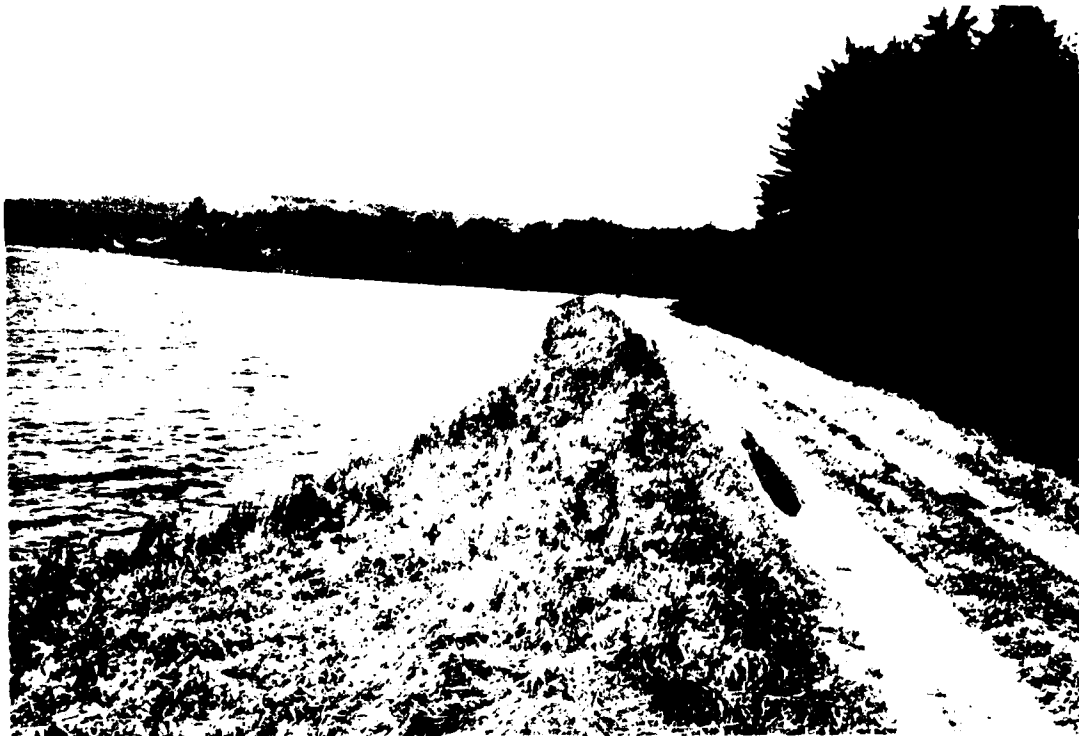
The earth embankment appears to be in generally good conditions. The horizontal and vertical alignments of the crest are good with only minor rutting caused by vehicular traffic occurring near the west abutment. (See Photograph No. 2).

② CREST OF DAM NEAR WEST ABUTMENT,  
NOTE RUTTING DUE TO TRAFFIC AND VEGETATION ON UPSTREAM RIPRAP

11. The low level valve access shaft should be repaired and a more secure decking be installed.
12. Crest rutting should be filled to grade and seeded. Measures should be taken to prevent unnecessary traffic on crest.

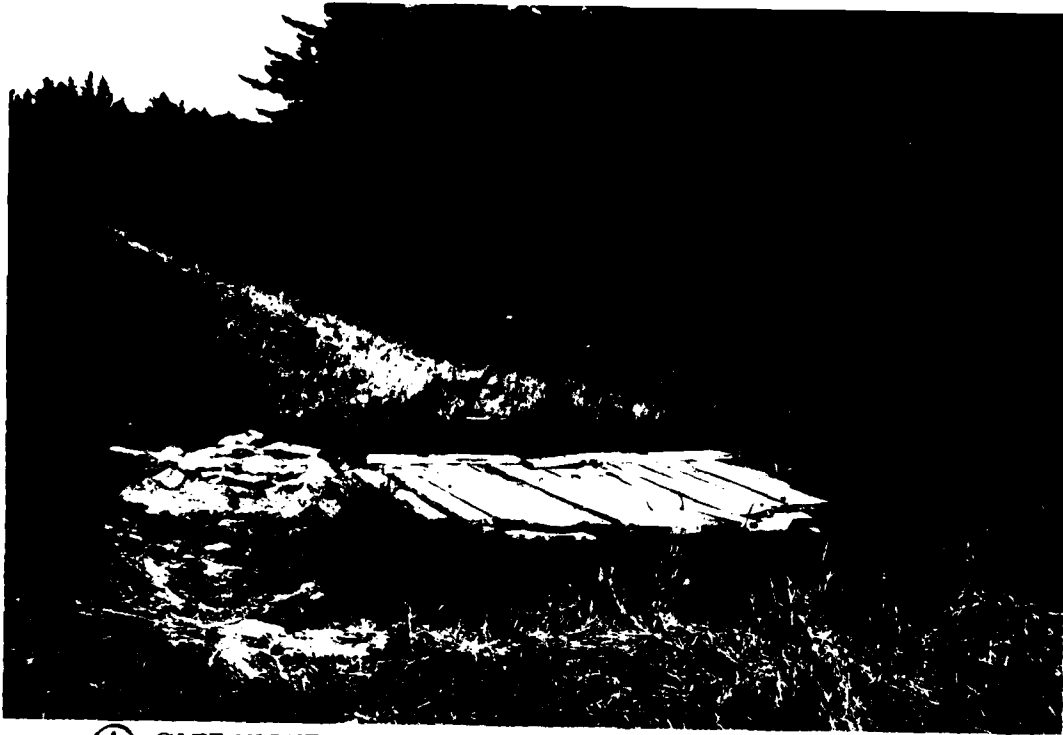
The low level gate valve operating stand is rusty but operable. The mechanism is chained and padlocked to prevent unauthorized operation. (See Photograph No. 4). The gatehouse was destroyed in a fire 10 March 1977. The gate valve stem is located within a circular shaft of cemented brick and stone. It is reported that the shaft is in need of repairs. The top of the shaft is covered by nailed wooden planking.

④ GATE VALVE OPERATING MECHANISM FOR LOW LEVEL  
OUTLET AND FOUNDATION OF DESTROYED GATE HOUSE

8. All masonry walls should be repointed.
9. Debris and overhanging trees should be removed and hauled away from all downstream channels.
10. Gatehouse should be replaced as soon as possible and gate operating mechanism greased and painted.
