WHITIN RESERVOIR DAM

MA. 00200

PHASE I INSPECTION REPORT  
NATIONAL DAM INSPECTION PROGRAM

JULY 1980

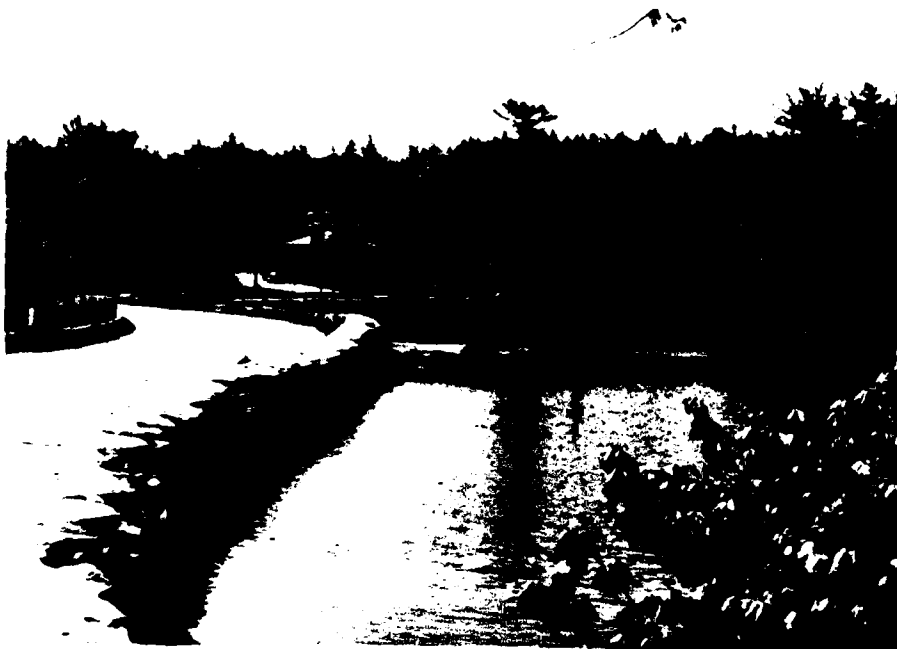
9. Gate structure on upstream face of dam

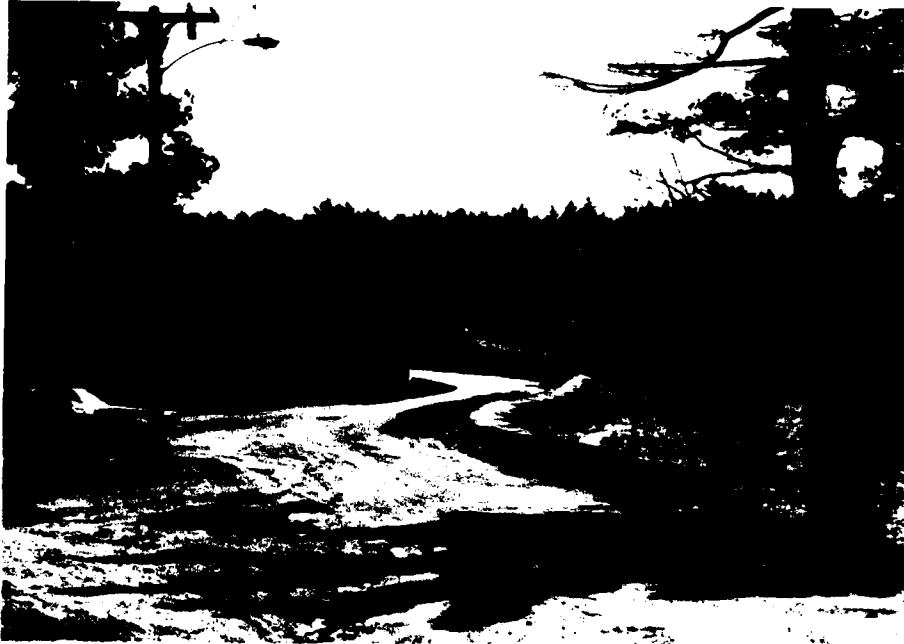
3. View along crest of dam

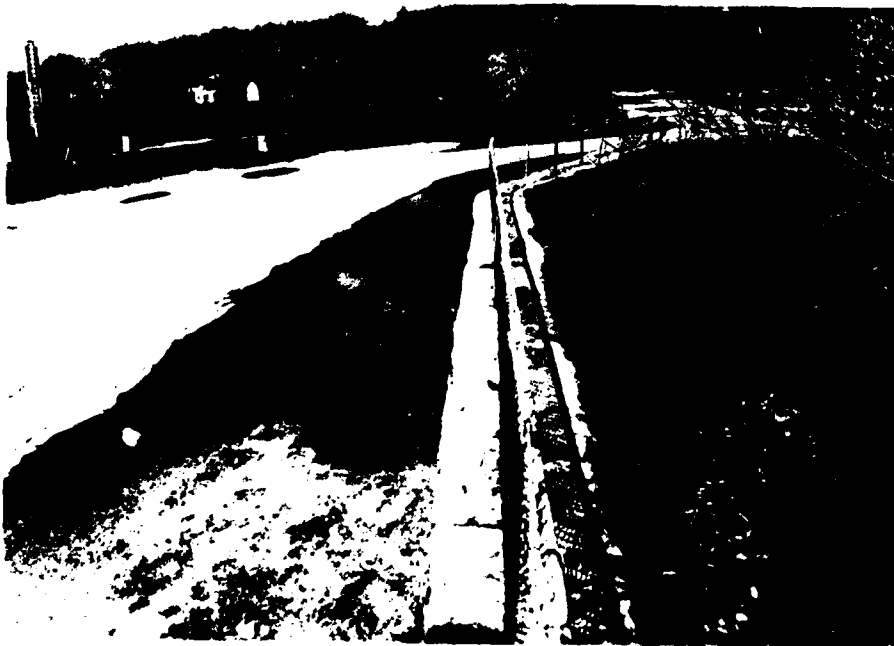
4. Crest of dam and downstream face
