AD-A154 527

NATIONAL PROGRAM FOR INSPECTION OF NON-FEDERAL DAMS
WINDSOR LAKE DAM MA 0. (U) CORPS OF ENGINEERS WALTHAM
MA NEW ENGLAND DIV JUL 78

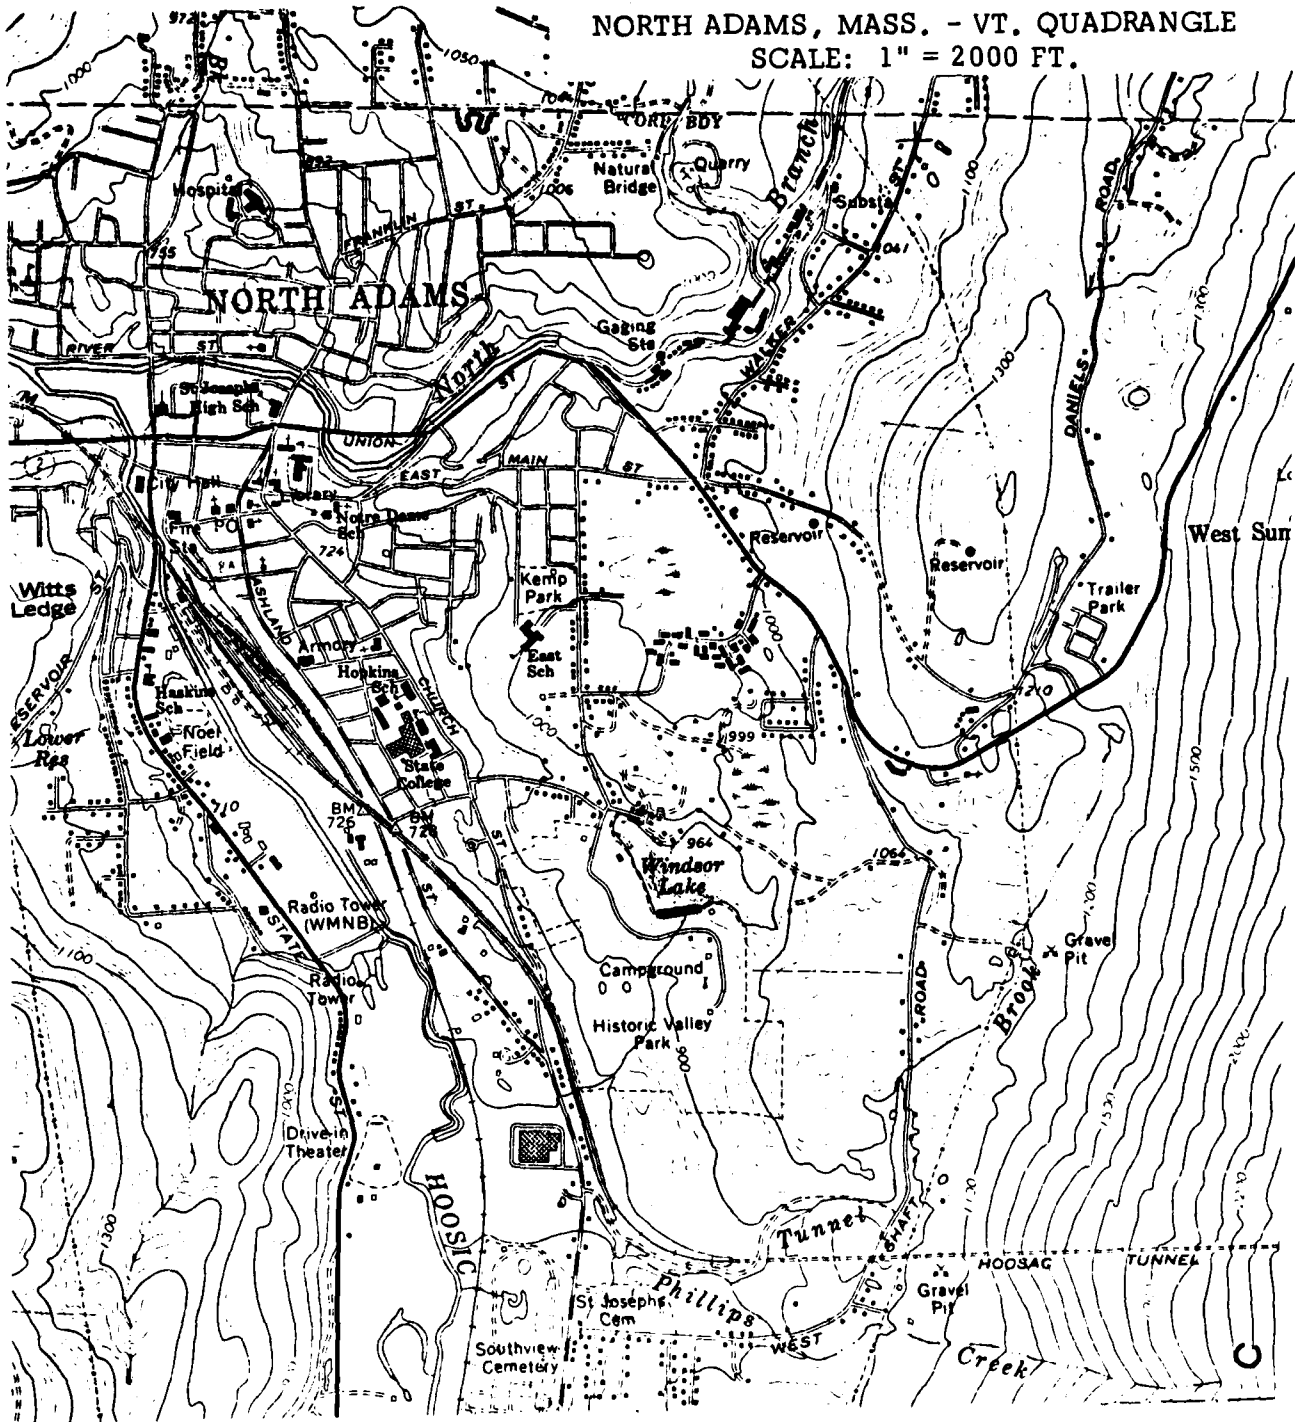
TOPOGRAPHIC MAP
WINDSOR LAKE DAM AND RESERVOIR

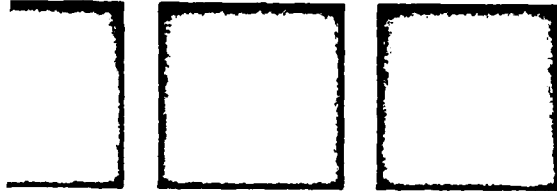
TACONIC SOIL INVESTIGATIONS, INC.
7 LEBANON, NEW YORK 12125

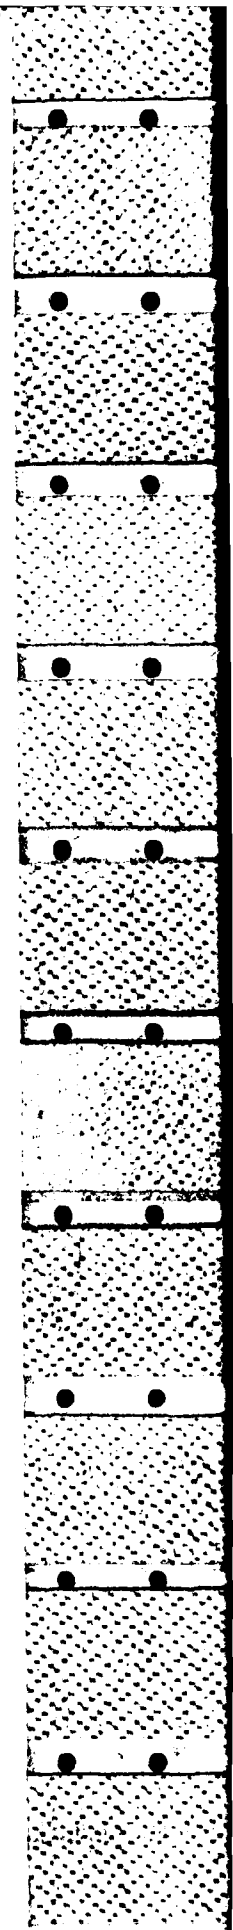
⑤ SPILLWAY LOOKING DOWNSTREAM
NOTE RIPRAP ON UPSTREAM SLOPE

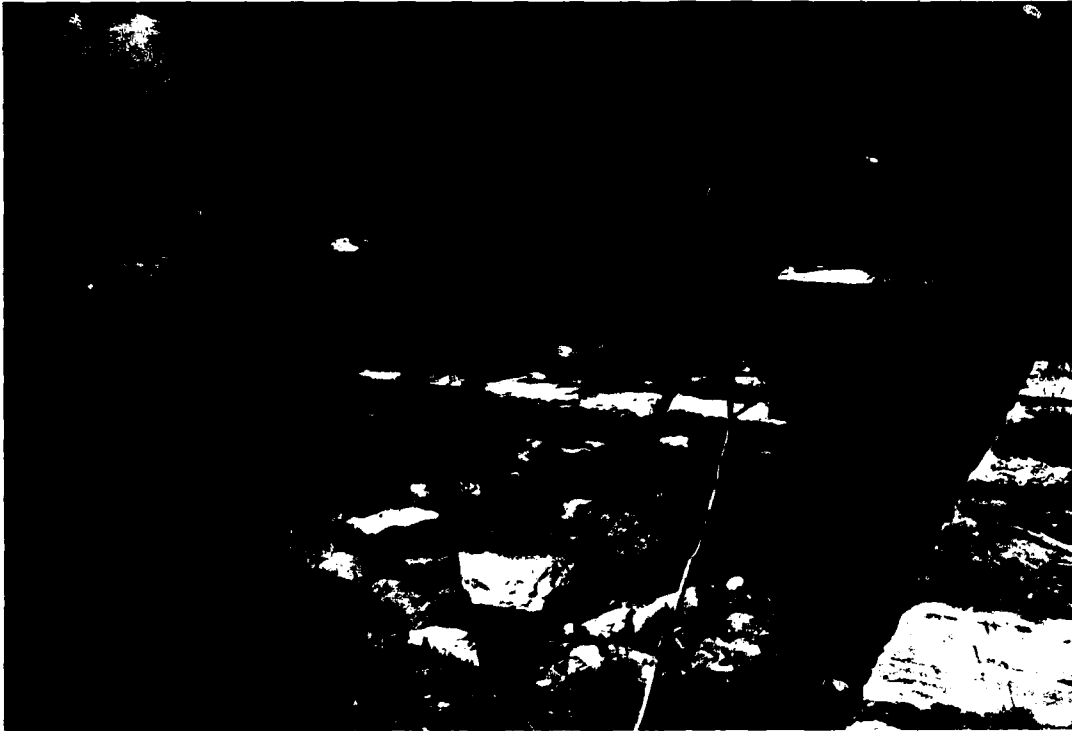
⑥ SPILLWAY LOOKING UPSTREAM (NOTE DISPLACEMENT OF STONES),
VEGETATION IN SPILLWAY CHANNEL FLOOR AND
MISSING AND LOOSE MORTAR ON THE SPILLWAY WALL

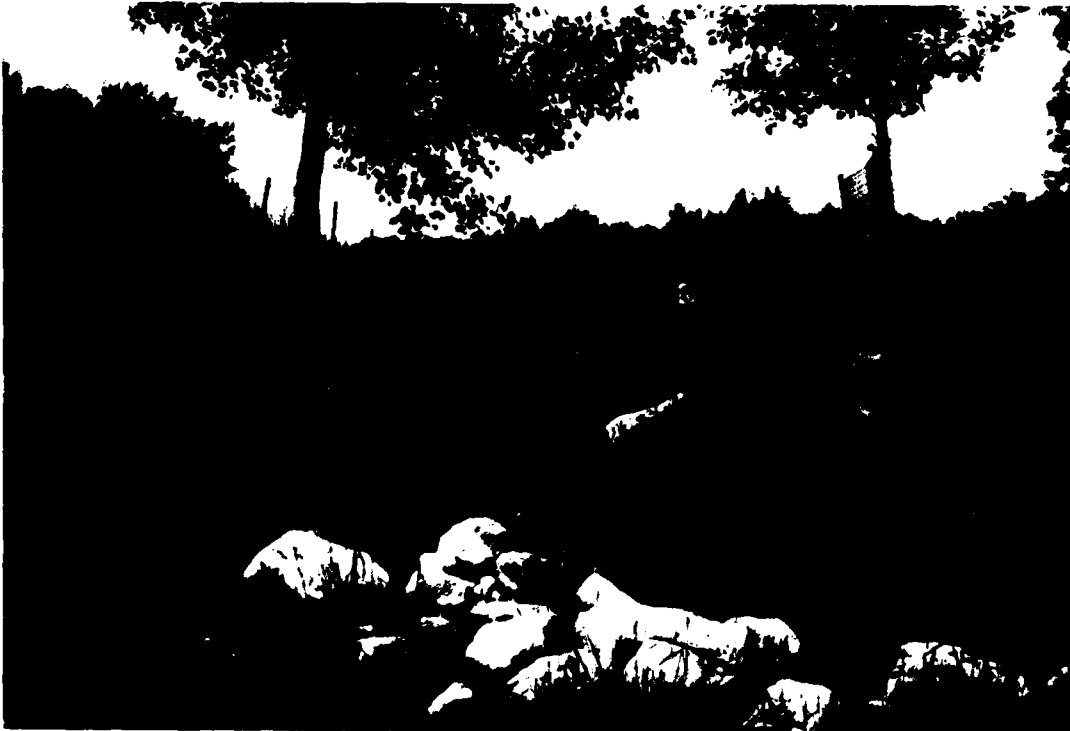
⑦ VIEW OF SPILLWAY CHANNEL LOOKING UPSTREAM
NOTE STONES IN FOREGROUND FOR DIVERSION OF CHANNEL
