MERRIMACK RIVER BASIN
NORTH ANDOVER, MASSACHUSETTS

LAKE COCHICHEWICK OUTLET DAM
MA 00278

PHASE I INSPECTION REPORT
NATIONAL DAM INSPECTION PROGRAM

DECEMBER 1978

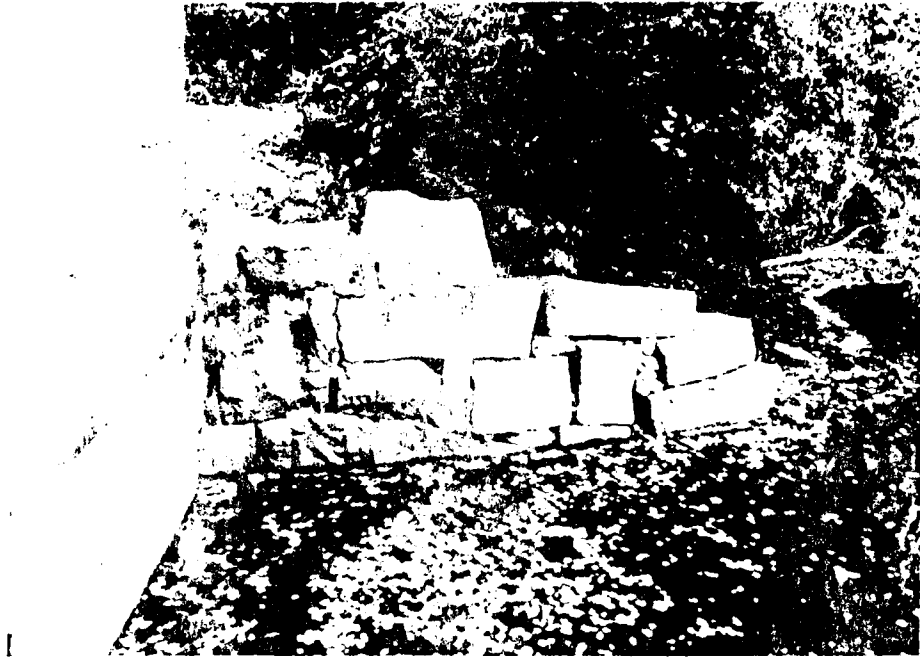
1. <u>Approach Channel</u>	
a. Obstructions	None observed
b. Channel bottom	Not visible
c. Channel wells	Granite masonry walls with upper mortared. Most of the mortar is missing. Voids present in left and right walls and blocks are displaced. Soil has eroded behind right wall

d. Log boom, screens, etc	None - water level gage cut into right wall
e. General structural condition	Due to presence of voids, displaced blocks and loss of backfill, the condition of the intake is considered fair

6. Right approach channel wall

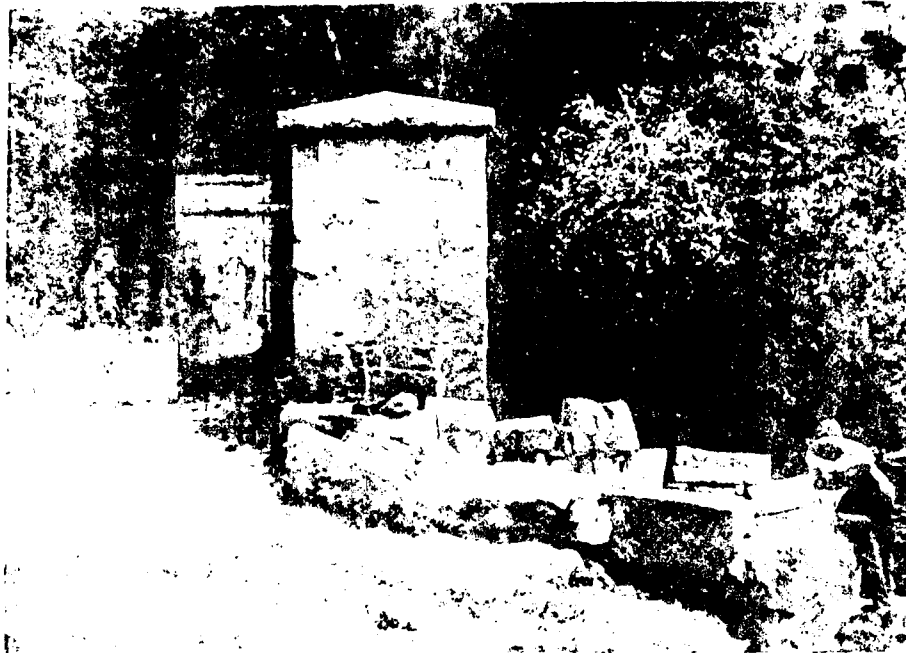
4. Left side of gate structure

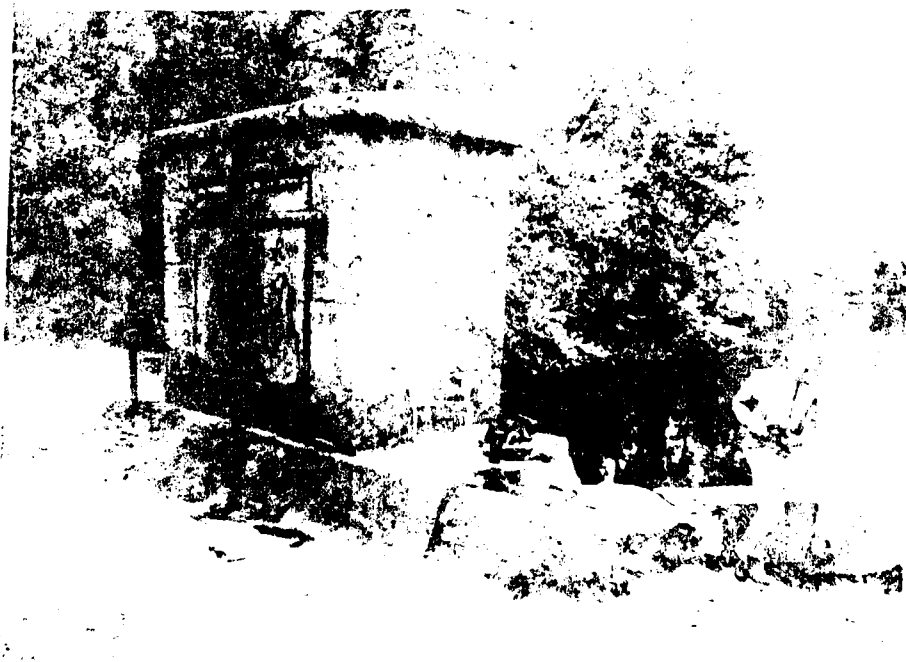
5. Gate structure and left approach channel wall
