FARMINGTON RIVER BASIN
TOLLAND, MASSACHUSETTS

LOST WILDERNESS LAKE
SOUTHERN DAM (TWINING POND DAM)
MA 00321

PHASE I INSPECTION REPORT
NATIONAL DAM INSPECTION PROGRAM

DECEMBER 1979

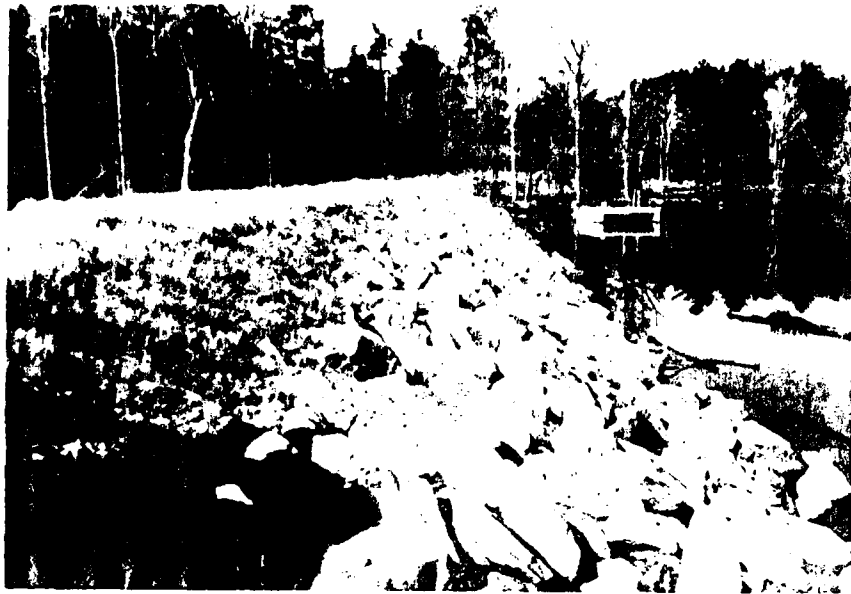
Photo 1 - Dam overview
looking westerly from
left abutment

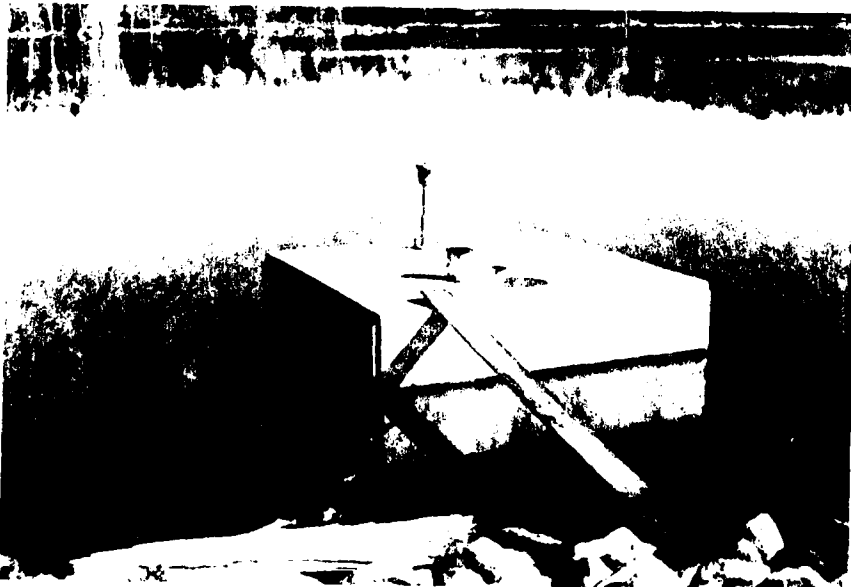
Photo 3 - Principal
spillway drop inlet
riser structure

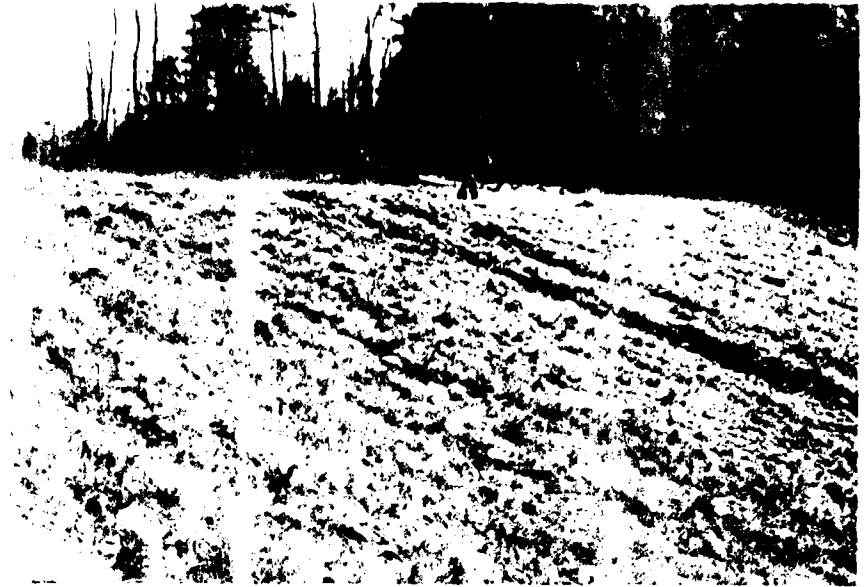
Photo 4 - View from
 top of emergency
 spillway. Note debris
 along crest of section
 and wet area along
 crest of slope.

Photo 5 - Top of slope
 at emergency spillway.
 Note wet area along
 entire top of slope.
