HOUSATONIC RIVER BASIN  
HINSDALE, MASSACHUSETTS

PLUNKETT RESERVOIR DAM  
MA 00226

PHASE I INSPECTION REPORT  
NATIONAL DAM INSPECTION PROGRAM

AUGUST 1981

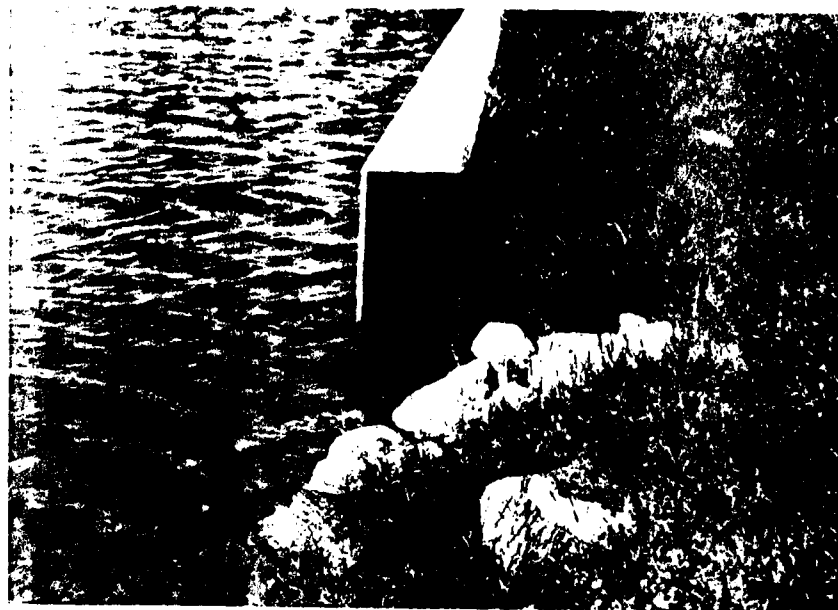
PHOTO NO.9 - Eroded area on upstream face at right end of spillway wingwall.

1. Repair of the riprap and existing sloughing on the upstream face of the dam.
2. The source of seepage found at the toe of the dam.

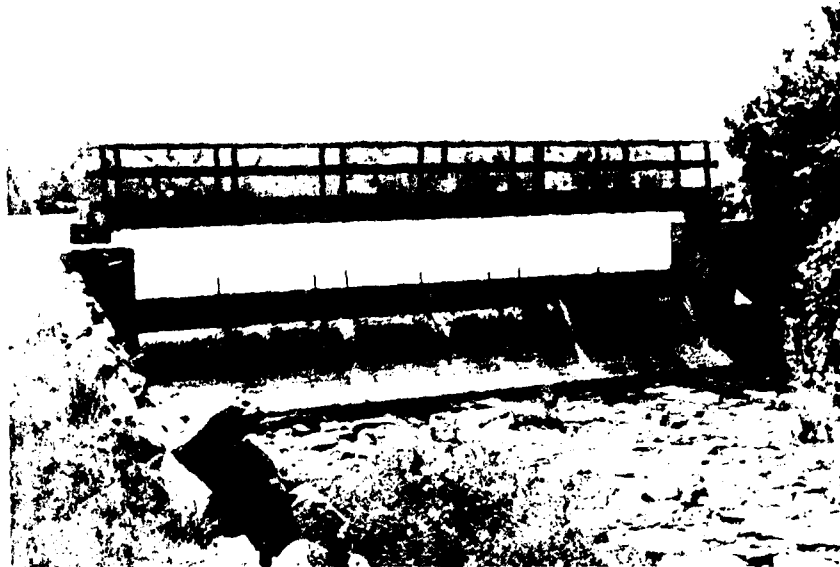
The spillway weir was in good condition. There were 14 inches of flashboard in place at the weir during the inspection. The pins and flashboards, shown in photograph 4 were observed to be in good condition. The spillway bridge was in good condition, however, it lacked lateral bracing and shook sideways easily.

PHOTO NO.7 - View of spillway weir and bridge.  
There are 14 inches of flashboards  
in place.

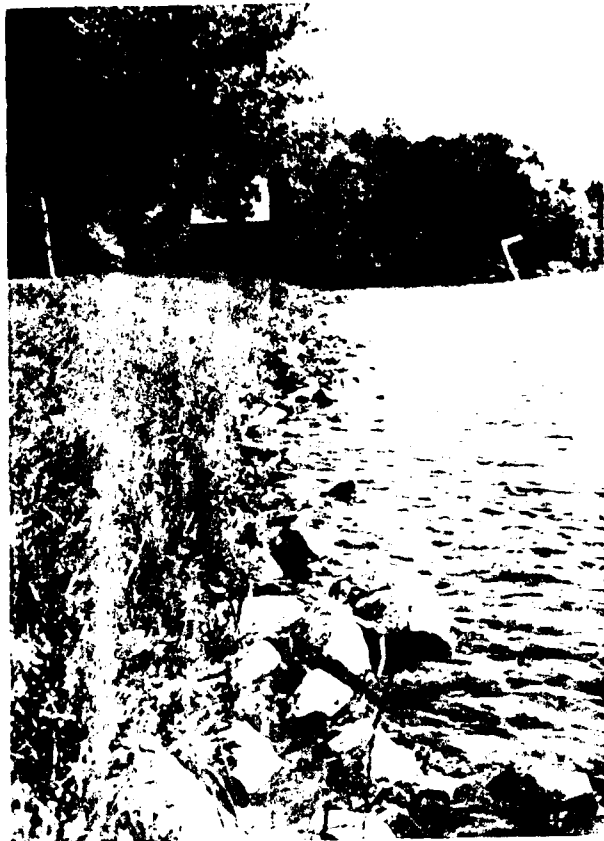
PHOTO NO.3 - Left half of up-  
stream face of  
dam from spillway.

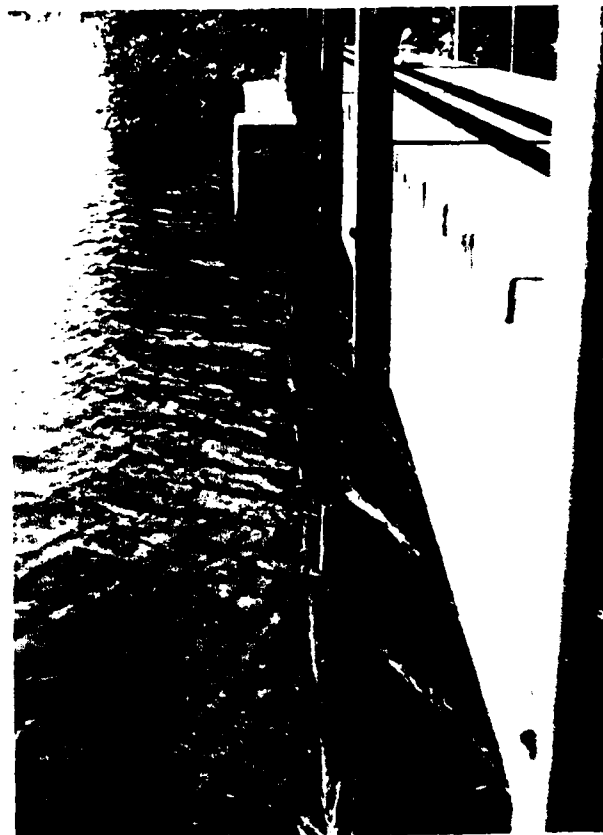
PHOTO NO.4 - Spillway flash-  
board assembly  
viewed from right  
side of spillway.
