HOUSATONIC RIVER BASIN  
WASHINGTON, MASSACHUSETTS

SANDWASH DAM  
MA 00316

PHASE I INSPECTION REPORT  
NATIONAL DAM INSPECTION PROGRAM

AUGUST 1981

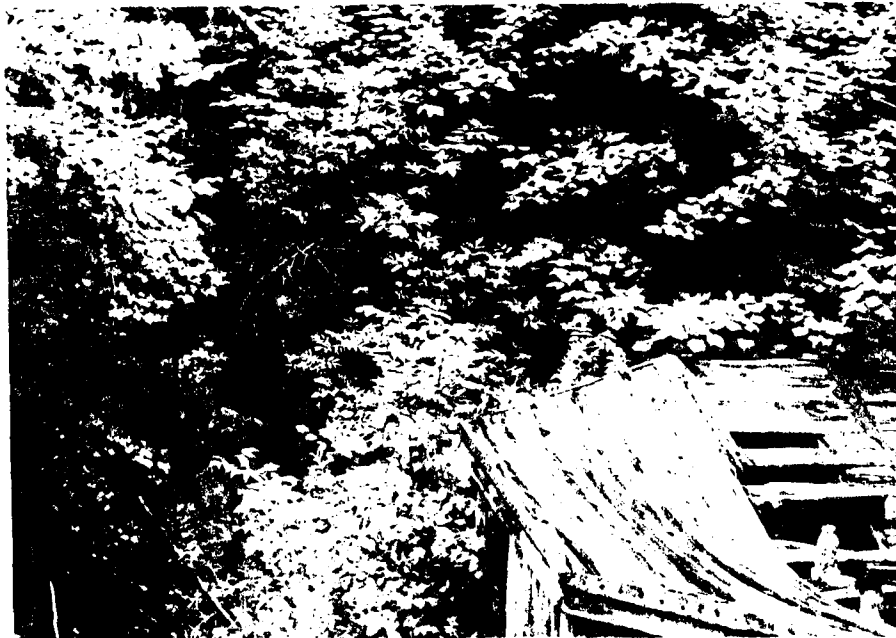
The downstream outlet structure masonry headwall was observed to be in good condition. The gates at the control chamber have not been operated in many years. They are kept in a position which diverts water directly to the outlet headwall. The aerator structure is basically abandoned and has not been in use in many years. See photographs 16 and 17.

PHOTO NO. 17 - View of Aerator Structure.
