HOUSATONIC RIVER BASIN  
BECKET, MASSACHUSETTS

GREENWATER POND DAM  
MA 00204

PHASE I INSPECTION REPORT  
NATIONAL DAM INSPECTION PROGRAM

MARCH, 1981

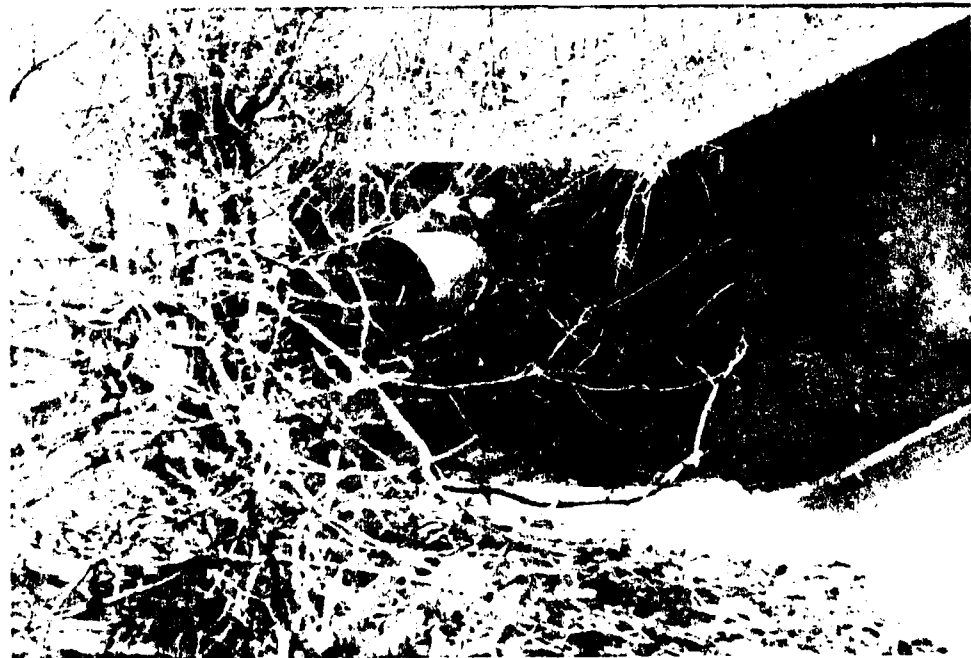
The downstream end of the 20" conduit is encased in a concrete yoke at the spillway wingwall (see Photograph 6, Appendix C). There is cracking around this yoke. There is a crack that goes up the upstream side and across the top of the wingwall. There is another large crack underneath the conduit. Seepage is coming from this crack on the order of 1 to 2 gallons per minute. The seepage appears clear; however, the area is characterized by a bright orange stain.

Photograph 6 - Outlet of 20" C.I. pipe at northerly spillway d/s  
wingwall. Note cracks around yoke and seepage stain  
from large crack beneath conduit.
