NORTH RIVER BASIN  
PEABODY, MASSACHUSETTS

BROWNS POND DAM  
MA 00192

PHASE 1 INSPECTION REPORT  
NATIONAL DAM INSPECTION PROGRAM

DECEMBER 1978

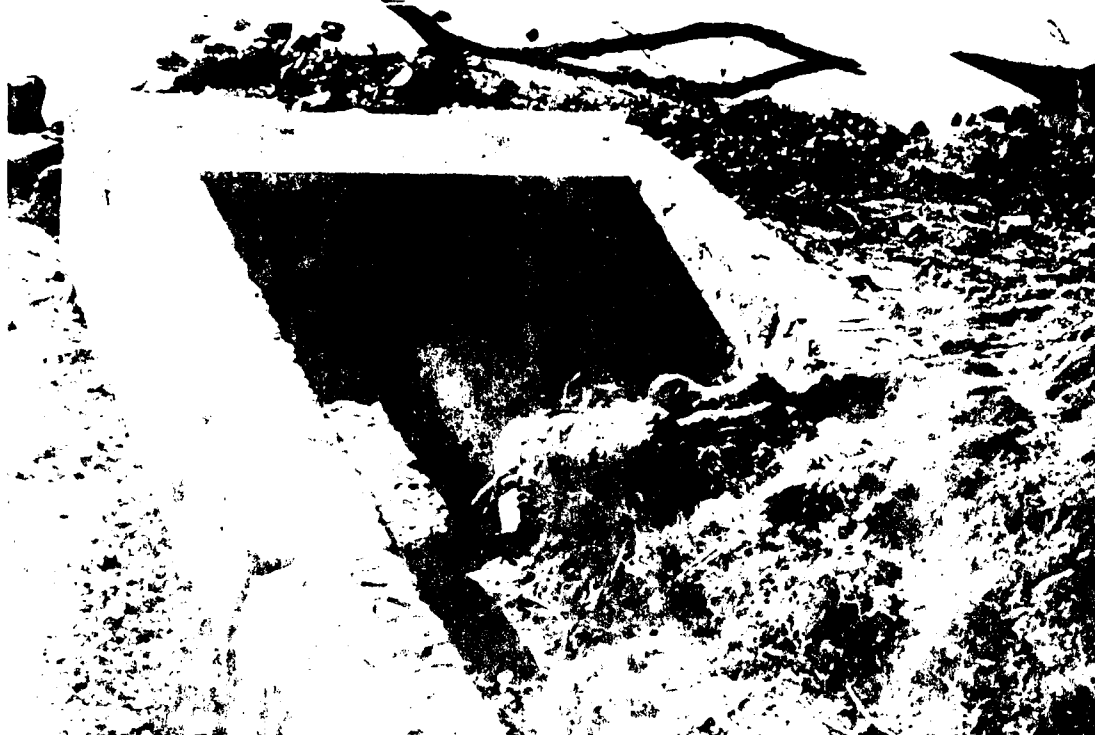
The concrete outlet structure and the 20-inch diameter cast iron outlet pipe which is protected by a steel trash rack are in good condition. The pipe shows minimal rusting and the condition of the concrete is good. (See Photograph No. 4). It is reported that the gate valve for the outlet pipe is in operating condition.

4. VIEW OF OUTLET STRUCTURE AND OUTLET PIPE. NOTE NOTCH RECENTLY CONCRETE FILLED.

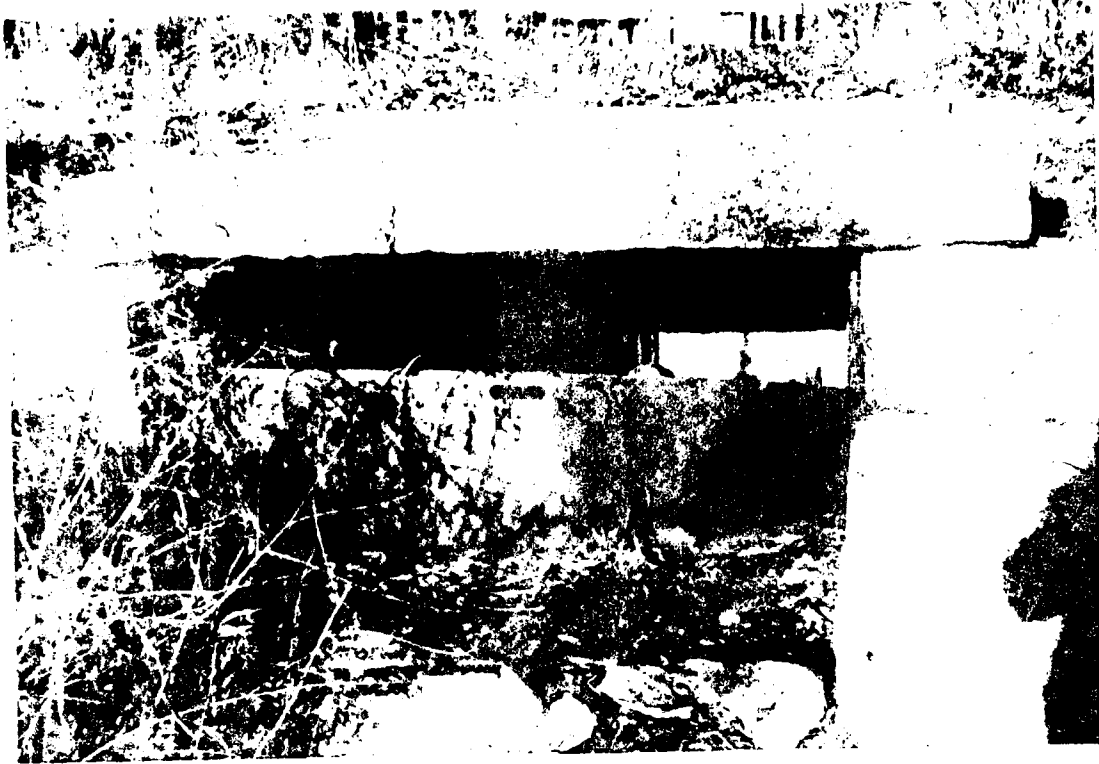
have fallen into the spillway approach channel. In addition, minor debris has accumulated in the channel. At several locations along the walls, mortar in the joints is loose and missing. At the time of inspection, there was a steel plate flashboard at the entrance to the spillway. (See Photograph No. 6).

The spillway is in good condition with the upstream training walls in fair condition. The stone blocks of the upper courses of both walls

6. VIEW OF SPILLWAY LOOKING DOWNSTREAM.  
NOTE STEEL PLATE FLASHBOARD AND IN BACKGROUND HEADWALL  
WITH ENTRANCE TO OUTLET PIPE COVERED WITH TRASH RACK.

6. The gullies and sloughed areas of the upstream slope should be filled with suitable material and compacted.
7. Stone blocks at the entrance and exit of the spillway should be removed.
8. Remove debris from spillway approach channel.
9. Missing stones should be replaced along the spillway training walls and all joints should be repointed.
10. The extent of the spillway outlet pipe should be determined and the broken portion of the pipe repaired.
11. The gate valve which controls discharges through the outlet pipe should be maintained in operable condition.

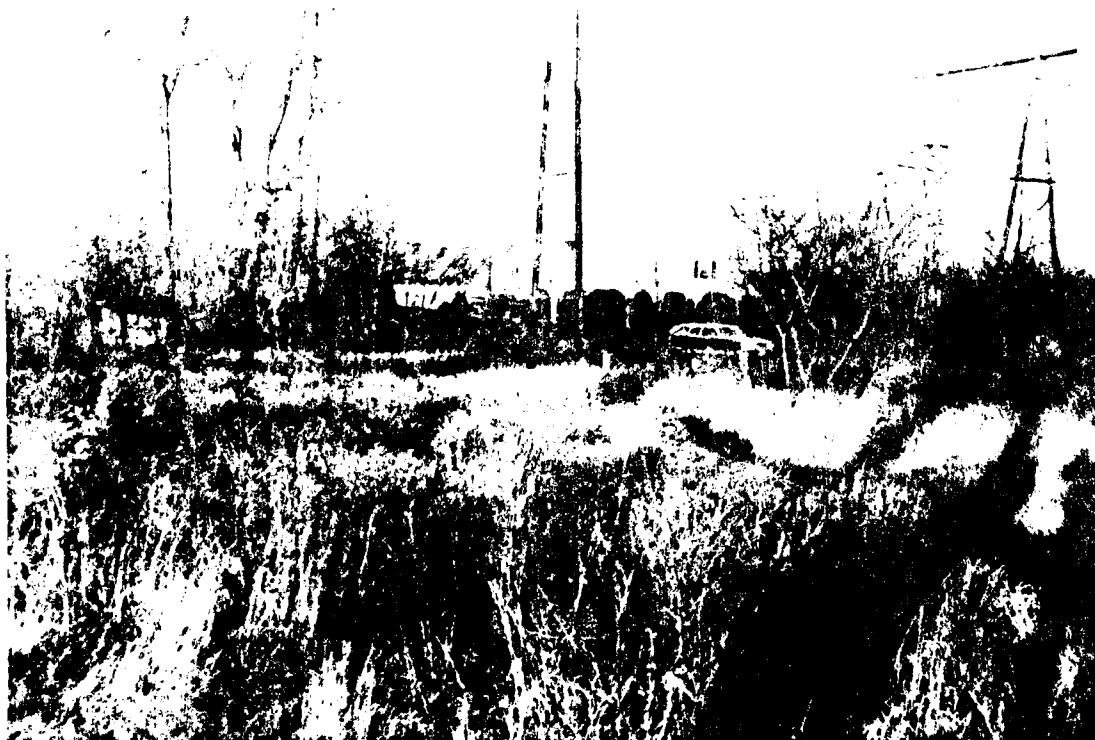
7. VIEW OF DOWNSTREAM CHANNEL. NOTE VEGETATION.
