MERRIMACK RIVER BASIN  
FRAMINGHAM, MASSACHUSETTS

FOSS RESERVOIR DAM  
MA00339

PHASE I INSPECTION REPORT  
NATIONAL DAM INSPECTION PROGRAM

APRIL 1981

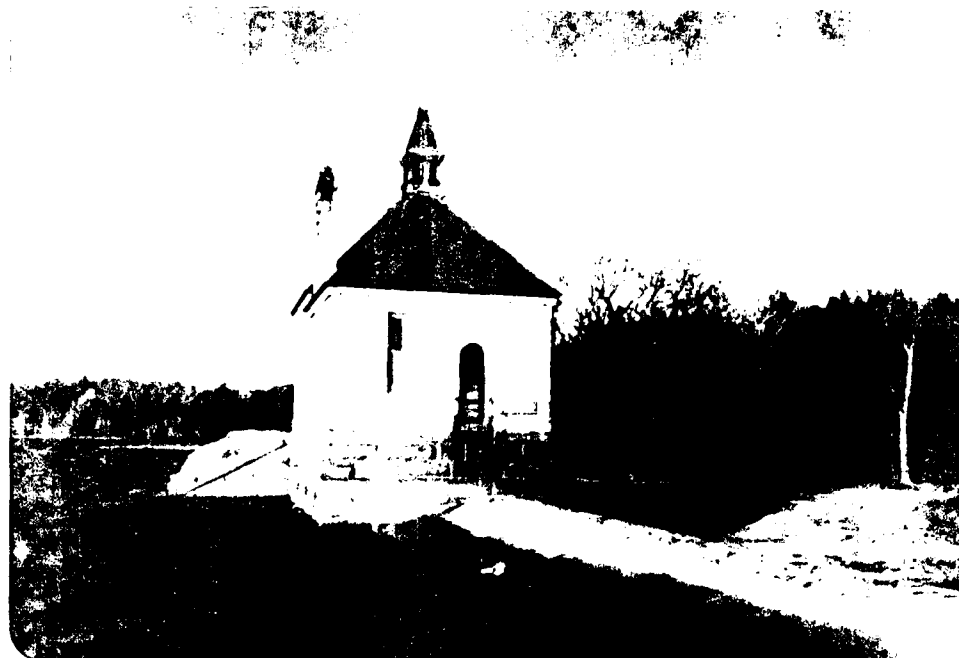
NO. 1 GATEHOUSE AND SPILLWAY NEAR SOUTH  
ABUTMENT OF DAM

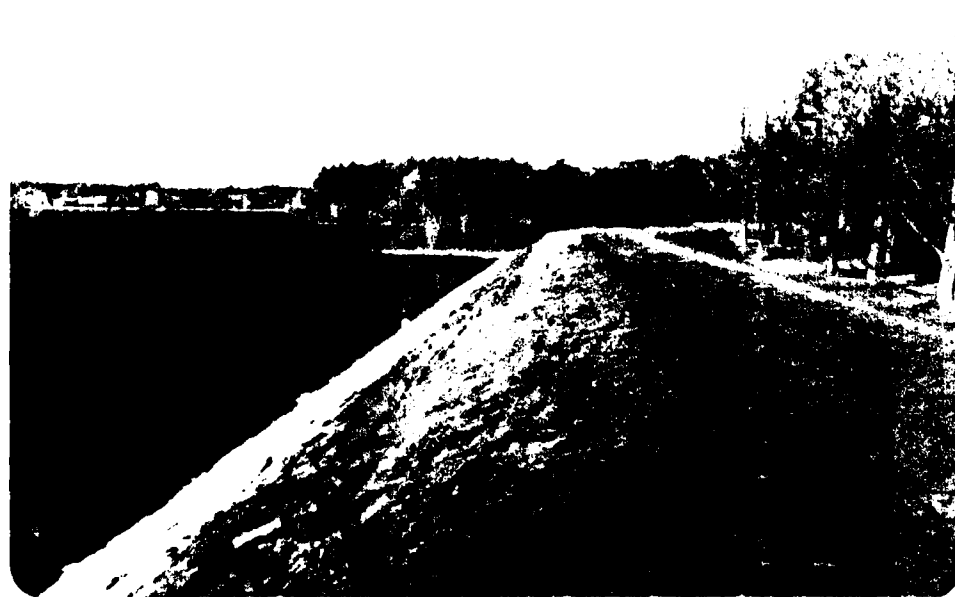
NO. 2 TOP OF UPSTREAM SLOPE OF DAM NORTH OF  
GATEHOUSE

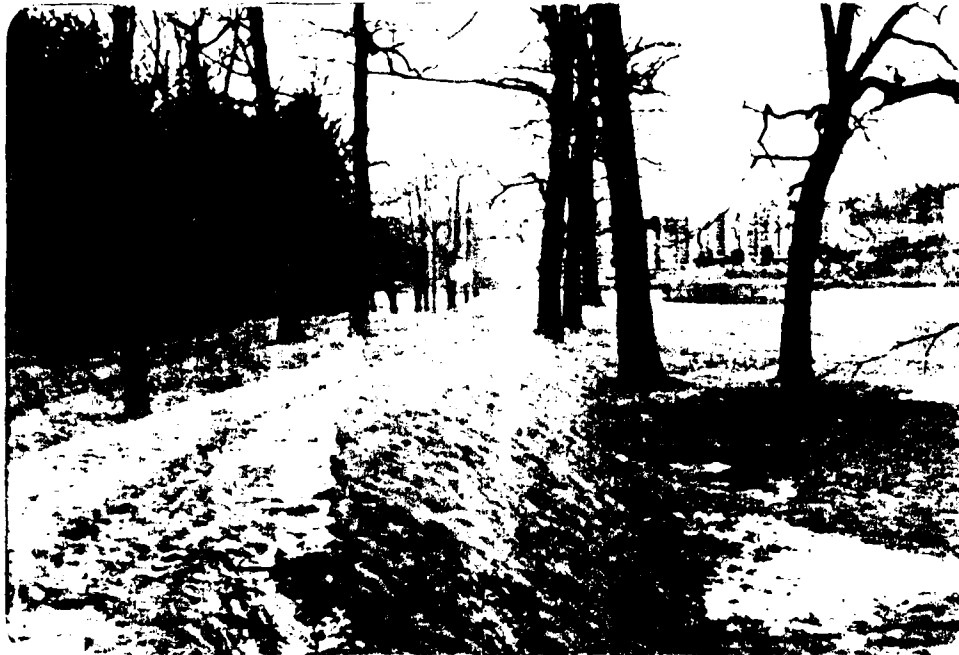
NO. 3 EMBANKMENT NEAR NORTH ABUTMENT

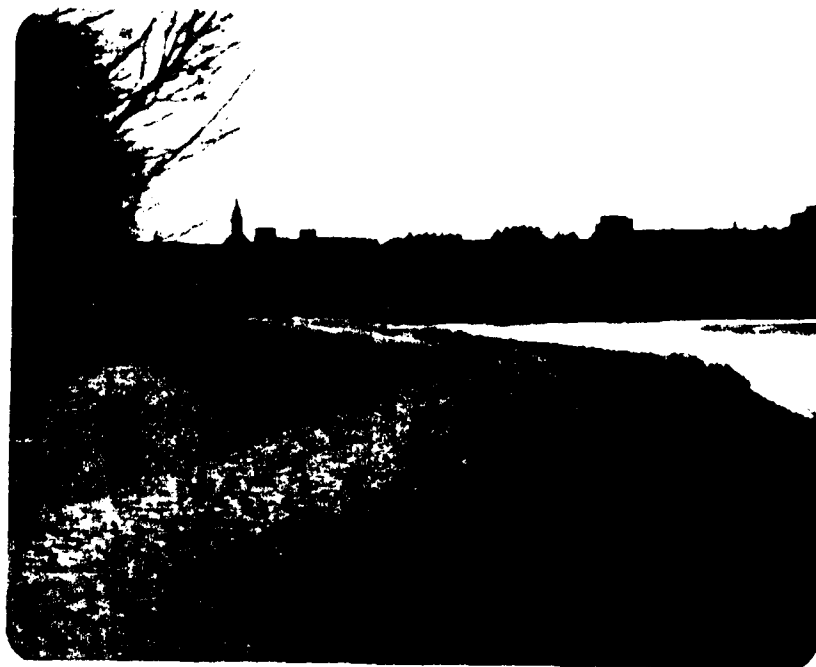
NO. 4 NORTH EMBANKMENT TO GATEHOUSE

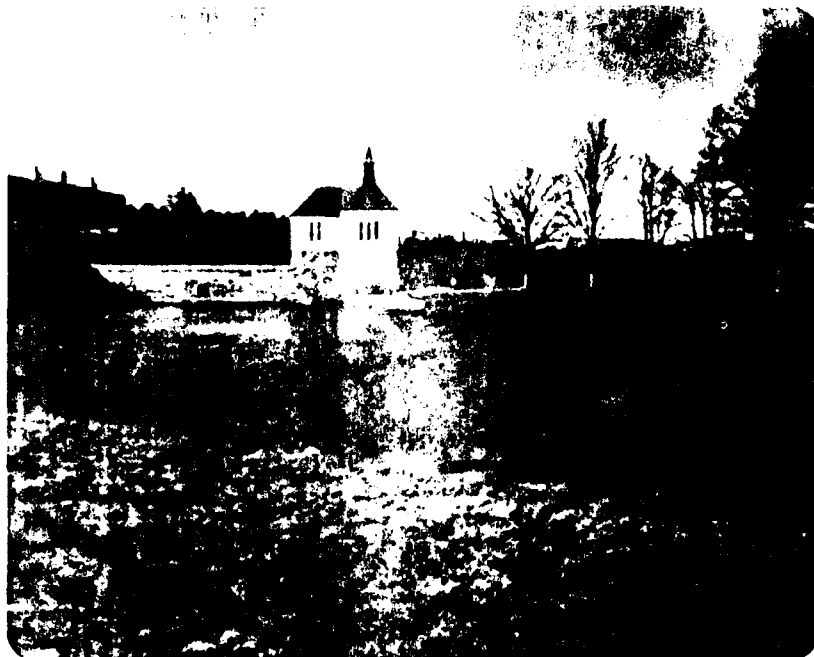
NO. 7 POND BELOW DAM
