AD-A154 653

NATIONAL PROGRAM FOR INSPECTION OF NON-FEDERAL DAMS
GOOSE POND DAM (MA 00... (U) CORPS OF ENGINEERS WALTHAM
MA NEW ENGLAND DIV JUN 79

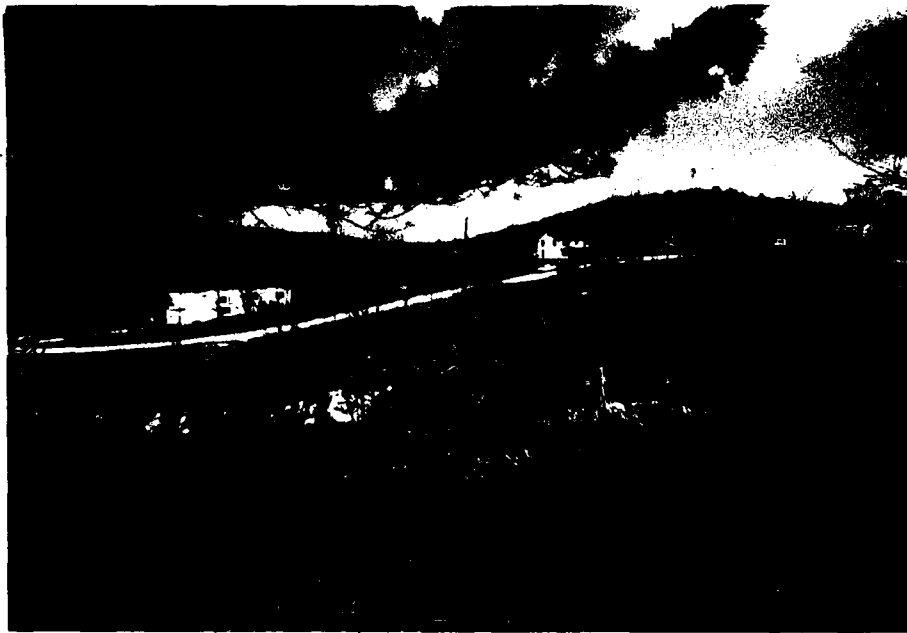
1. OVERVIEW OF DAM FROM LEFT ABUTMENT.

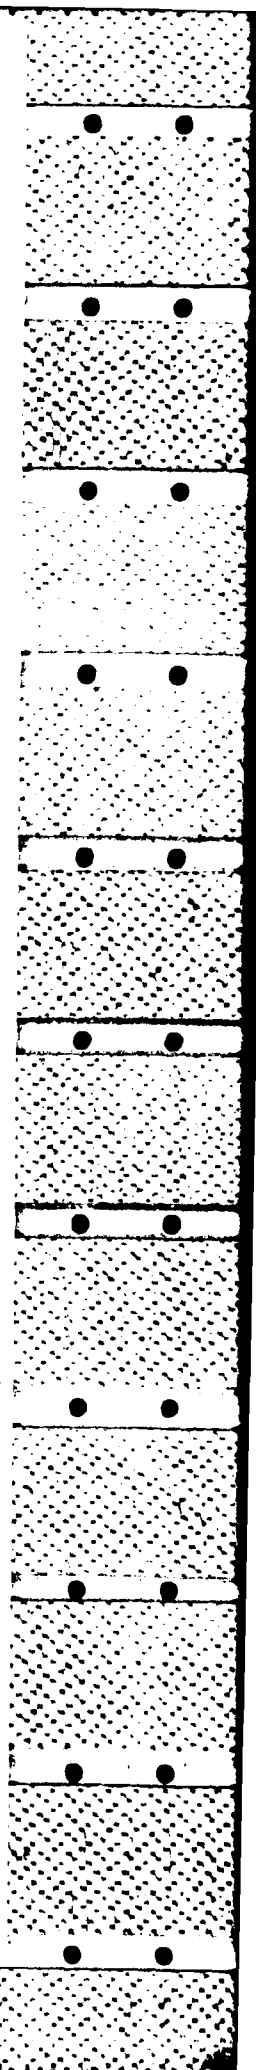
8. Downstream Face of Dam: Condition: 1. Good x 2. Minor Repairs _____
 3. Major Repairs _____ 4. Urgent Repairs _____

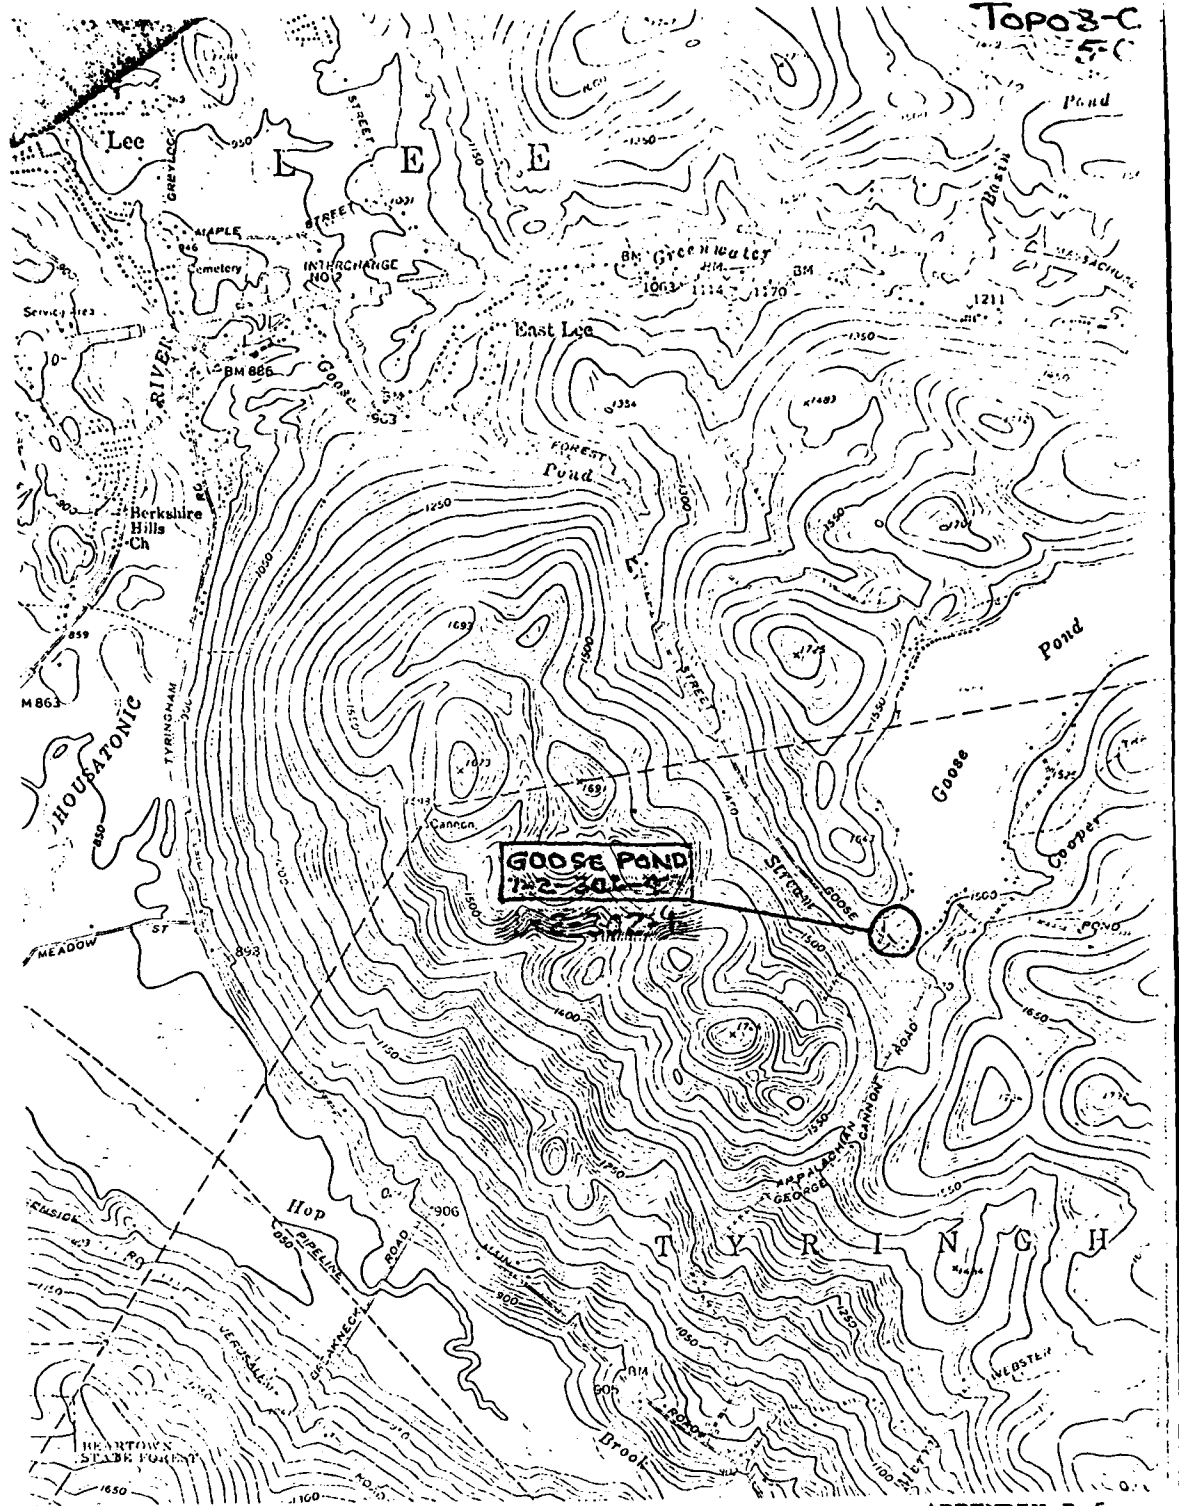
Recommendations Remove growth as necessary. Check spillway sidewalls and repair
as necessary.

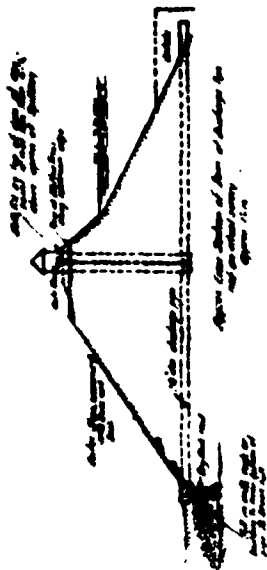
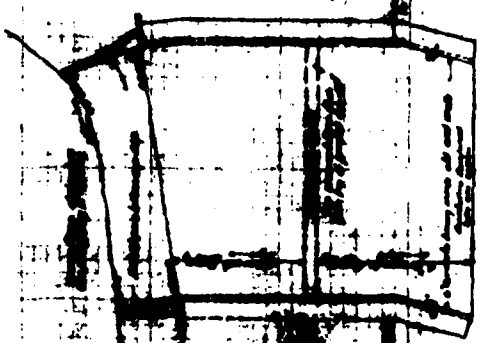
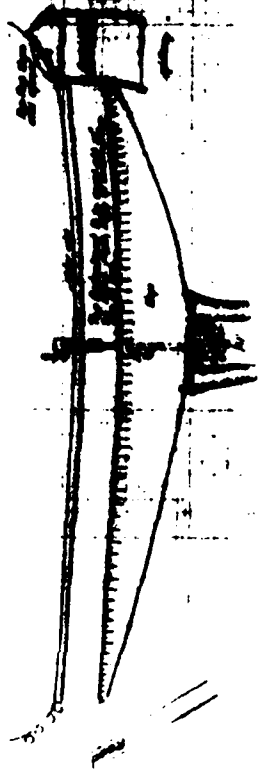
Approx. Long. Section of Span of Highway for ...

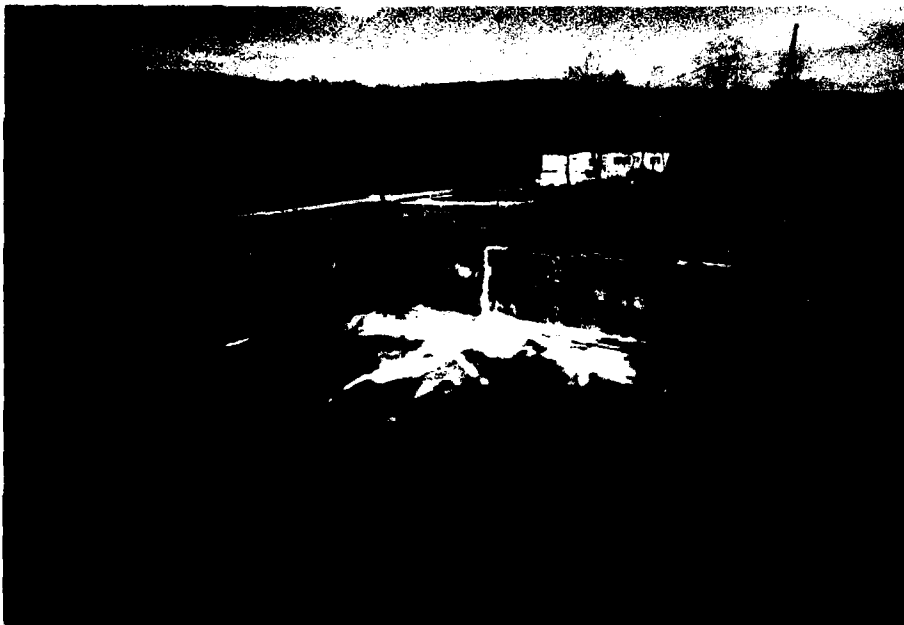
7. SPILLWAY BASE SLAB AND RIGHT SIDE WALL. NOTE RECENT CONCRETE REPAIRS.

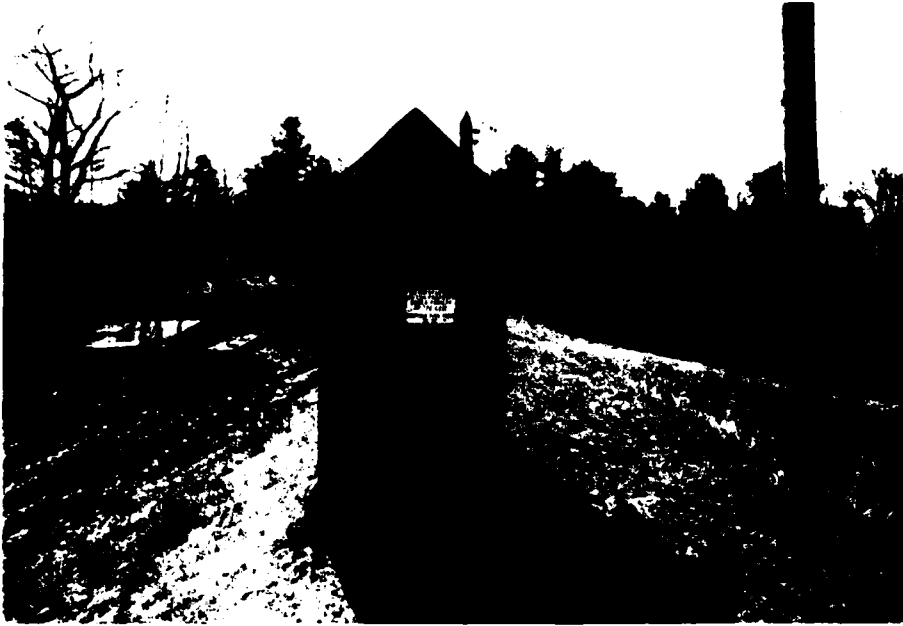
8. GATEHOUSE AND POWERLINE POLE ON DAM CREST.
