HOUSATONIC RIVER BASIN  
MONTEREY, MASSACHUSETTS

LAKE GARFIELD DAM  
MA 00249

PHASE I INSPECTION REPORT  
NATIONAL DAM INSPECTION PROGRAM

MARCH 1980

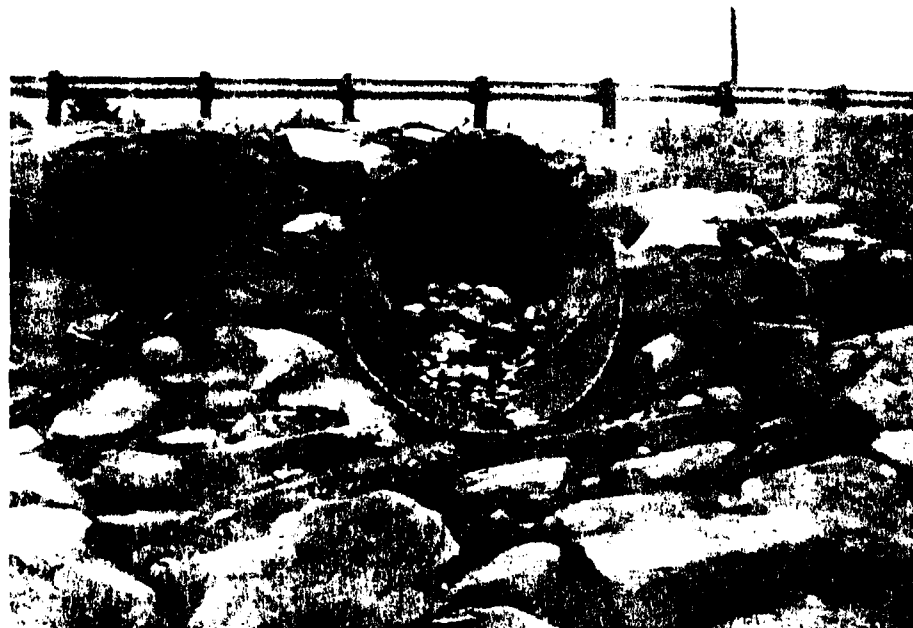
16

side of triple barrel  
showing typical  
accumulation.

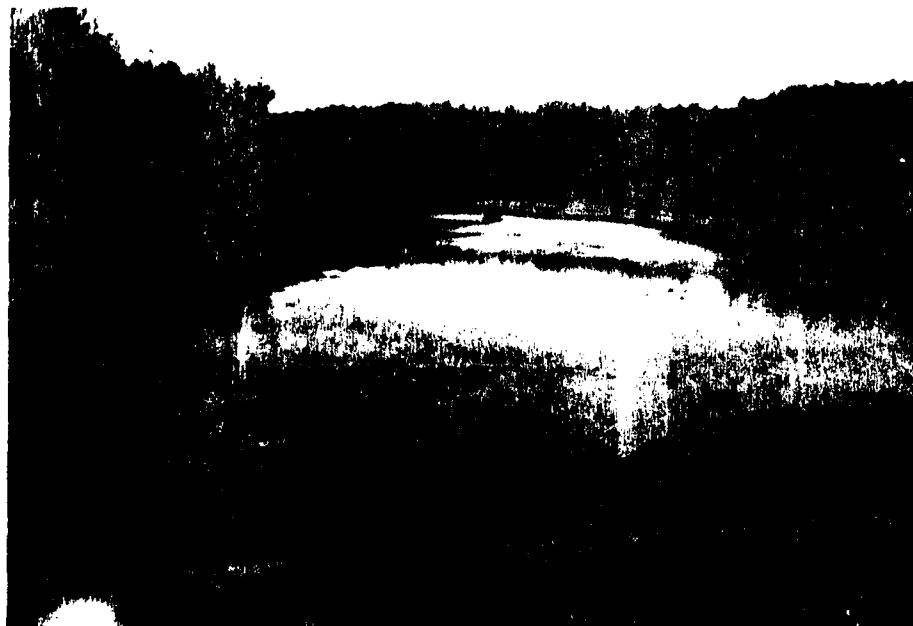
17

ndament area looking  
down of Tyringham Road  
arts towards dam  
tion. (dam not in photo)

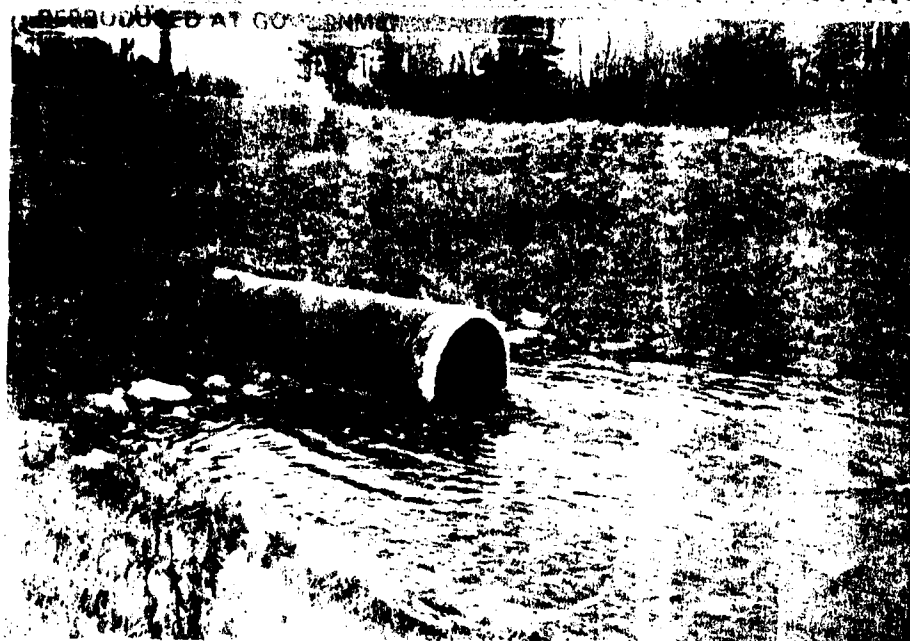
Fig. 9

Principal spillway outlet  
shift at stilling basin.
