NORTH SILVER LAKE DAM  
MA 00307

PHASE I INSPECTION REPORT  
NATIONAL DAM INSPECTION PROGRAM

DEPARTMENT OF THE ARMY  
NEW ENGLAND DIVISION, CORPS OF ENGINEERS  
WALTHAM, MASS. 02154

AUGUST, 1980

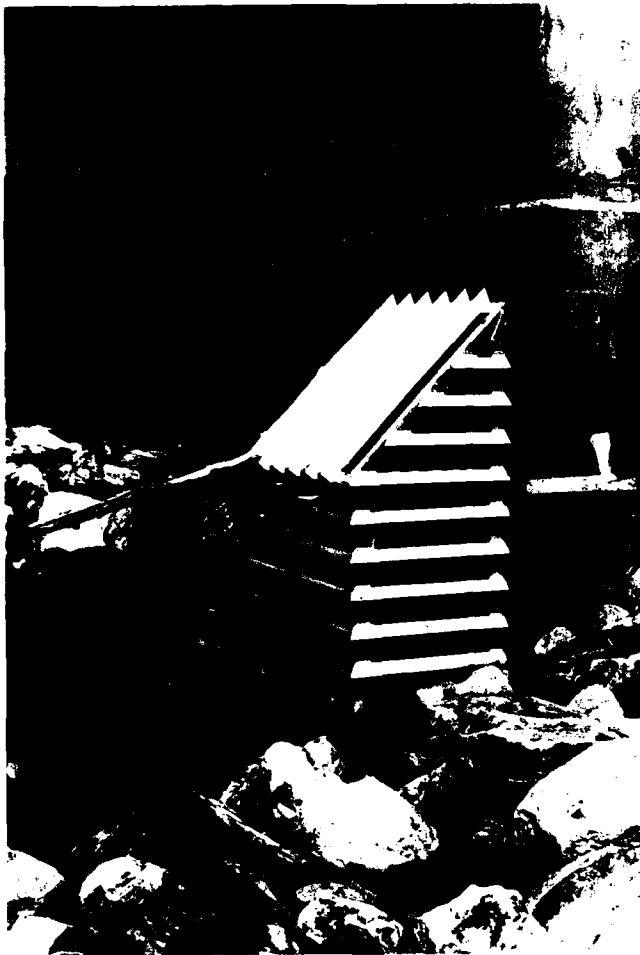
The concrete riser (principal spillway) is located to the right of the middle of the dam and is in generally good condition. (See Appendix C, photographs 5 & 6.) There is minor debris at the trash rack on the low stage riser orifice. The general condition of the principal spillway riser is good, with no spalling, rusting or staining of concrete apparent. Minor seepage, efflorescence and cracking was detected at the transition of the riser with the 48" outlet conduit. This condition is being monitored by SCS (see Section 6).

View of trash rack at upstream face of riser. Trash rack protects the 10" by 36" normal pool orifice (not visible).

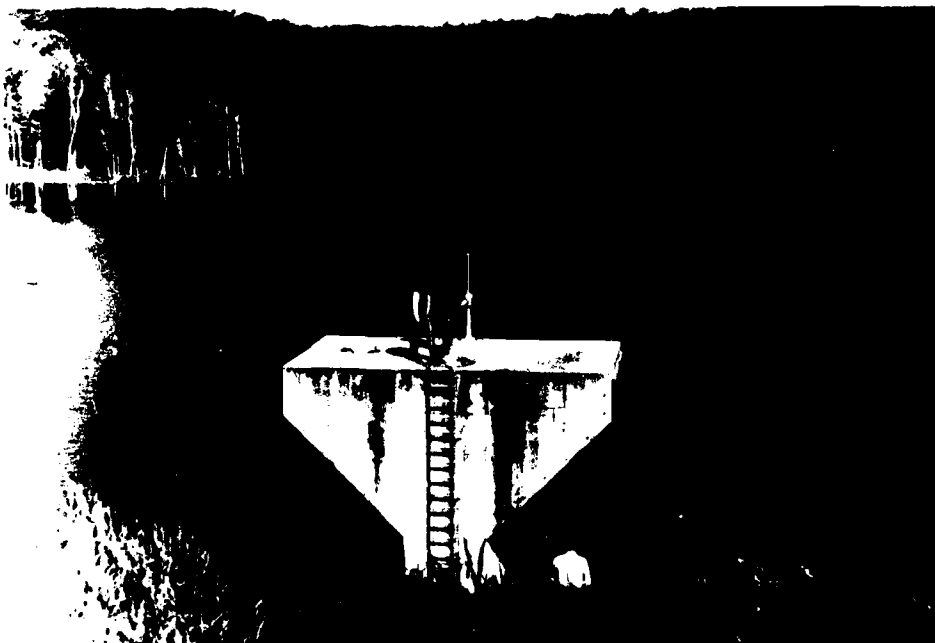
During the inspection the gate for the 24" reservoir drain was opened without difficulty. The gate would not seat tightly upon closure due to accumulation of rust in the operating mechanism. This condition has subsequently been remedied and the gate is operating satisfactorily. Routine cleaning and lubrication of the gate mechanism is necessary to prevent this condition from reoccurring.

Figure 6 - View of the downstream face of riser showing inspection manhole and gate operator with floor stand for the 24-inch reservoir drain.

The existing formal inspection and maintenance procedures including the technical inspection are good. The 24-inch reservoir drain sluice gate should be operated periodically to exercise the mechanism. Periodic lubrication and preventive maintenance of the mechanism should be carried out in accordance with the manufacturer's recommendations. The key for the gate operating handle should be secured to the operating shaft.
