MASSACHUSETTS — RHODE ISLAND COASTAL BASIN
WALTHAM, MASSACHUSETTS

MOODY STREET DAM
MA 00345

PHASE I INSPECTION REPORT
NATIONAL DAM INSPECTION PROGRAM

FEBRUARY 1979

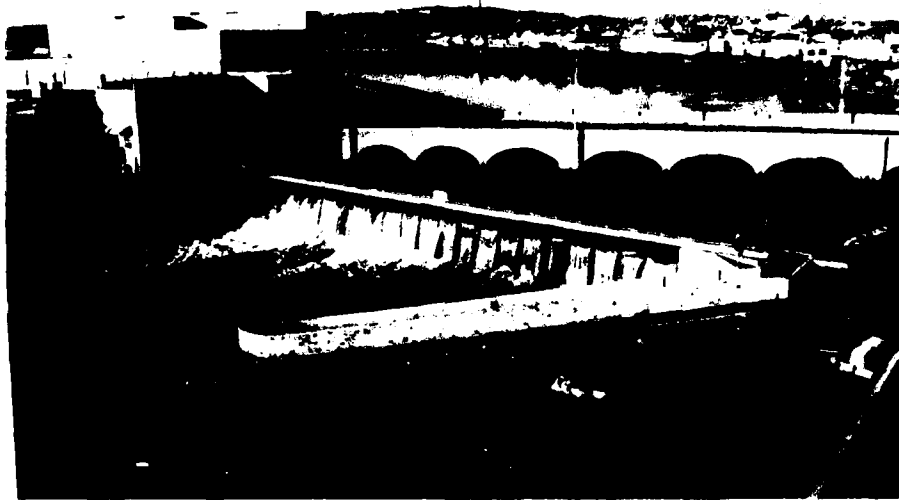
d. Reservoir Area. The area along the Charles River upstream from the Moody Street Dam is highly developed and has low relief, Photos No. 1 and 9. There appears to be no probability that landslides into the river would cause waves which would overtop the dam. No conditions which might result in a sudden increase in sediment load into the river were noted.

A new reinforced concrete fishway structure at the left end of the spillway was near completion, Photos No. 1 and 7. The condition of the fishway was excellent.

1. Overview of Moody Street Dam

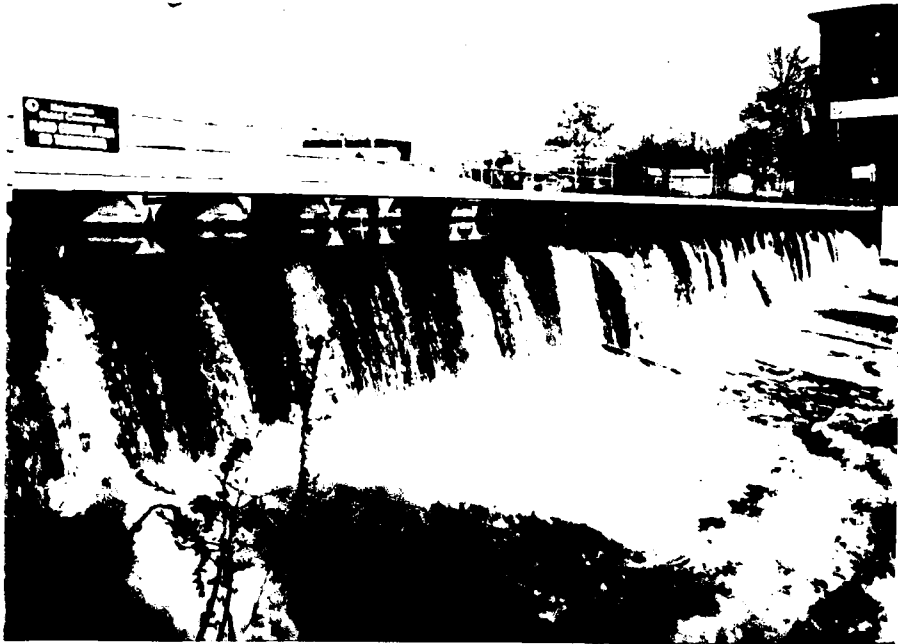
b. Dam. The spillway weir is constructed on granite masonry and is apparently founded on glacial till. A complete examination of the weir was not possible due to flow of water, Photos No. 1, 2, 3 and 4. The downstream apron was not visible. There is apparently no means to lower the water level below the spillway crest.

3. Spillway viewed from right bank

2. Examine the dam at a time when there is low flow to assess the condition of the granite masonry spillway weir, the downstream apron and the flashboards.
3. Assess the potential vulnerability of the dam to seismic events by conventional equivalent static load methods.

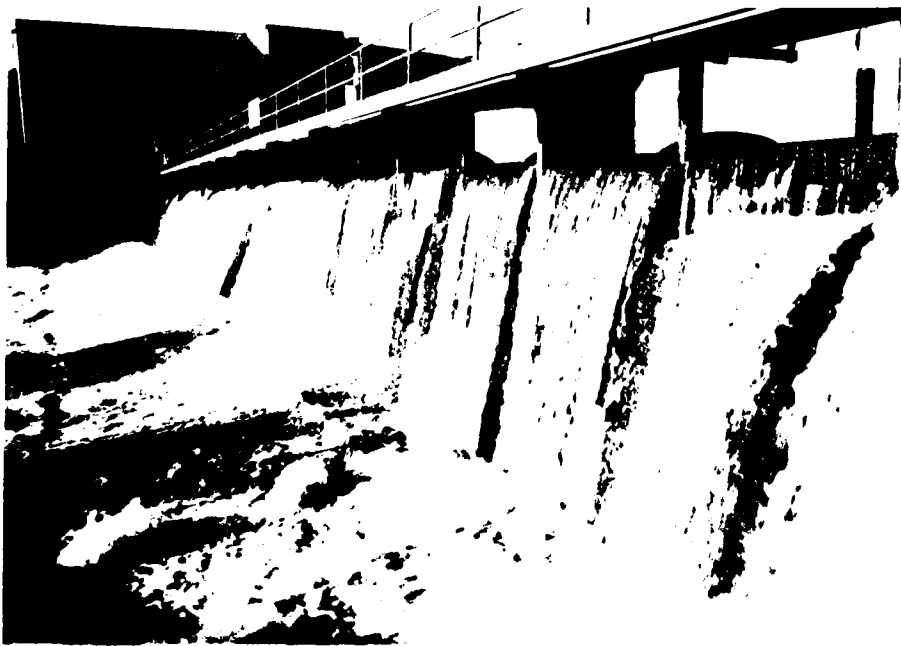
4. Spillway viewed from left bank
