**FINAL**  
NORTH RIVER BASIN  
PEABODY, MASSACHUSETTS

**SPRING POND DAM  
MA 00193**

**PHASE 1 INSPECTION REPORT  
NATIONAL DAM INSPECTION PROGRAM**

DECEMBER 1978

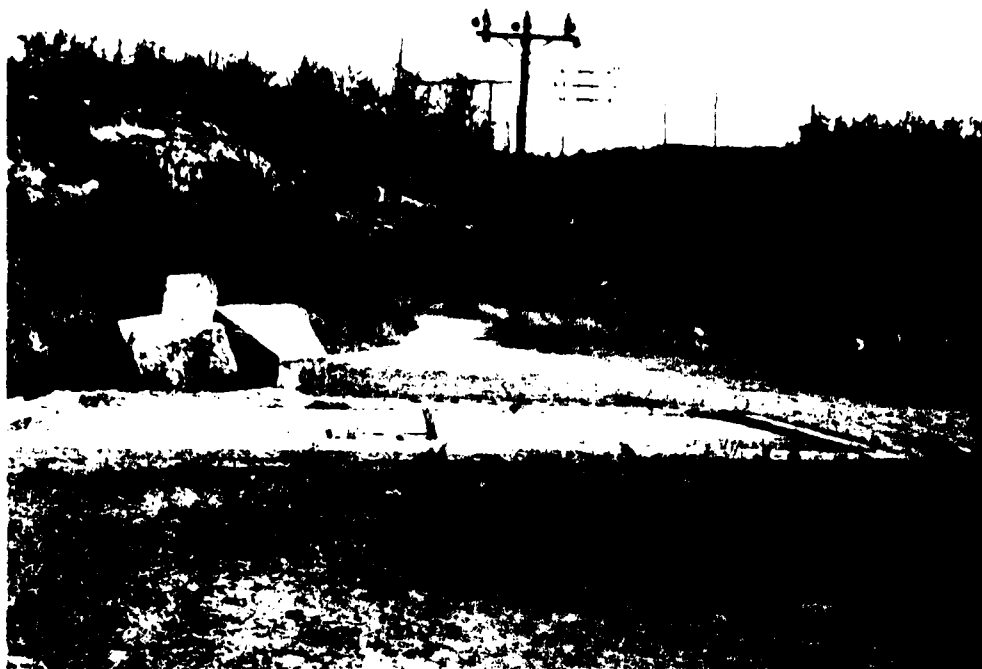
The earth embankment appears to be in generally good condition. The horizontal alignment of the crest is generally good and the vertical alignment is also good except for some depressions and ruts which have been created by traffic, especially trail bikes. (See Photograph No. 2). There is a high voltage transmission tower and a telephone pole located on the crest of the embankment. (See Photograph No. 2). Several concrete blocks were observed on the crest. It is reported that these will be placed, at some future date, on the upstream slope as additional slope protection. (See Photograph No. 2).

2. VIEW OF CREST. NOTE REMNANT OF GATE HOUSE IN FOREGROUND AND HIGH VOLTAGE TRANSMISSION TOWERS.

5. Remove all brush, shrubs and young saplings from both slopes and the crest.
6. Refill areas of erosion and gullies on the downstream slope and crest.
7. Replace stones missing on upstream riprap slope protection.
8. Traffic on the crest should be eliminated. If this is not practical, consideration should be given to paving the crest.
9. Consideration should be given to relocating the high voltage transmission tower off the dam crest.

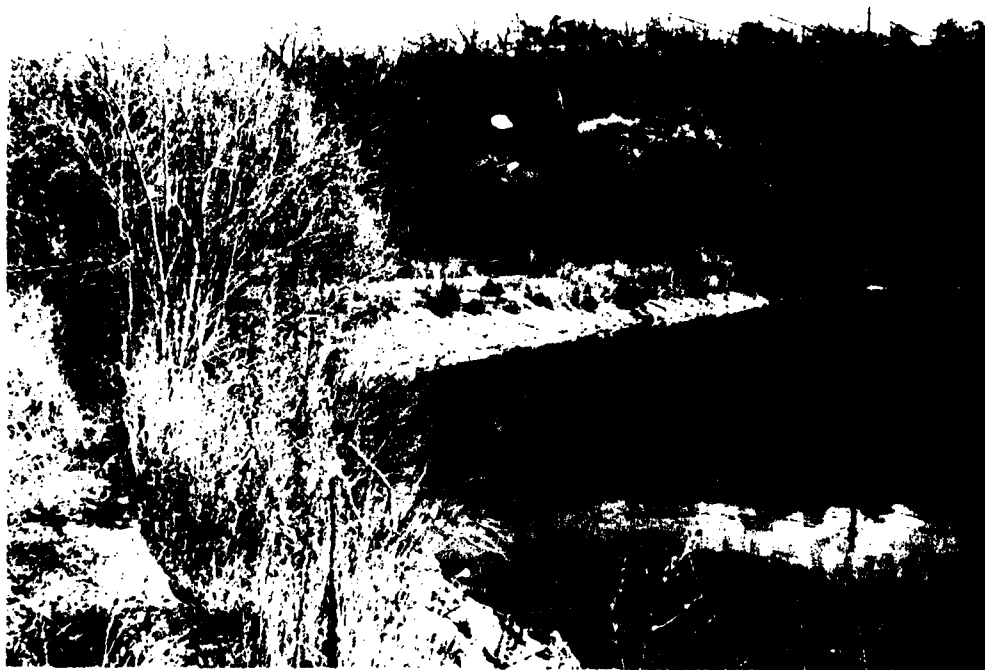
The upstream slope is in generally good condition. The cemented riprap is in good condition, however, the cemented section of riprap extends only little more than half way along the length of the embankment. The remainder of the slope protection consists of uncemented riprap. In this area some stone is missing, and others have been displaced. There are saplings, tall weeds, brush and grass growing through the riprap. (See Photograph No. 3). Two 8-inch diameter pipes located on either side of and parallel to the spillway and about one foot below the dam crest were observed. Reportedly these pipes had been used as overflow pipes but have since been plugged.

3. VIEW OF UPSTREAM SLOPE. NOTE CEMENTED STONE RIPRAP AND VEGETATION.
