NATIONAL PROGRAM FOR INSPECTION OF NON-FEDERAL DAMS  
AMERICAN TISSUE DAM (U) CORPS OF ENGINEERS WALTHAM  
MA NEW ENGLAND DIV OCT 78

Based on the visual inspection and past operational performance the dam is judged to be in fair condition. The dam structure appears to be in good condition but the gate works are in poor condition. The dam is not presently operated.

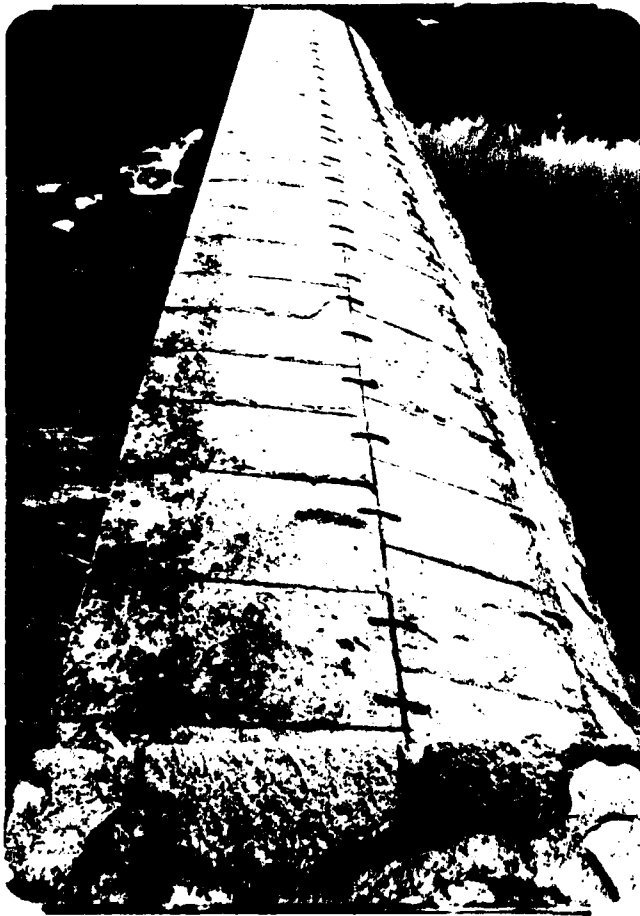
- (f) Some tree and brush growth has occurred in the masonry of the dam. The embankment sections of the dam are tree and brush covered.
  - (g) The cap stones in the spillway are solidly mortared. The iron u-pins which attach the stones to each other are badly rusted but are intact.

7  
DAM SPILLWAY CREST

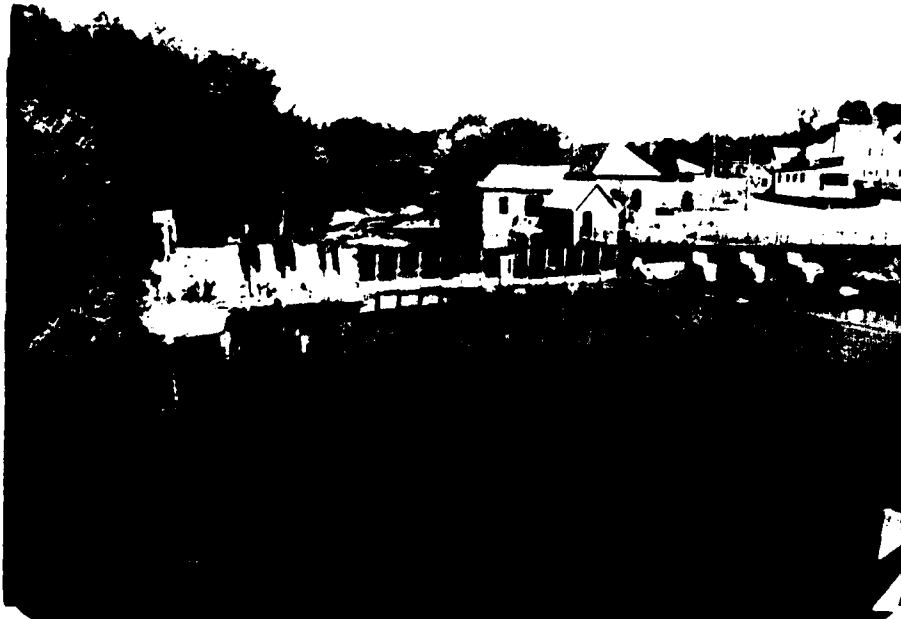
8  
GARDINER WATER DISTRICT DAM
