**MOUSAM RIVER BASIN
SHAPLEIGH, MAINE**

**EMERY MILLS DAM
ME-00186**

**PHASE I INSPECTION REPORT
NATIONAL DAM INSPECTION PROGRAM**

OCTOBER 1978

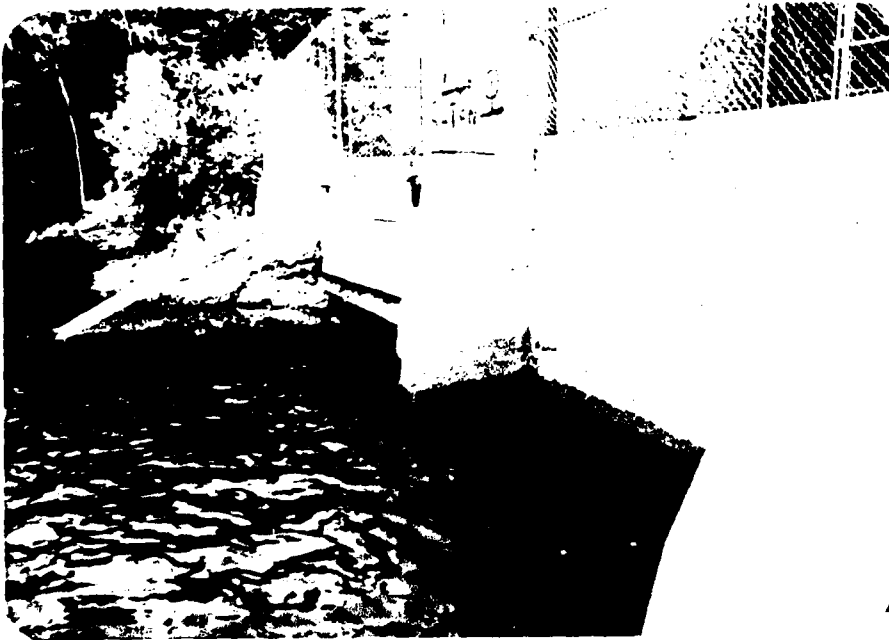
3

- (a) The dam structure appears to be true to line and grade; no horizontal or vertical movement was observed.
- (b) Some spalling of the concrete surfaces in the areas of the controlled outlet gatehouse has occurred. See photograph 3.

CONTROL GATE INTAKE STRUCTURE

5. Repair areas of spalled concrete.
 6. Provide around-the-clock surveillance during periods of anticipated high runoff.
 7. Develop a formal warning system and implement its use in the event of an emergency.

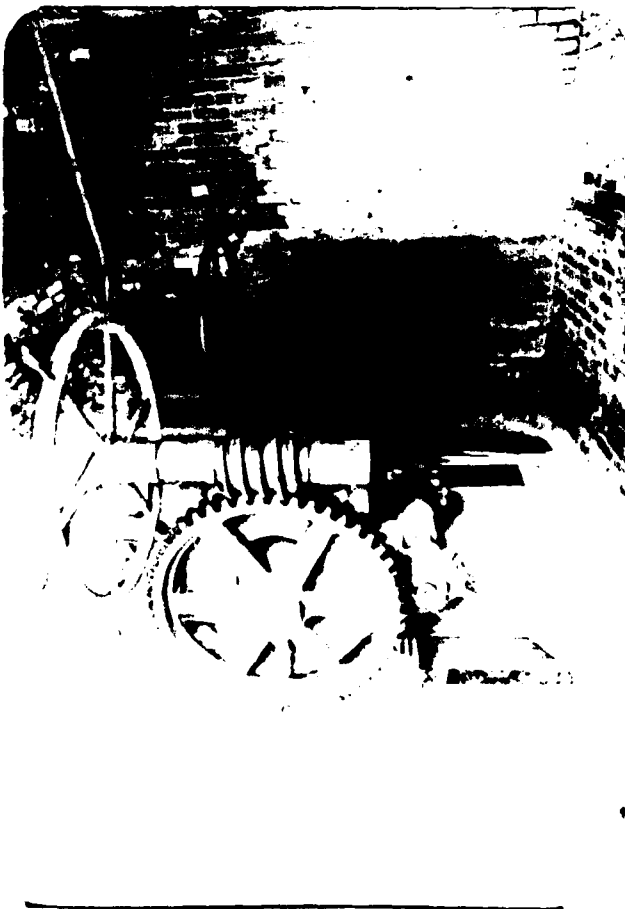
4

CONTROL GATE MECHANISM

- b. Operating and Emergency Control Gates - the gates are raised by means of a vertical rack and gear. The gate stems, one for each gate, consist of steel beams. These beams appear to be in good condition; very little corrosion has occurred. The gate operating equipment was found to be in good repair. See photograph 4. The gates were operated during the inspection and it was observed that they operated properly.
