AD-A154 689 NATIONAL PROGRAM FOR INSPECTION OF NON-FEDERAL DAMS  
ASSABET RIVER DAM (MA.. (U) CORPS OF ENGINEERS WALTHAM  
MA NEW ENGLAND DIV DEC 79

ASSABET RIVER DAM

OVERVIEW  
ASSABET RIVER DAM  
WESTBOROUGH, MASSACHUSETTS

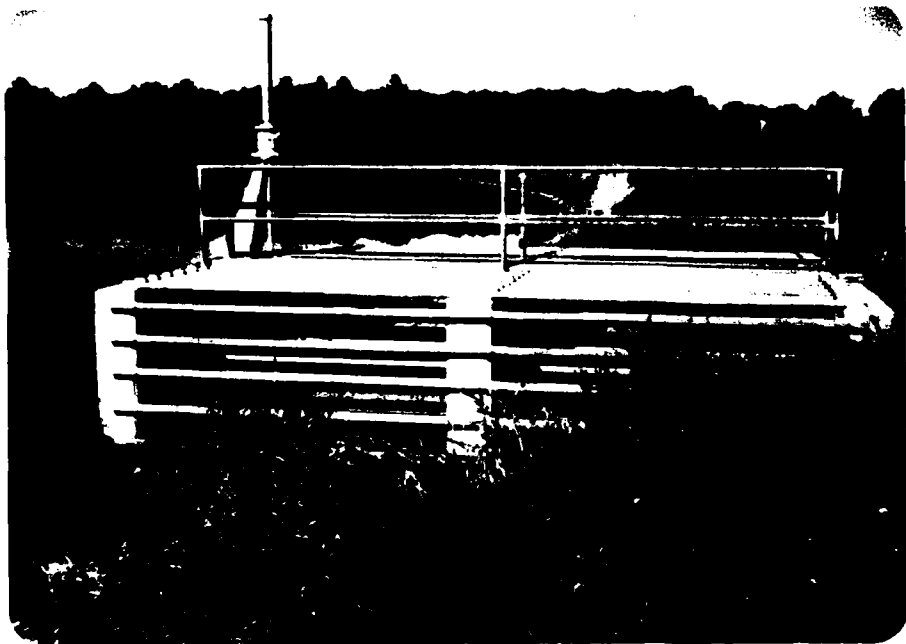
**NO. 1 OUTLET WITH TRASH RACKS AT SPILLWAY**

gate is operable and at the time of the inspection was partially open to maintain flow in the Assabet River. It was not operated at the time of the inspection. The concrete on the intake structure was in good condition, although there was some minor pitting and staining on the walls. The trash rack around the intake structure is in fair condition. Some of the bar racks below the waterline show signs of heavy corrosion and several of the bolts are corroded. The riprap protection around the structure is in poor condition and in several areas the riprap is missing.

- 4.3 Maintenance of Operating Facility. The operating mechanism at the dam is the sluice gate on the low-level outlet. This gate is operated by the SCS personnel during their annual inspection. The condition of the trash racks around the outlet structure (see Photo No. 1 in Appendix C) is also reported and maintenance performed as required.
