EAGLE LAKE DAM

MA 00979

PHASE I INSPECTION REPORT
NATIONAL DAM INSPECTION PROGRAM

AUGUST 1978

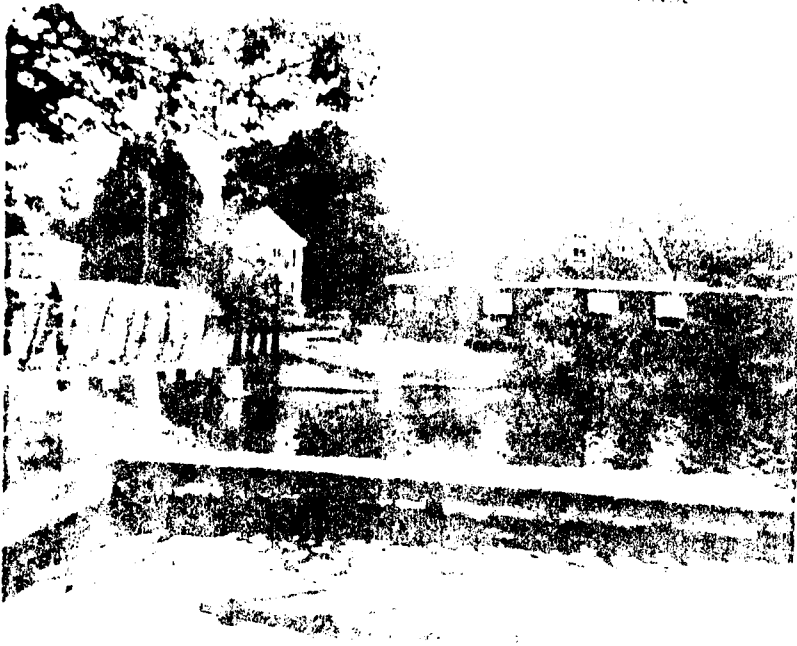
2

Upstream View of Dam from Left Bank

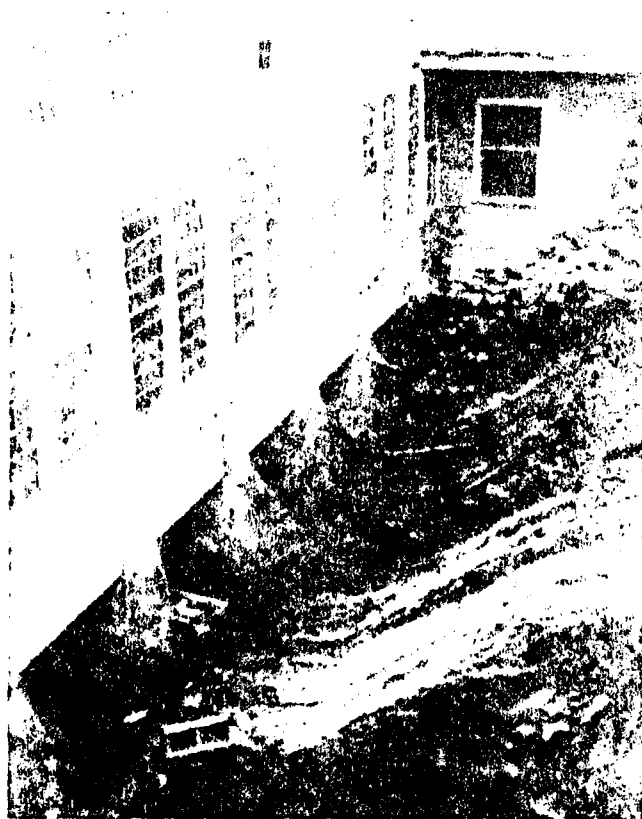
3

Downstream View of Spillway from Bridge

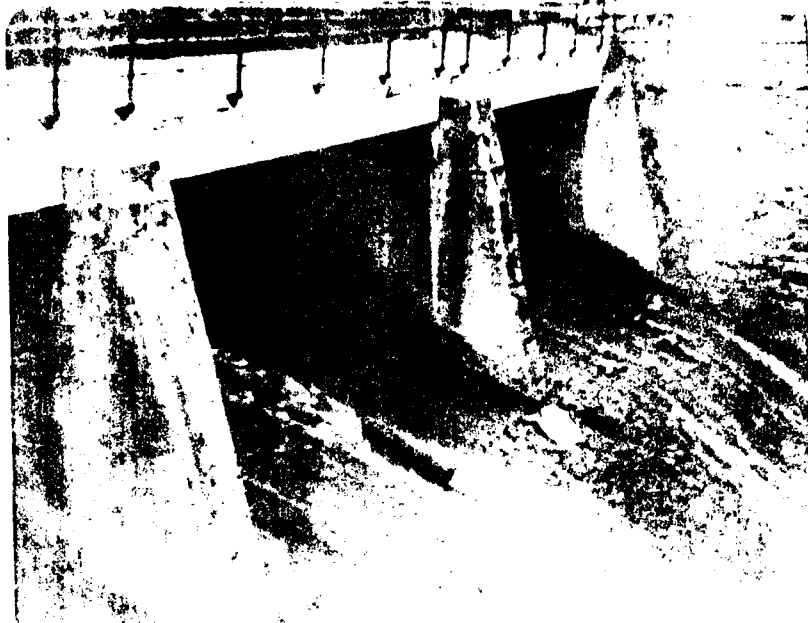
4

Downstream View of Spillway
from Right Bank

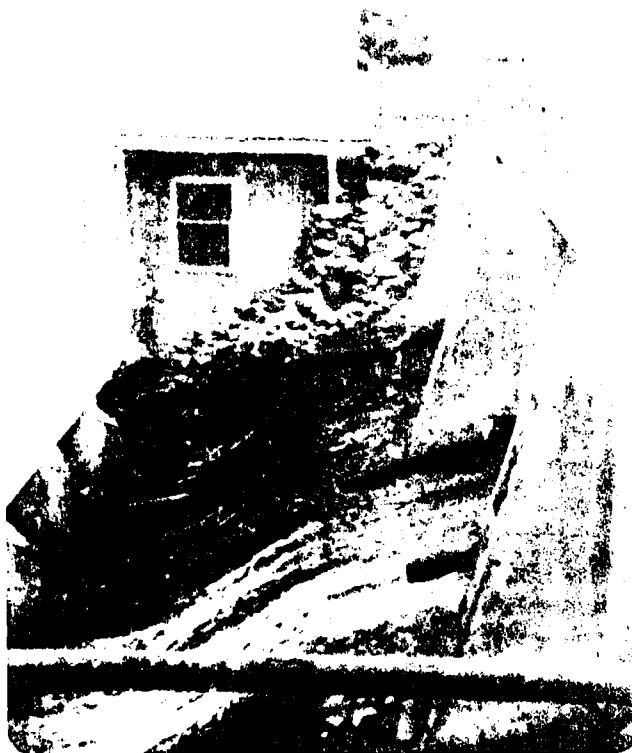
5

Downstream View of Spillway
from Left Bank

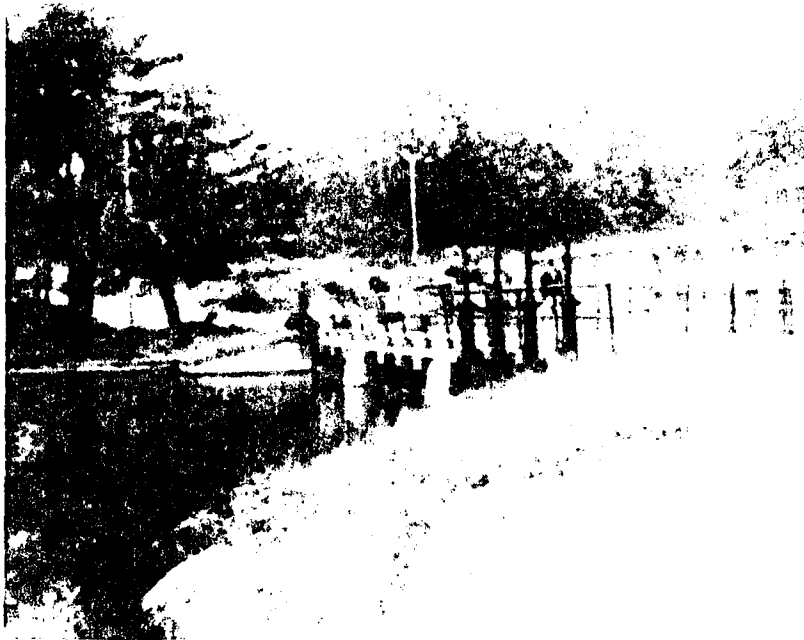
Upstream View of Spillway from Right Bank
