NATIONAL PROGRAM FOR INSPECTION OF NON-FEDERAL DAMS
SEBAGO LAKE DAM (ME-0... (U) CORPS OF ENGINEERS WALTHAM
MA NEW ENGLAND DIV SEP 78

ME-00071
DOCUMENT IDENTIFICATION

Sep 1978

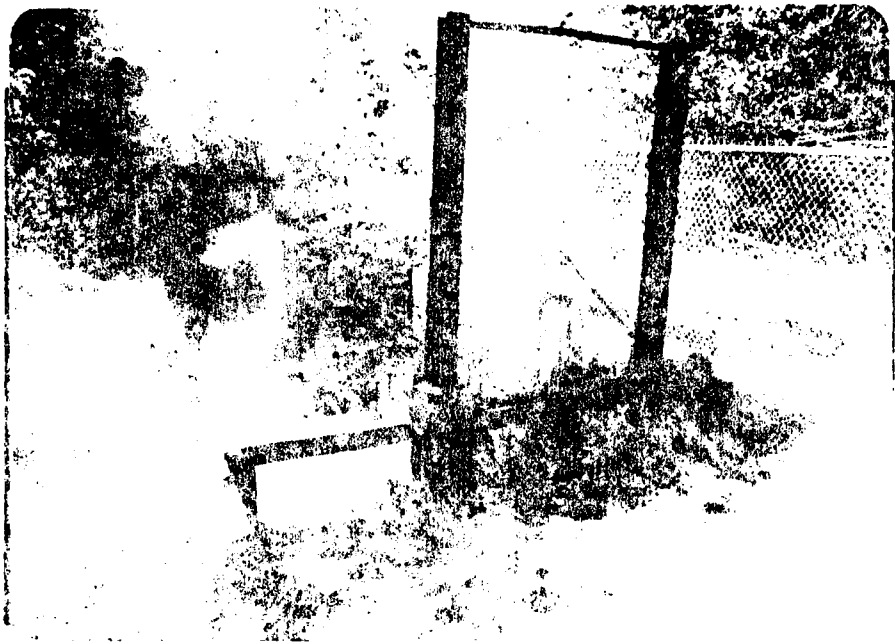
11
OLD CANAL GATE

- (d) The timber gate in the old canal lock located in the southerly portion of the dam is badly deteriorated. Earth fill has been placed upstream of the old canal lock but the gate is in effect acting as a retaining structure (photograph 11).

1. Trees and brush should be cut from all masonry faces of the dam.
2. A reinforced concrete wall should be placed in the old canal lock to replace the old timber gate which is badly deteriorated.
